Field campaign

Topic	Tailgate hinge bolt (SC18/14)
Market area	Bentley: worldwide (2WBE),Hongkong-Macau (5HK)
Brand	Bentley
Transaction No.	2052498/2
Campaign number	EB11
Note	
Type	
US code

Bentayga

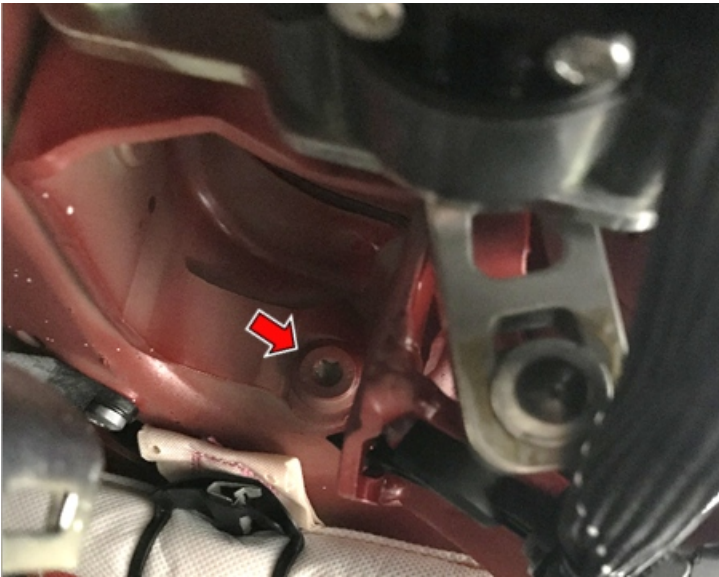
Figure 1

The tailgate hinge bolt to the body can experience torque relaxation

Replace the highlighted old bolt (*Figure 1*) with the highlighted new bolt **N 107 884 01** (*Figure 2*) on **both** tailgate hinges

20 Nm + 90°

The bolt must be tightened to 20Nm + 90° and no more

The bolt must be replaced if re-torque is required

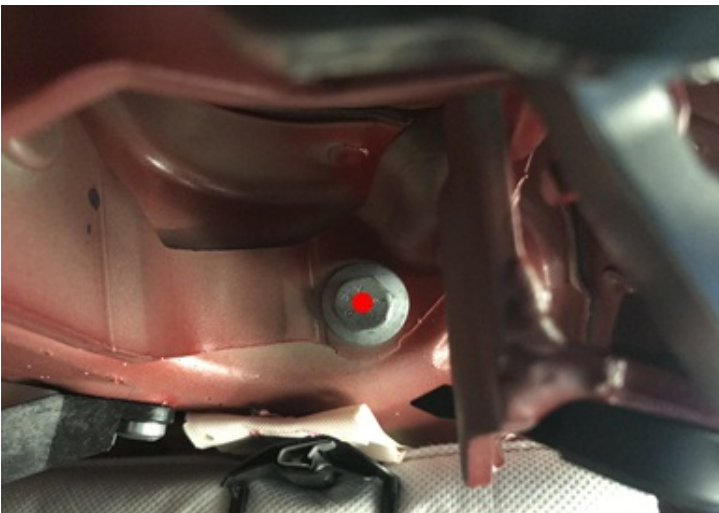
Figure 3

If the vehicle is not already listed as repaired in 'Repair history' (in Elsa Pro) check the vehicle has the RED paint mark applied to the new bolts as shown in *Figure 3*. In the event that the campaign has not been applied, please carry out the required work in accordance with these instructions

On completion apply a RED paint mark to each of the new bolts (Figure 3). The presence of the RED paint mark confirms campaign completion
