Multiple Indicators On and Option Fuse (E21) Blown

AFFECTED VEHICLES

Year	Model	Trim	VIN Range
2016-19	MDX	ALL	ALL

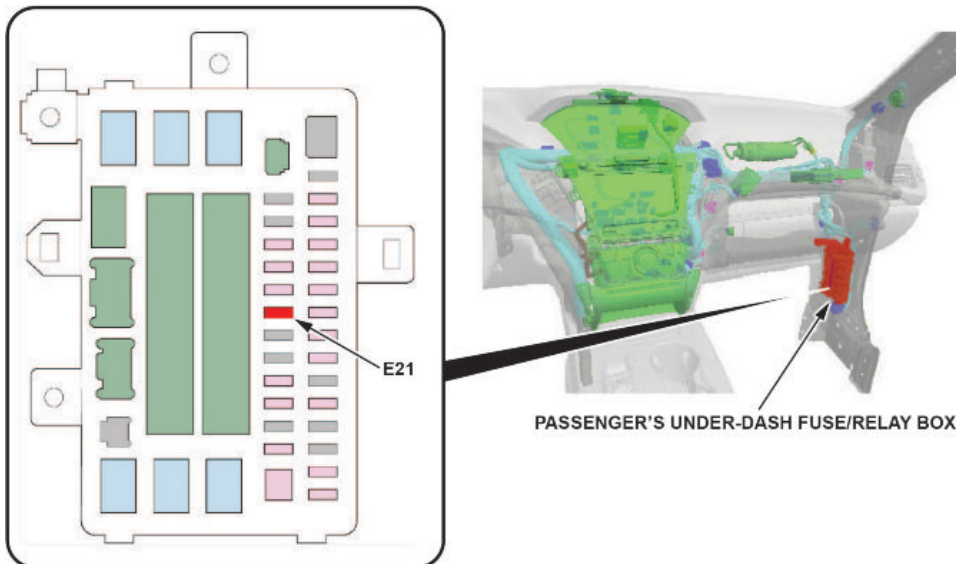
MDX

1. Check the option fuse.

- If the option fuse is blown, replace the battery fan motor. Refer to the service information. Then go to step 2.
 - If the option fuse is not blown, this bulletin does not apply. Continue with normal system troubleshooting.
2. Replace the option fuse (7.5 A).
