Lower half-fairing repair procedure with rivet Part no.73640351A

Panigale V4, Panigale V4 S, Panigale V4 Speciale
Service Repair Bulletin SRV-SRB-19-002

Date: January 24, 2019
To: Dealer Principal, General Manager, Service Manager, North American Dealer Network
From: Richard Kenton, Technical Director
Eric Bradley, Technical Training and Publications Manager

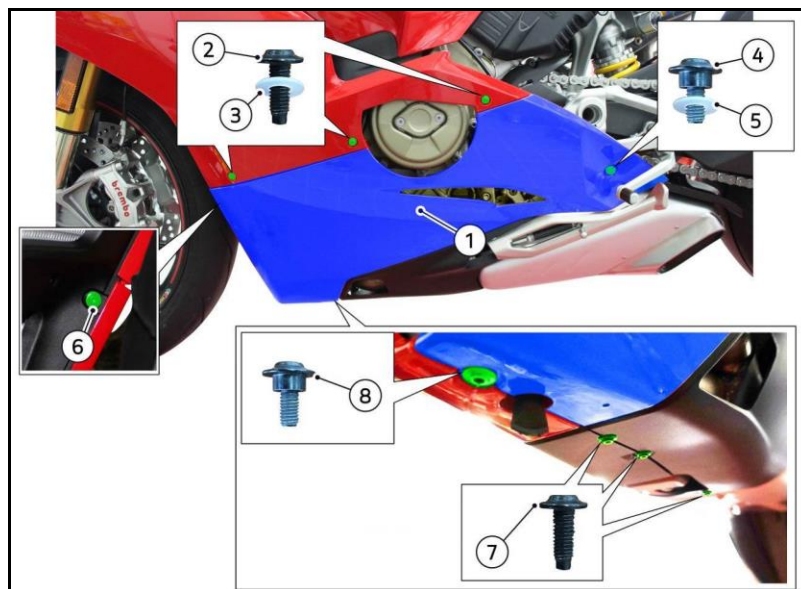
This Service Bulletin is to inform you how to repair the lower left half-fairing in case of detachment from the silencer cover with rivet \varnothing 5.25x1, Part no.73640351A.

If the lower left half-fairing detaches itself from the silencer cover at the vibration welding point (bike front area), it will NOT be necessary to order a new spare half-fairing.

1. Remove the lower LH half-fairing (1) after removing:
 - 1.1 the 3 M5x12 screws (2) with relevant nylon washer (3)
 - 1.2 the M5x9 screw (4) with collar with the relevant nylon washer (5)
 - 1.3 the M5x12 screw (6)
 - 1.4 the 3 M5x12 lower screws (7)
 - 1.5 the M5x8.5 lower screw (8) with collar
