TECHNICAL SERVICE BULLETIN

Transmission Clutch Fluid Overheating During Track Use - Vehicles Equipped With Parallel Coolers Only

18-2391

Ford 2017 Ford GT

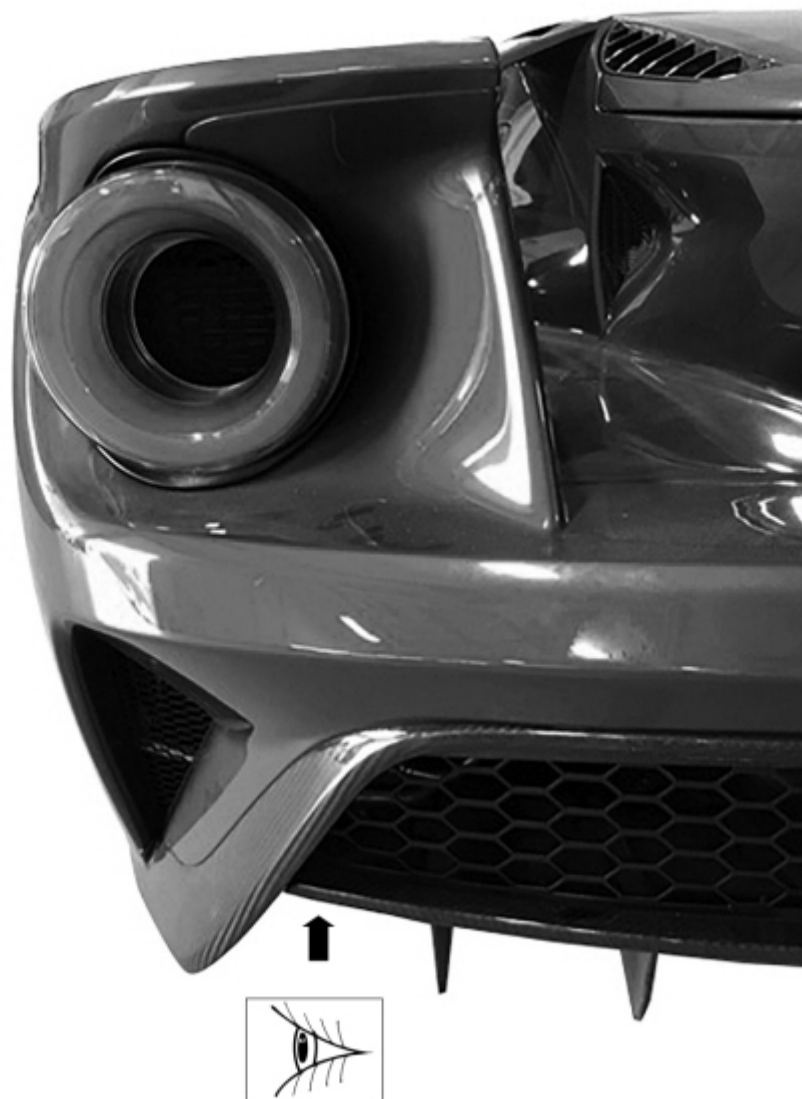
Figure 1

1. Inspect the factory equipped transmission gearset and clutch cooler by looking thru the rear fascia grille opening at the left side of the rear bumper cover. (Figure 1) Is the vehicle equipped with a perpendicular transmission gearset and clutch cooler? (Figure 2-3)

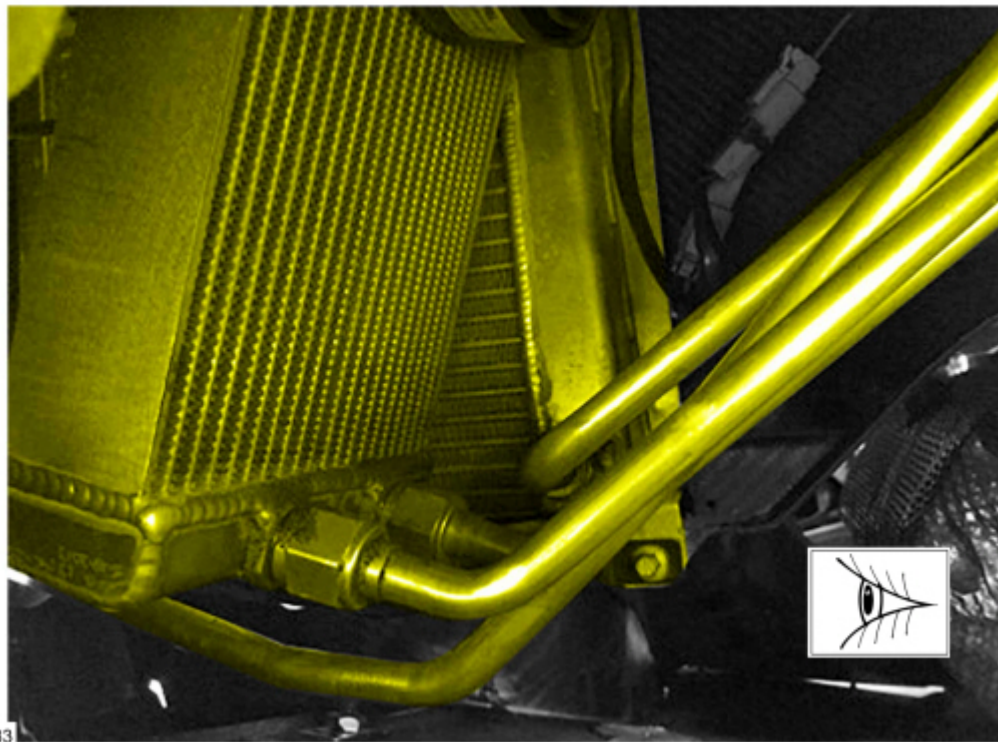
Figure 3 - Perpendicular

(1). Yes - this article does not apply. Refer to Workshop Manual (WSM), Section 307-02 for normal diagnostics.
