## Audio 20: Welcome light settings misadjusted after bus idle

| Topic number | LI82.85-P-069261 |
| Function group | 82.85 Navigation and Communication system (CNS, ICS, COMAND, FleetBoard) |
| Validity | MODEL 292, 166, 242, 156, 172, 117 with code 522 or 520 or 505 |

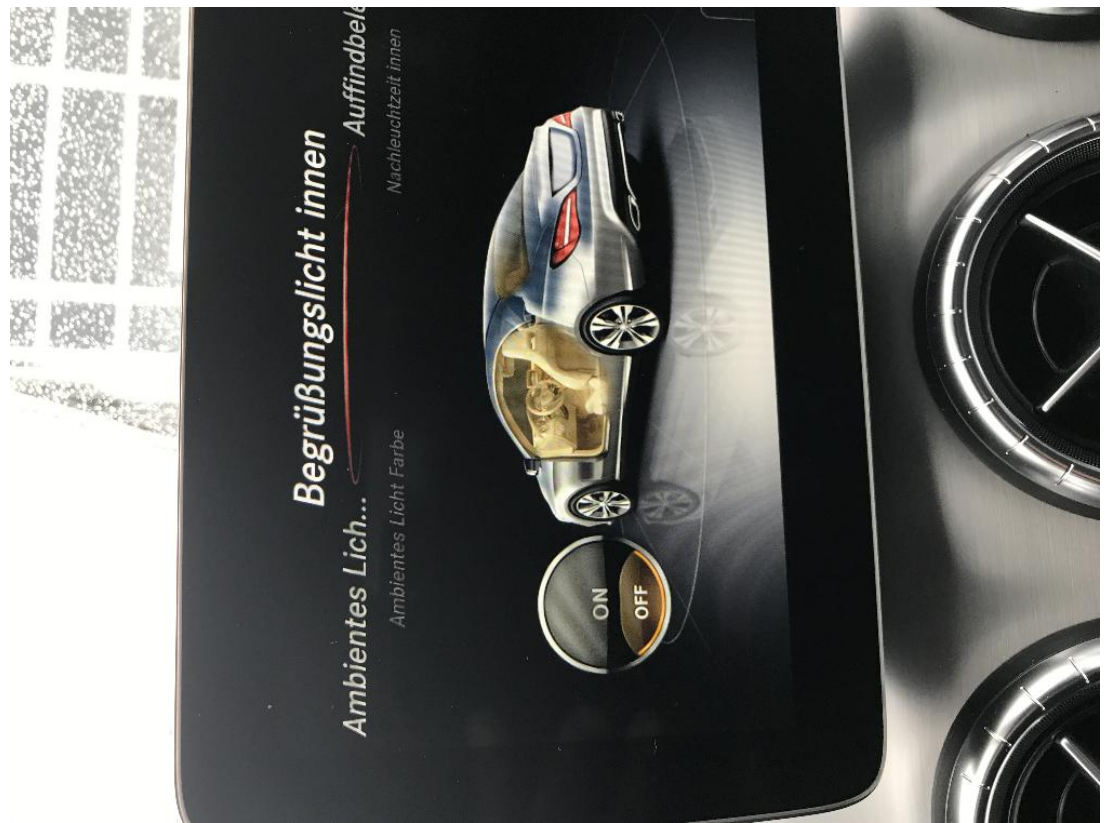
IMG\_1513.JPG:

The "interior welcome light" setting changes from ON to OFF after a bus idle with no action by the customer.

| Attachments | |
|---|---|
| IMG_1513.JPG | Welcome light settings |

Possibly the software for the Audio20 control unit (A26/17).

Perform software update of head unit to software release E433.1 (18/31.40) or newer.
