## Smart audio system - Radio inoperative - New software available

| Topic number | LI82.60-P-063836 |
| Validity | BR453 with smart audio system, SA code 537/561/505/562 |

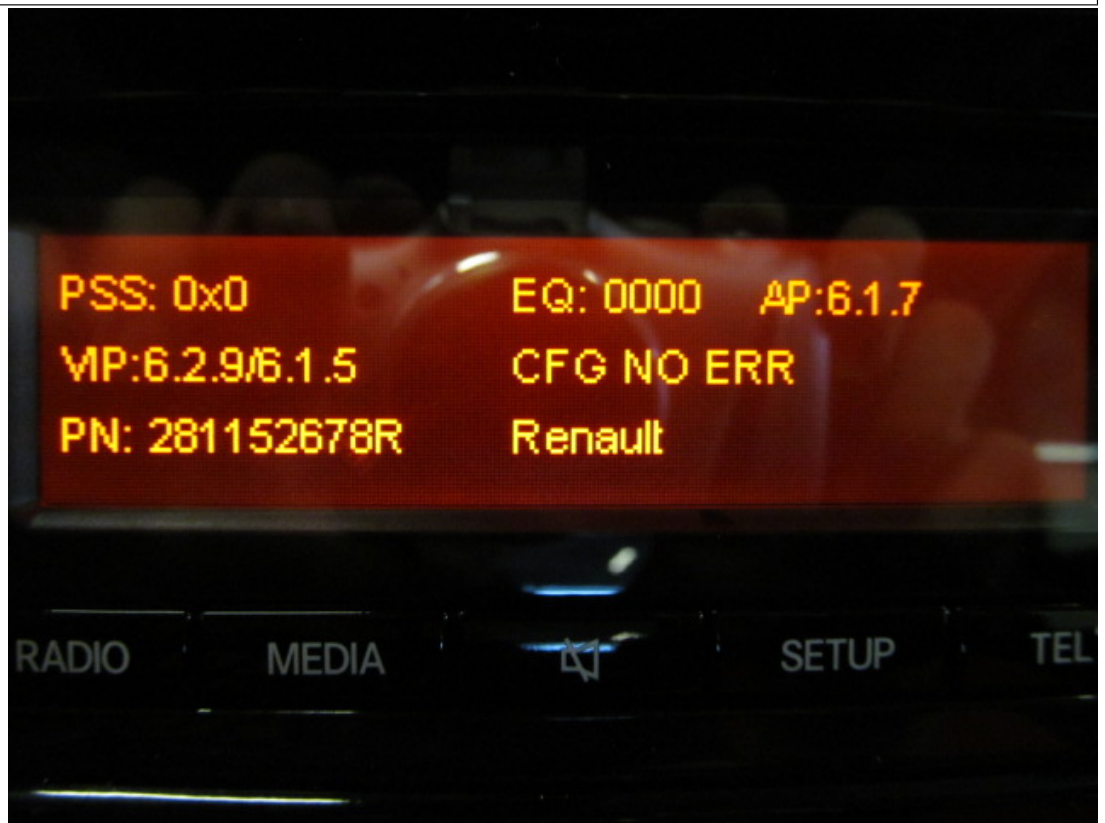
IMG\_2513[1].JPG:

The Audio radio (A2) (smart audio system) does not work and shows a display message similar to that in the attachment.

| Attachments | |
|---|---|
| IMG_2513[1].JPG | Display message |

May be due to the USB software being not installed, incorrect, or incomplete.

Perform control unit programming "A2 - Radio - smart audio system (Audio)".

Please follow the description in XENTRY Diagnosis. The additionally required USB software can be found in the XENTRY Portal:

When selecting the USB software, always make sure that the assignment to the CAN software is correct; refer to the explanation for the appropriate USB software in the XENTRY Portal.

SCN coding must be performed after successful programming.
