ESP, BAS, PRE-SAFE - Fault message in instrument cluster

Topic number	LI54.18-P-067550
Version	4
Function group	54.18 Cable harnesses
Date	01-25-2019
Validity	Model 213, 238 and 257
Reason for change	Repair method revised and text optimized.
Reason for block

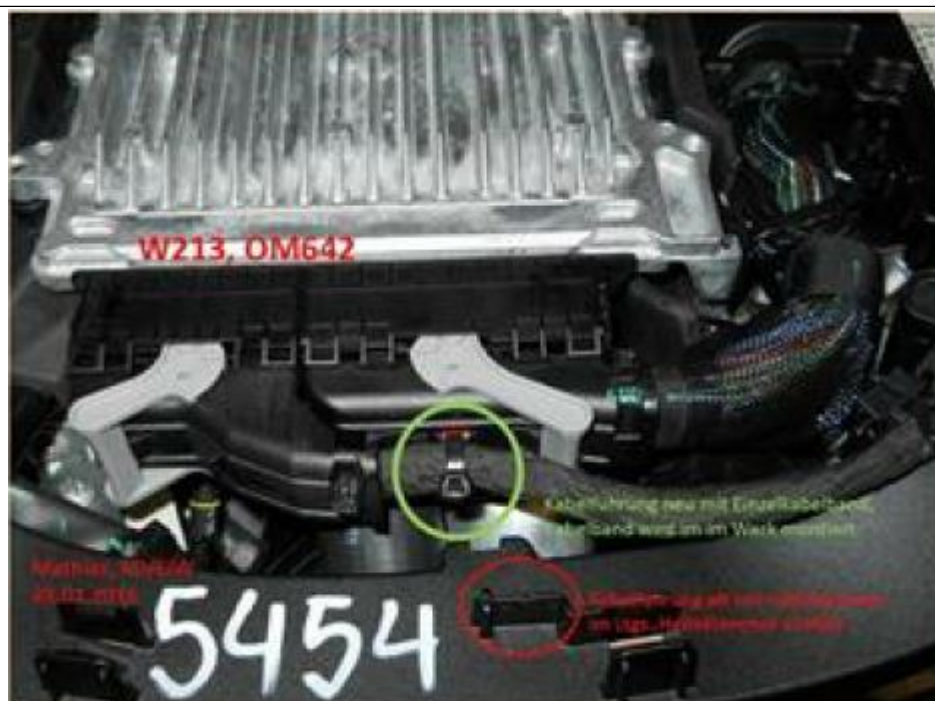
KabelbandSteckerF.JPG:

Attachments	
File	Description
KabelbandSteckerF.JPG	Cable strap on engine control unit on engine model 642.
