## Message "SRS - Service Required" displayed in instrument cluster and SRS lamp active

Topic number	LI54.18-P-069309
Version	1
Function group	54.18 Cable harnesses
Date	01-25-2019
Validity	Model 177
Reason for change	Additional operation deleted, damage code + FC added and text optimized
Reason for block

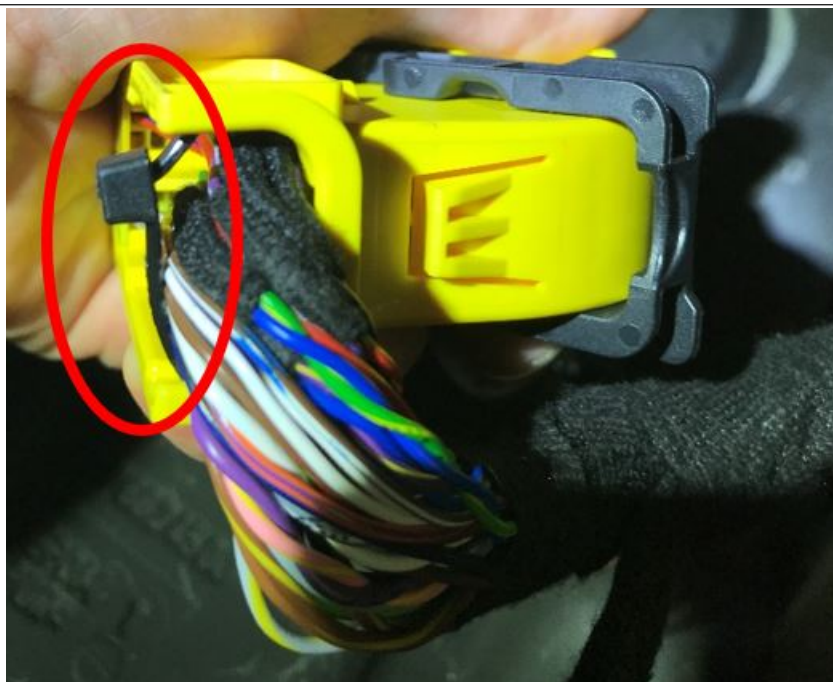
1.JPG:

Attachments	
File	Description
1.JPG	Photo "1": Cable tie on 104-pin coupling to airbag ECU; to be removed.
2.JPG	Photo "2": Positioning of new cable tie on coupling collar
3.JPG	Photo "3": After adjustment of cable tie on 104-pin coupling, in connected state.
4.JPG	Photo "4": Felt strip, final state

1. Disconnect (detach) the 104-pin coupling to the airbag control unit (N2/10, plug 1).
2. Remove the cable tie on the housing of the disconnected coupling using small side cutting pliers (see attachment, photo "1").
3. Remove the contact socket carrier from the housing and then wrap fabric tape around ALL the lines at the level of the coupling collar (plug collar) where the cable tie was previously.
