LTB01009NAS7

TECHNICAL BULLETIN

02 JAN 2019

InControl® Touch Pro™ Features May Not Function As Expected

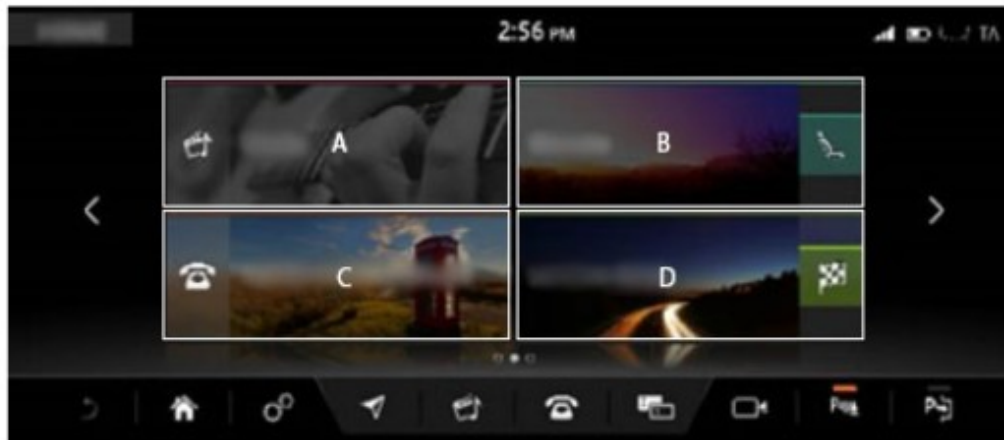
E229092

Vehicles with Single-Screen System current 4-tile home screen:

- **A** - Media
- **B** - Climate
- **C** - Phone
- **D** - Navigation
