N266 UPS12118-1BNAS1 TECHNICAL BULLETIN 03 JAN 2019

Update Prior to Sale: Transmission Oil Cooler

MODEL:	MODEL YEAR:	VIN:	APPLICABILITY:
Discovery (LR)	2019	081311-090740	TDV6 3.0L Diesel
Range Rover Sport (LW)	2019	815191-832643	TDV6 3.0L Diesel
Range Rover (LG)	2019	518189-534168	TDV6 3.0L Diesel

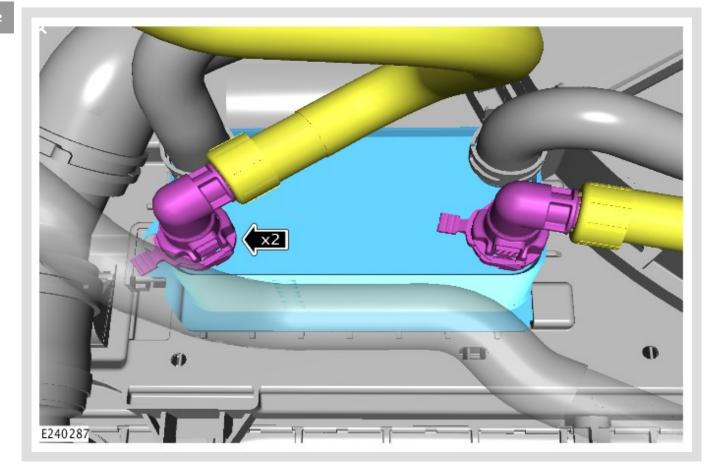
Inspect the automatic transmission to automatic transmission fluid cooler pipe connectors.

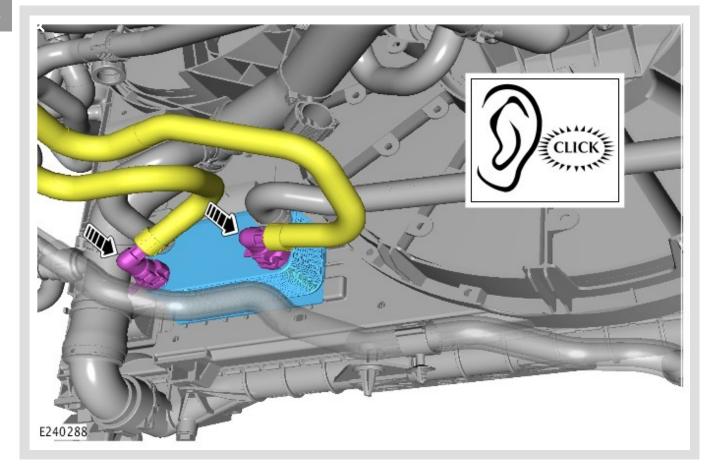
Push the automatic transmission fluid cooler pipes/connectors.

- If there is no movement (no 'click') from both pipes/connectors, the pipes/connectors are fully connected.
 - Install the engine undershield (see TOPIx Workshop Manual section 501-02: Front End Body Panels -- Engine Undershield).
 - Release the vehicle.
- If there is movement ('click') from one or both pipes/connectors, the pipes/connectors are not fully connected.
 - Go to Step 4.
- Inspect the automatic transmission fluid level (see TOPIx Workshop Manual section 307-01:
 Automatic Transmission/Transaxle -- Automatic Transmission Fluid Level Check).
- Install the engine undershield (see TOPIx Workshop Manual section 501-02: Front End Body Panels -- Engine Undershield).
