N279 UPS13518-1BNAS1

# TECHNICAL BULLETIN

18 JAN 2019

Update Prior to Sale: SV-Autobiography - Bumper Blanking Plate

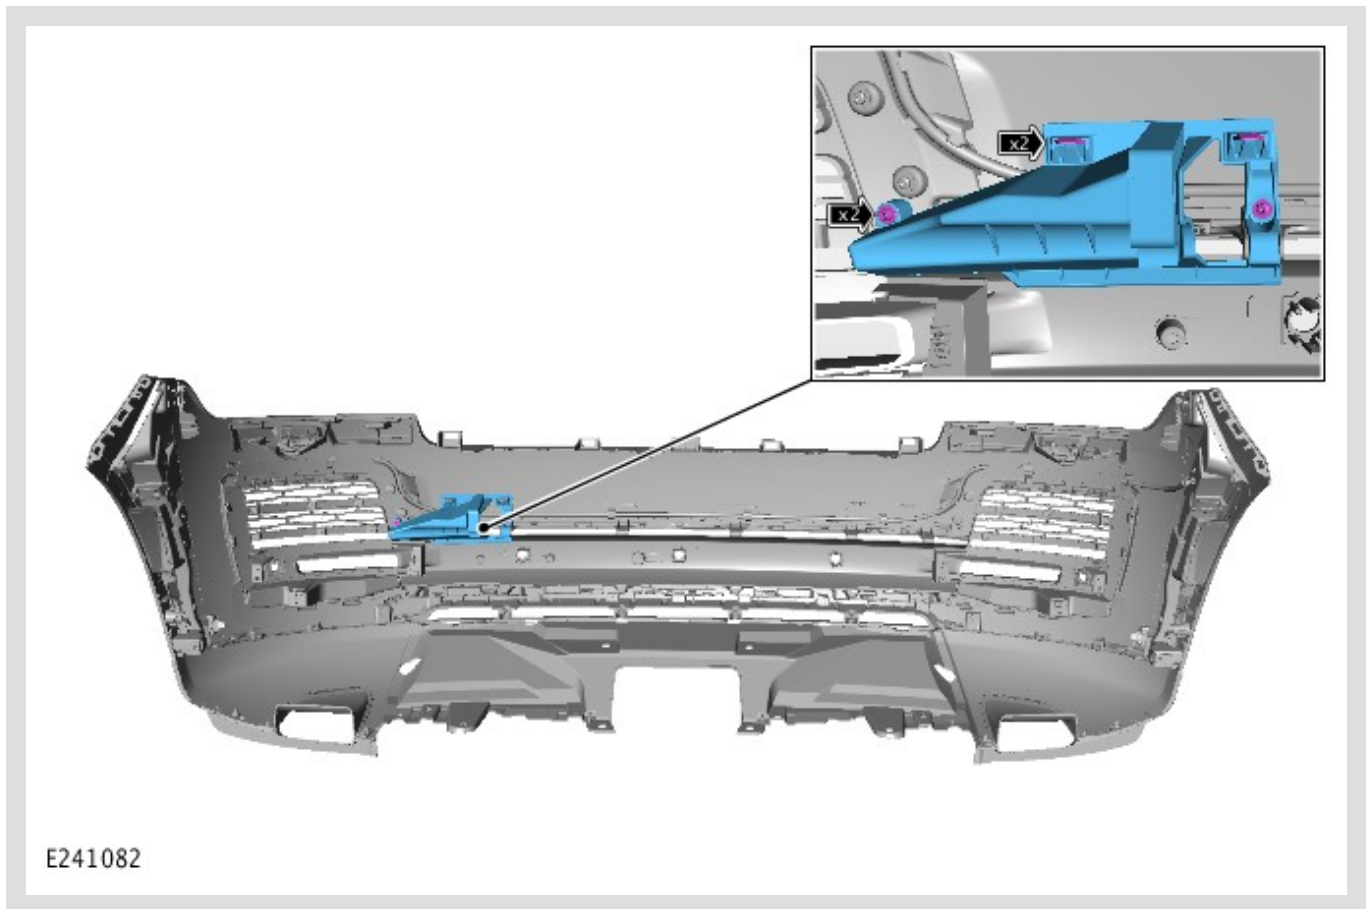
2

A potential issue has been identified on a limited number of Land Rover vehicles within the listed Affected Vehicle Range may have a front bumper with a blanking plate installed when not required, which could lead to the vehicle overheating.

Remove and discard the front bumper blanking plate.
