Countries: CANADA, UNITED STATES **Document ID:** IK0900133
Availability: ISIS, FleetSIS, Body Builder, IsSIR **Revision:** 1
Major System: COOLING **Created:** 1/3/2019
Current Language: English **Last Modified:** 1/3/2019
Other Languages: NONE **Author:** Bobby Christopher
Viewed: 179

Title: CV Coolant Fill Level

Applies To: CV

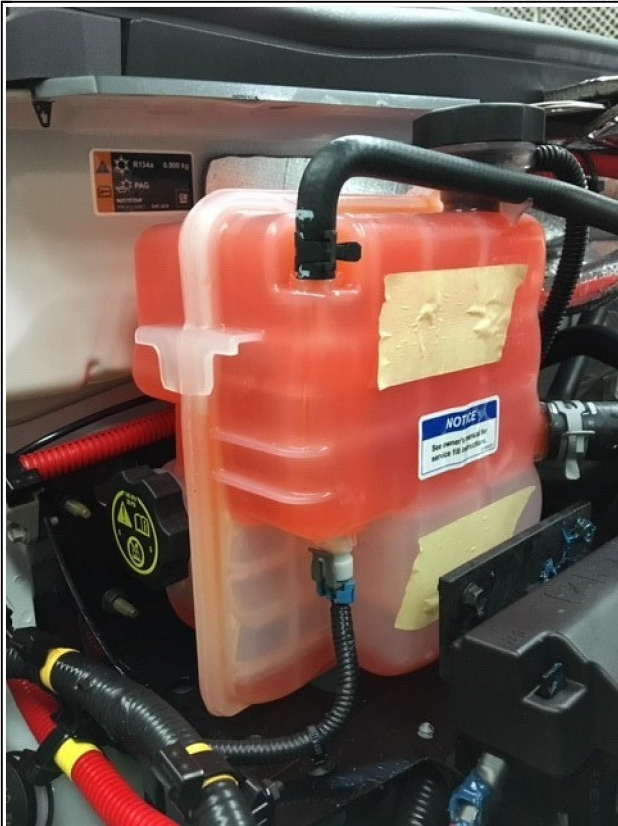
Figure 1 - Proper coolant level when leaving the plant

CV vehicles will arrive at their destinations with some coolant in the lower chambers of the surge tank and with the upper chambers filled to the top of the tank (reference Figure 1 below). This is correct but different from other Navistar vehicles which arrive at their destinations with coolant levels between cold min and cold max.

- CV vehicles will appear to be “over-filled” with coolant when they leave the Navistar assembly facility.
- These vehicles typically have up to 1.4 L of air trapped in the engine after completing the on-line coolant evac/fill procedure.
- Coolant is added to the lower chambers of the surge tank and upper chambers are topped off above the fill line to the top of the bottle per the GM and Navistar recommended procedure.
- As the vehicles are used in the field, the air is gradually released from the engine and displaced by coolant from the surge tank.
- The recommended fill procedure ensures that the total vehicle coolant levels will remain high enough to avoid a low coolant condition as the trapped air is displaced.

Proper fill with upper chamber full to top of tank (brim full) and residual coolant in lower chamber

1. None required if coolant level in surge tank is at or above cold max. Upper surge tank chambers filled above cold max and as high as the top of the tank and coolant remaining in lower chambers are normal for these vehicles and coolant should not be removed from them.
2. Coolant levels below cold min require the coolant fill service procedure described in the CV Technician Manual 0001111853.
3. Coolant levels observed between cold min and cold max should be topped off to top of tank unless the vehicle is known to have completed multiple (three or more) thermal cycles with engine coolant temps exceeding 212°F (100°C) and then cooling to 70°F (21°C) during each cycle.
