Title: VIN Glare Remedy

Applicability: MY18 Revero

PURPOSE: This will mitigate a VIN reflection on the windshield from the drivers field of view.

Type: Technical Service Bulltein

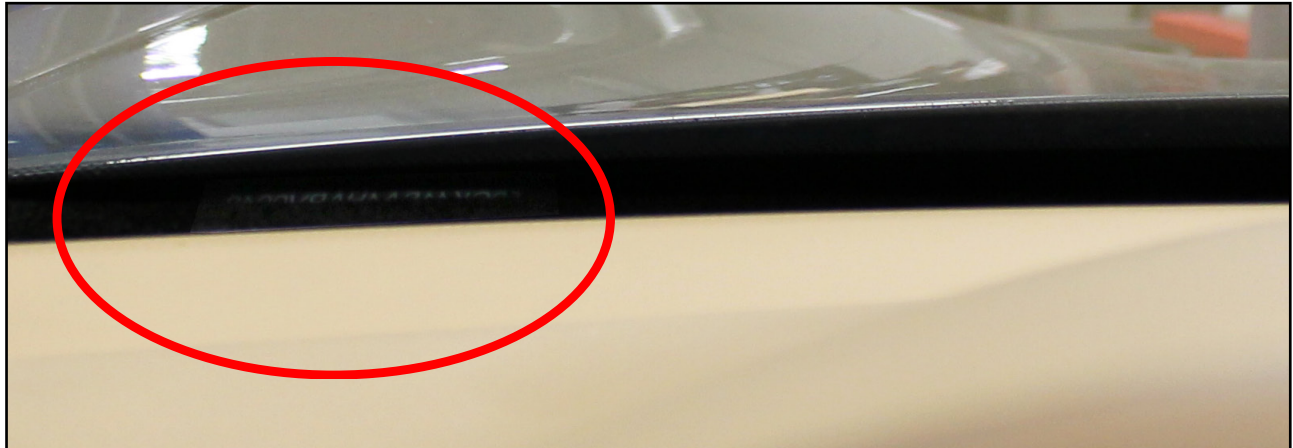
fig. 1a

1. Verify the VIN glare into the cabin. This is seen over the steering wheel in front of the dash as shown below (fig. 1a).

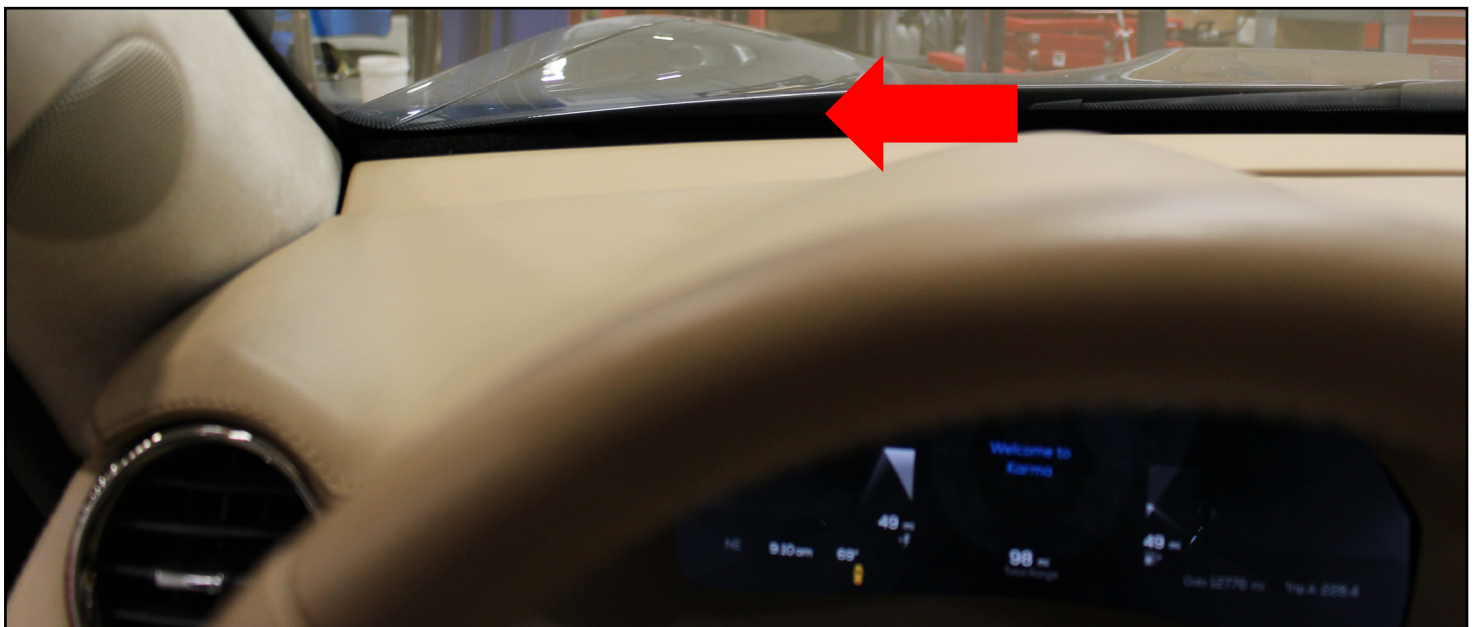
fig. 4b

The VIN glare is no longer visible as seen below (fig. 4b).
