February 2, 2019

Product Update: Telematics Control Unit

Year	Model	Trim	VIN Range
2019	Passport	Elite, Touring	Check the iN VIN status for eligibility.

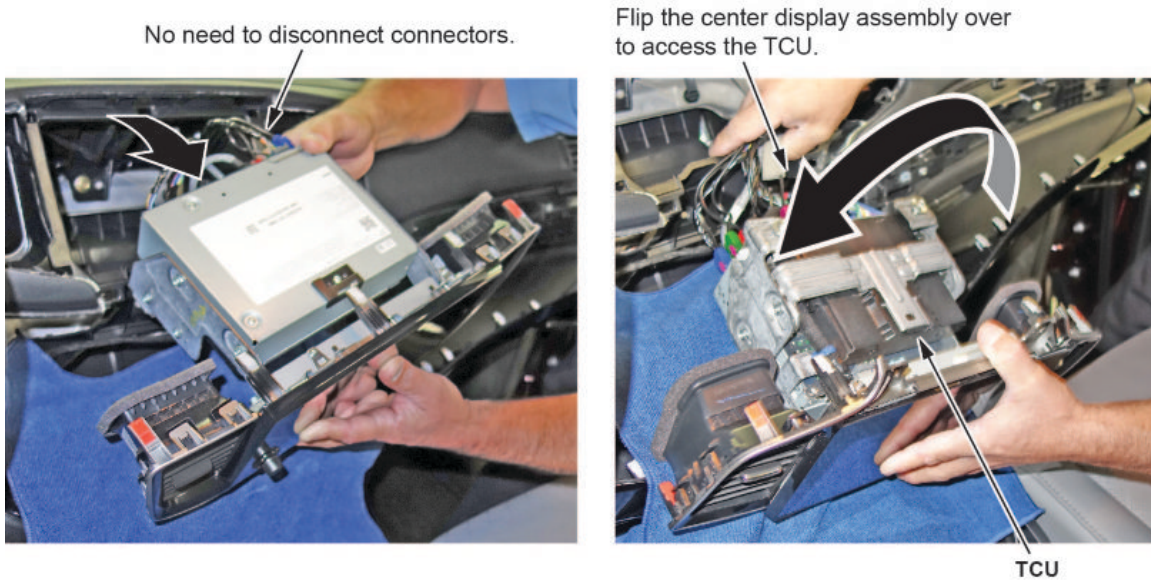
6.1. To prevent damage, turn over the center display and place it on clean shop towels as shown then disconnect the four connectors from the TCU.

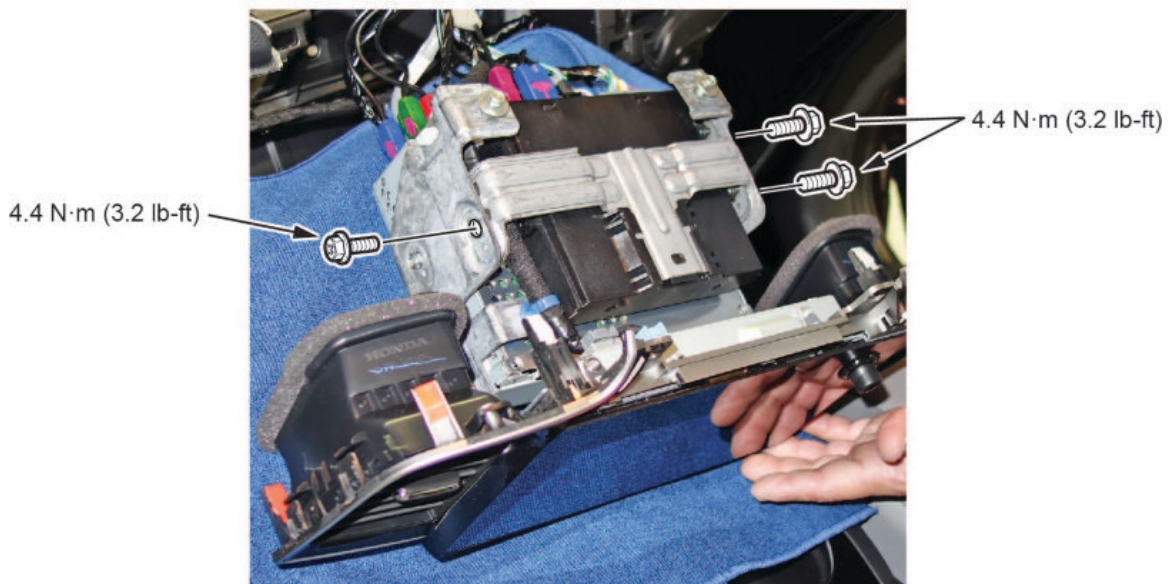
6.2. Remove the three screws from the bracket and slide the TCU out.

To avoid confusing the original and replacement TCUs, use a permanent marker to place an "X" on the original TCU before removal.

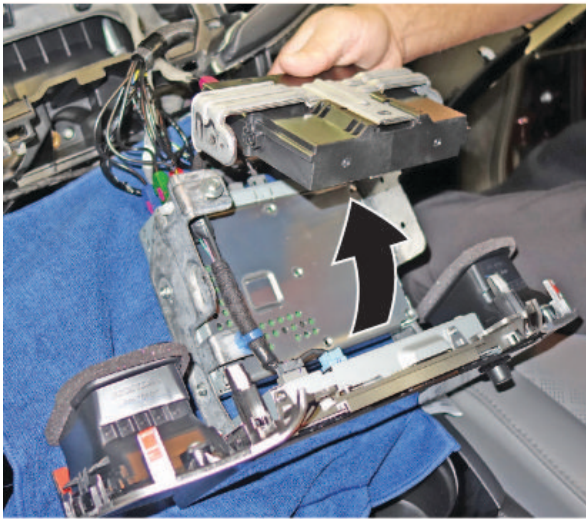
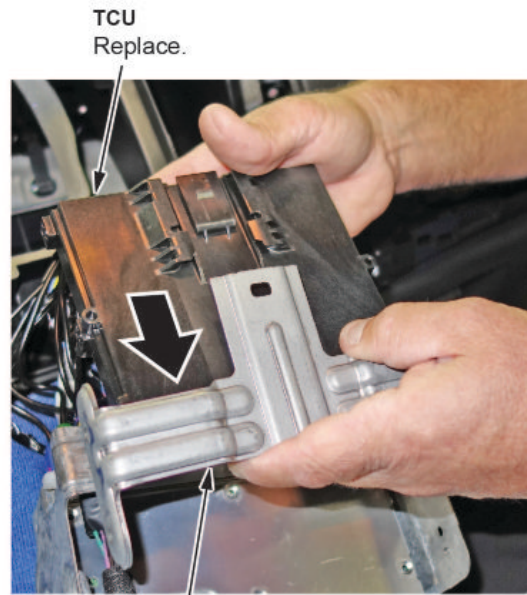
TCU BRACKET
Retain.

6.3. Remove the TCU bracket, and install it on the replacement TCU.

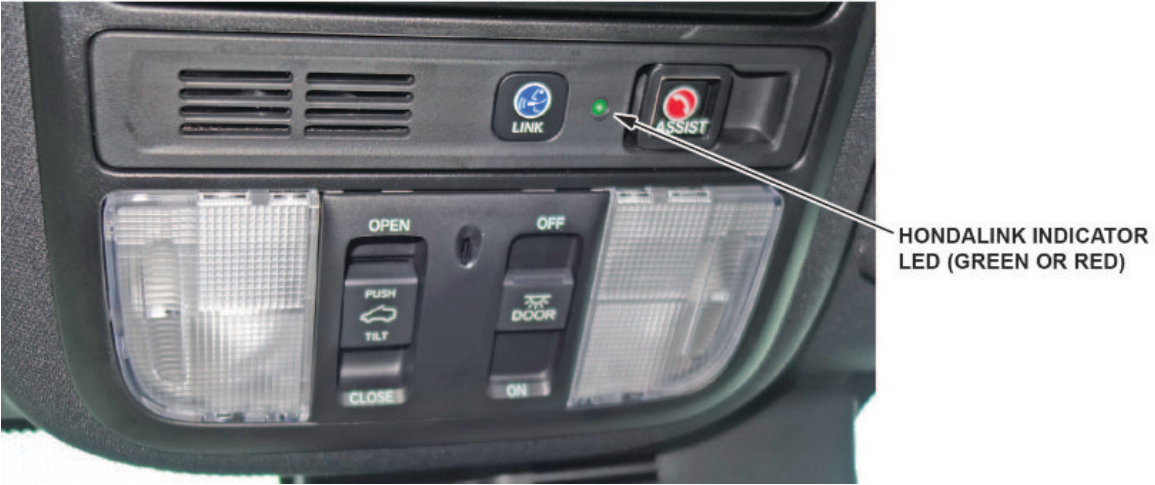
11. After 15 minutes, turn the ignition to OFF, then back to ON. Confirm that the HondaLink indicator turns green.

If the HondaLink indicator is red, check the TCU connectors.
