## SERVICE BULLETIN

**APPLICABILITY:** All 2019MY Vehicles

**NUMBER:** 15-236-18R

**SUBJECT:** Reprogramming File Availability for Optimization of Harman Gen 3.1 Audio and Navigation Head Units

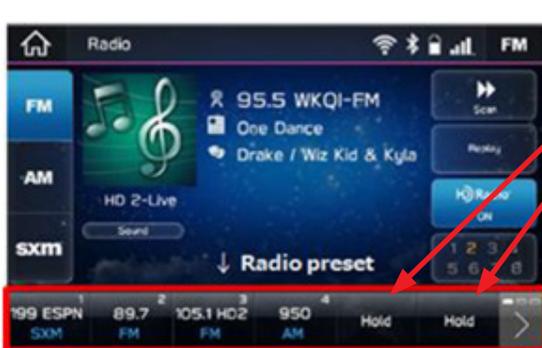
1)- Station presets are lost. The touch button reads “Hold”.

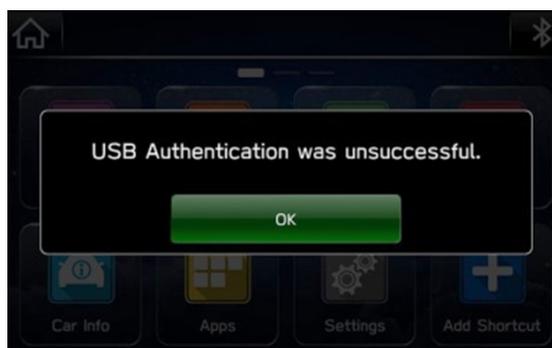
**NOTE:** If an attempt is made to install the wrong “grade” file into the wrong grade head unit (EXAMPLE: “Base” update file into a “Mid” or “High” head unit), the USB Authentication error screen below will be displayed:
