GLOBAL SAFETY FIELD INVESTIGATIONS
DCS4945
URGENT - DISTRIBUTE IMMEDIATELY

Subject: N182188930 - Special Coverage
Auxiliary Transmission Cooler Line Fluid Leak

Models: 2017-2018 Chevrolet Silverado HD
2017-2018 GMC Sierra HD
Equipped with L5P (Duramax Diesel Engine)

N182188930 Auxiliary Transmission Cooler Line Fluid Leak

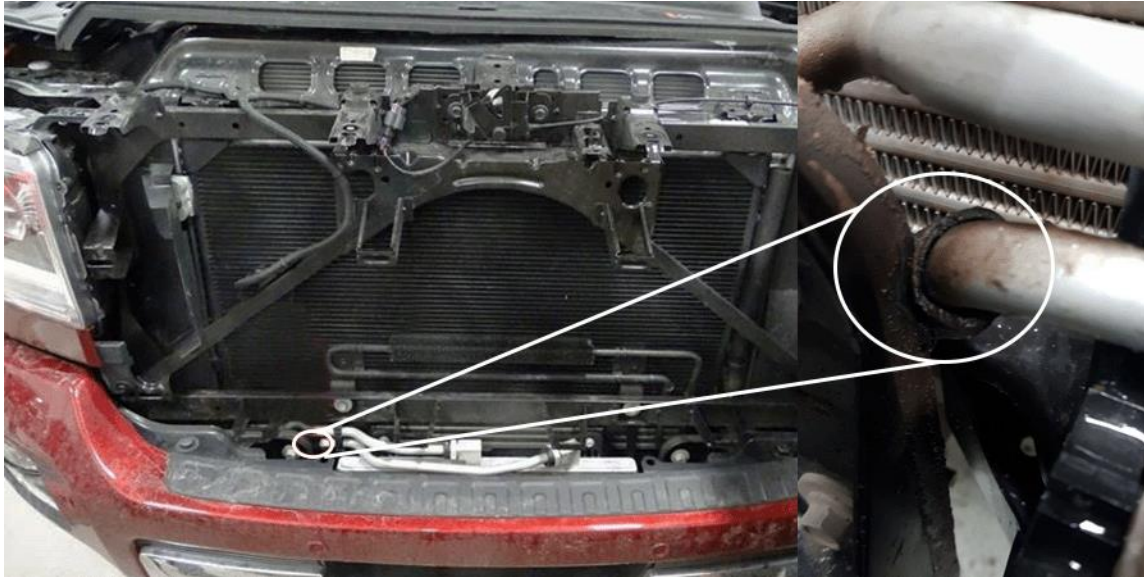
5165323

Condition	Some 2017-2018 model year Chevrolet Silverado HD and GMC Sierra HD vehicles equipped with a Duramax Diesel engine, the transmission cooler lines may be rubbing on the front frame/bumper mount bracket. This condition could cause the cooler lines to leak. Transmission fluid may be seen on the ground under the front bumper. Some drivers may have difficulty selecting gears or experience transmission slip.
Special Coverage Adjustment	<p>This special coverage covers the condition described above for a period of 6 years or 72,000 miles (116,000 km), whichever occurs first, from the date the vehicle was originally placed in service, regardless of ownership.</p> <p>For vehicles covered by Vehicle Service Contracts, all eligible claims with repair orders on or after January 3, 2019, are covered by this special coverage and must be submitted using the labor operation codes provided with this bulletin. Claims with repair orders prior to January 3, 2019, must be submitted to the Service Contract provider.</p> <p>Vehicle owners or lessees who paid for repairs referenced in this Special Coverage ("Customers") are eligible for reimbursement of their reasonable and customary expenses in accordance with the procedures specified below. The conditional right to reimbursement is provided by GM solely in the interest of customer satisfaction and is personal to Customers. <i>Customers may not assign and GM does not consent to any assignment of any Customer's right to submit reimbursement claims, or to receive reimbursement, or any other rights granted by this Special Coverage to any third party, including but not limited to service contract providers, and this Special Coverage is not intended to and does not confer any third party beneficiary, subrogation or contribution rights, or any other rights to reimbursement, against GM, whether in law, equity or otherwise, on any third parties.</i></p>

1. Determine if the Transmission Fluid Cooler Thermal Bypass Valve lines are leaking from a rub-through condition in the area shown (or another area near the thermal bypass valve). If necessary, use a borescope to aid in pinpointing the leak without vehicle disassembly.
 - If the lines exhibit a rub-through condition and are leaking, proceed to step 2.
 - If the lines do not exhibit a rub-through condition (or are leaking from a non-rub-through condition) no further action is required. Any further repairs and/or diagnosis are not covered under this special coverage.
2. Replace the Transmission Fluid Cooler Thermal Bypass Valve. Refer to *Transmission Fluid Cooler Thermal Bypass Valve Replacement (L5P With MW7)* in SI.

Correction	Dealers are to replace the transmission cooler lines. The repairs will be made at no charge to the customer.
