Bulletin No.: PIC5836E

PIC5836E Rattle or Buzz Noise from Rear Speaker or Speakers - Worse with High Bass Levels

Brand:	Model:	Model Years:	VIN:		Engine:	Transmissions:
			from	to		
Cadillac	ATS	2013 - 2019	All	All	All	All

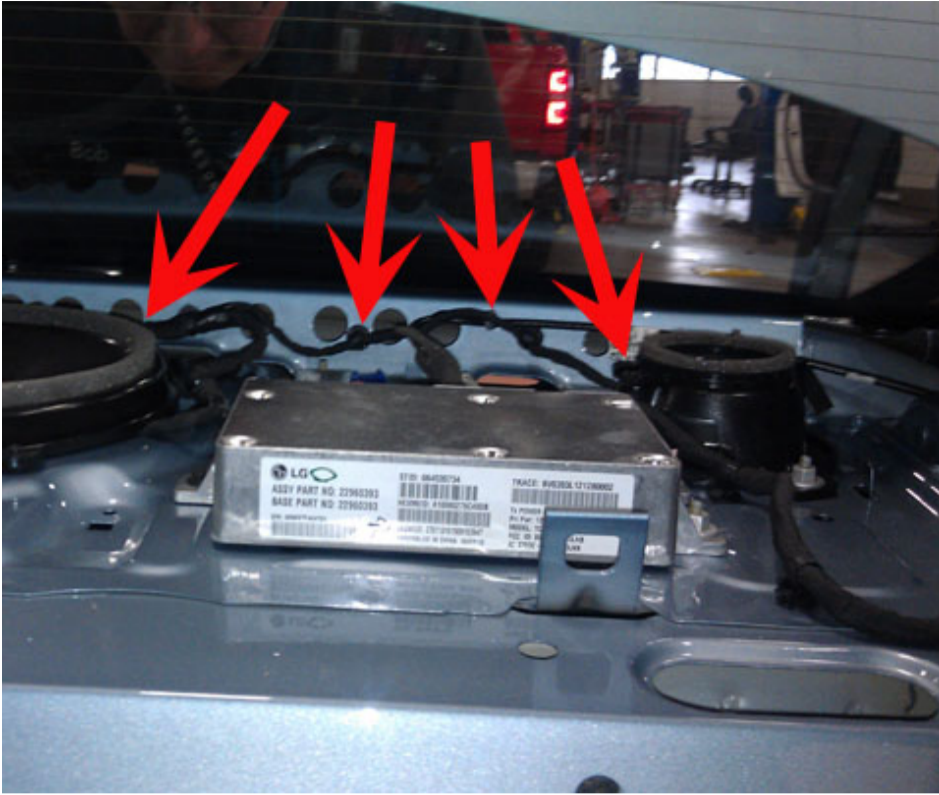
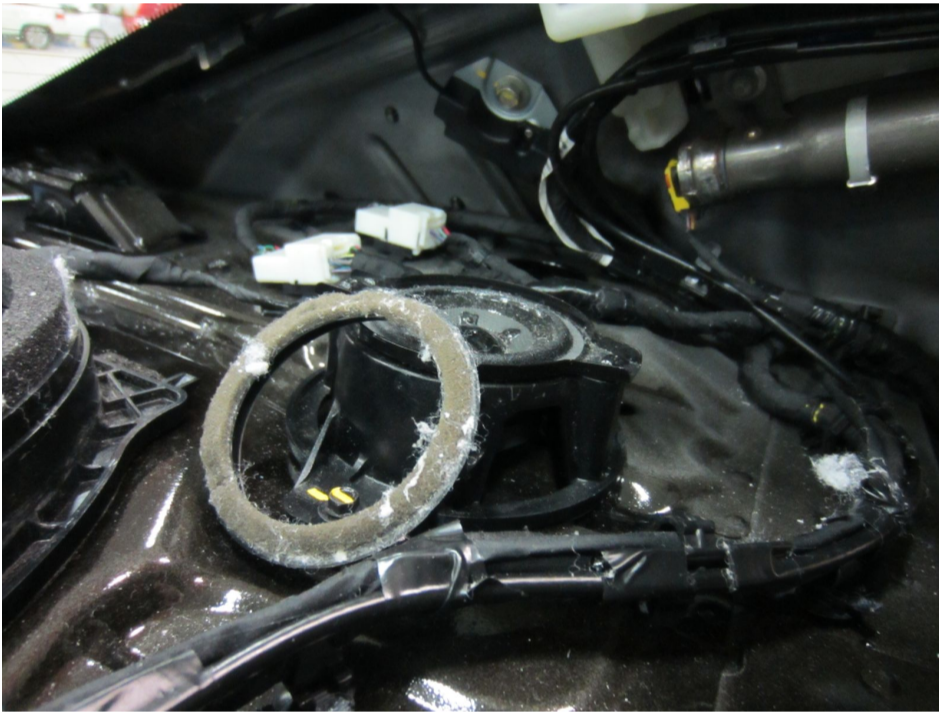
- 1. Improper speaker mounting or loose trim, wiring harnesses, or other parts may cause an audible buzz or distortion.**
- 2. Rattle or buzz from the OnStar module.**
- 3. Seat belt retractor buzz - Center seat belt retractor bolt may be contacting decklid torque rod inside trunk causing metallic rattle.**
- 4. Child tether cover may be loose in package shelf trim.**
- 5. Package shelf trim and / or trunk upper trim plastic Christmas tree fasteners may buzz to shelf at attachment holes.**
- 6. Leading edge of package shelf, behind rear seat back.**
- 7. Package shelf "J" hooks loose.**

- 1. Inspect the rear speaker and the surrounding interior trim for proper and secure mounting. If the speaker trim has come loose, replace the speaker. If surrounding interior trim is found to be loose or improperly secured, correctly secure the item and add foam to insulate items as needed. Add foam to the subwoofer speaker connector to prevent contact to the under shelf trim from making contact. Use ½" by 5/16" of Kent Adhesive Backed Shim Stock (foam) p/n P40125 or equivalent.**
