Preliminary Information

PIT5307F SES MIL / Service Suspension System / ABS MIL / No Crank / Misfire / A/C Inoperative (Inspect Engine Harness Chaffing At Vacuum Pump Pulley)

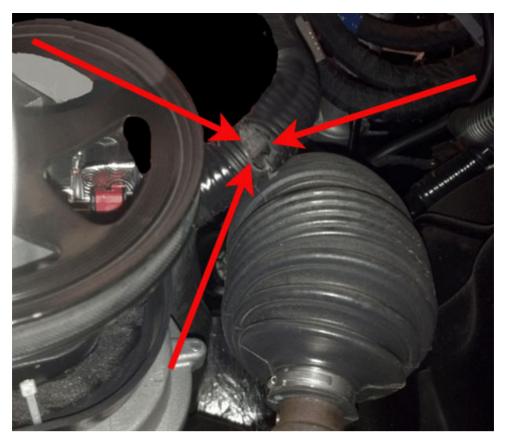
- SES MIL
- ABS MIL
- Service Suspension System Message
- Misfire
- Hesitation
- Low engine power
- Erratic transmission shifting
- No crank
- A/C inoperative
- Low engine oil level message
- Fuse(s) blown: "STRTR" fuse 11/104 (F11UA/F104UA) and/or A/C Clutch Fuse 35/60 (F35UA/F60UA)
- As well as any combination of the following DTCs may be found: B393B, C0035, C0040, C0575, C0580, C0615, C0620, C0625, C0630, C0696, P06DA, P06DB, P06DC, P06B6, P06B7, P250A, P0300, P0324, P0325, P0326, P0327, P0328, P0330, P0331, P0332, P0333, P0340, P0341, P0335, P0336, P0532, P0533, P0641, P0011, P0010, P2088, P2089, and/or P2230.

These issues could be caused by the engine harness rubbing on the engine vacuum pump pulley, as shown below.

Repair any damaged circuits, and resecure the harness away from the pulley to prevent the issue from reoccurring.
