Preliminary Information

PIC5903B Spark EV Chevrolet Volt Opel Ampera Models With Or Without Service Vehicle Soon Lamp - SVS - or Check Engine Lamp On With DTC P0534 Set Current Or History

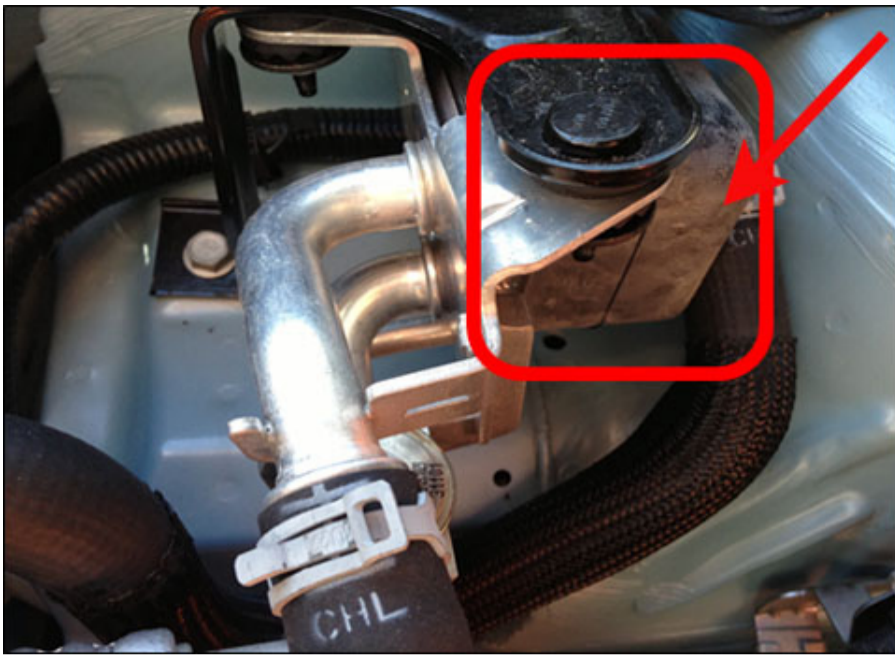
A. Shown below is a picture of the RESS Cooler from the Spark EV. The black insulator cover can be easily pulled back to inspect the Cooler Plate notches without removal.

For Volt and Ampera models the inspection remains the same once the RESS Cooler has been removed from the vehicle.

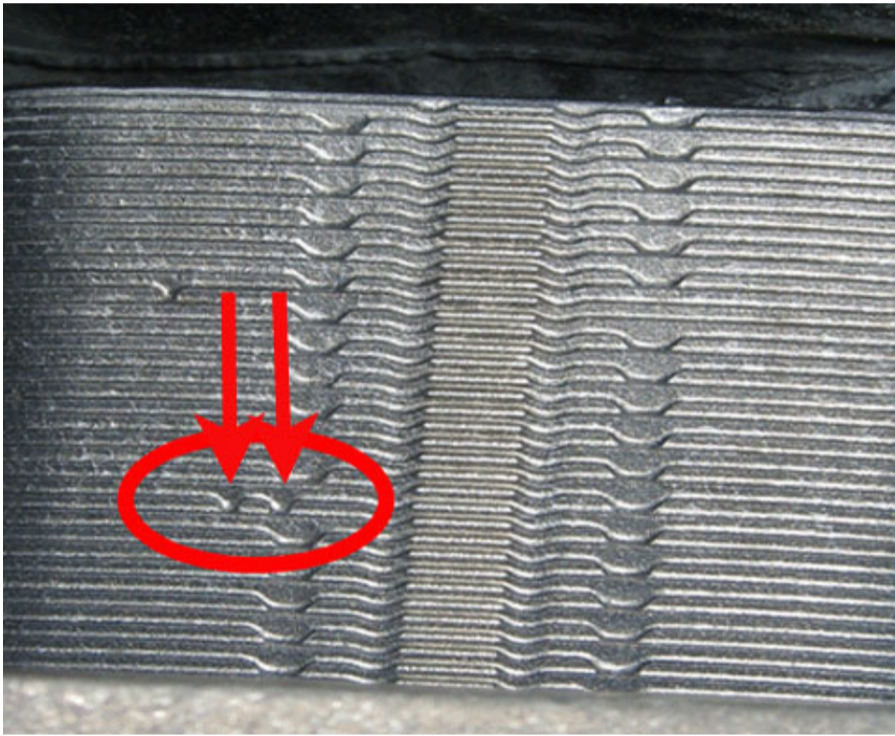
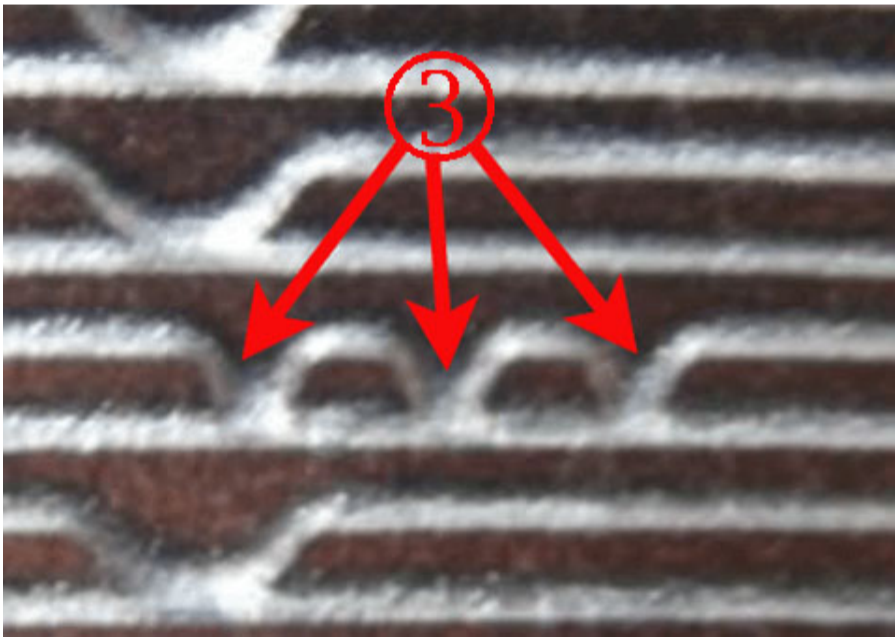
3 Notches equals replace cooler.

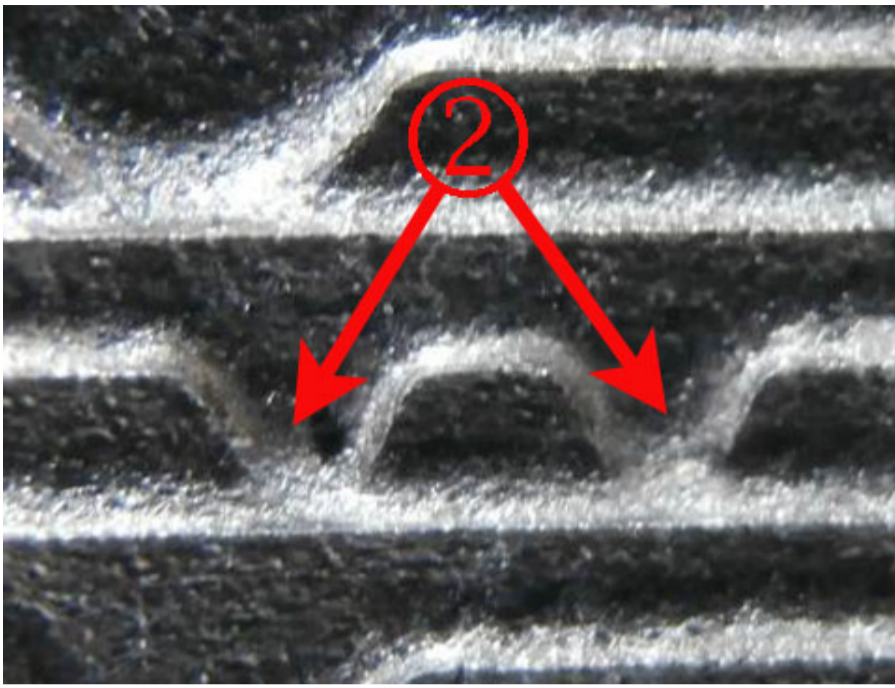
2 Notches equals DO NOT replace cooler.
