## **Preliminary Information**

# PIP5554A Information On setting The Timing On Gen 5 Engines To Help Prevent A P0016 From Setting

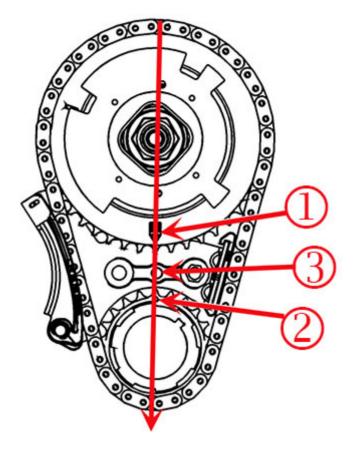
As you can see in this illustration of the gear set the vertical red line travels through the links at top and bottom.

In this case the chain was installed with the face links at the proper teeth that were 180 degrees from the proper timing marks.

This oil feed hole ( number 3 ) not being centered in the block throws the perception of the technicians off during alignment.

Simply mark the tooth that was 180 degrees opposite of the timing marks on both gears.

Then counted the links and folded the timing chain to mark the links at each end.

Then hang the chain on the two gears at these marks and then verified that the gears are now properly aligned.
