Preliminary Information

PIP5421G Malfunction Indicator Lamp Illuminated With DTC P0300 Models

Brand:	Model:	Model Years:	VIN:		Engine:	Transmissions:
			from	to		
Chevrolet	Malibu	2016	All	All	1.5L LFV	All
Chevrolet	Malibu	2017	Start of Production	1G1ZE5ST6HF214701	1.5L LFV	All

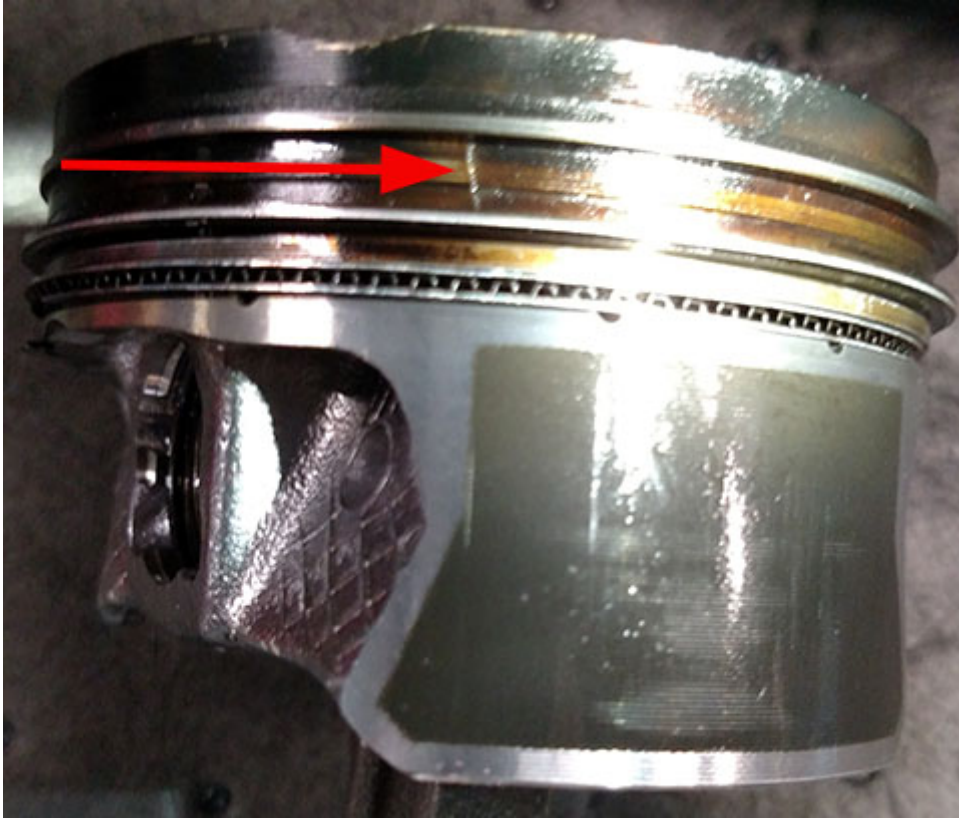
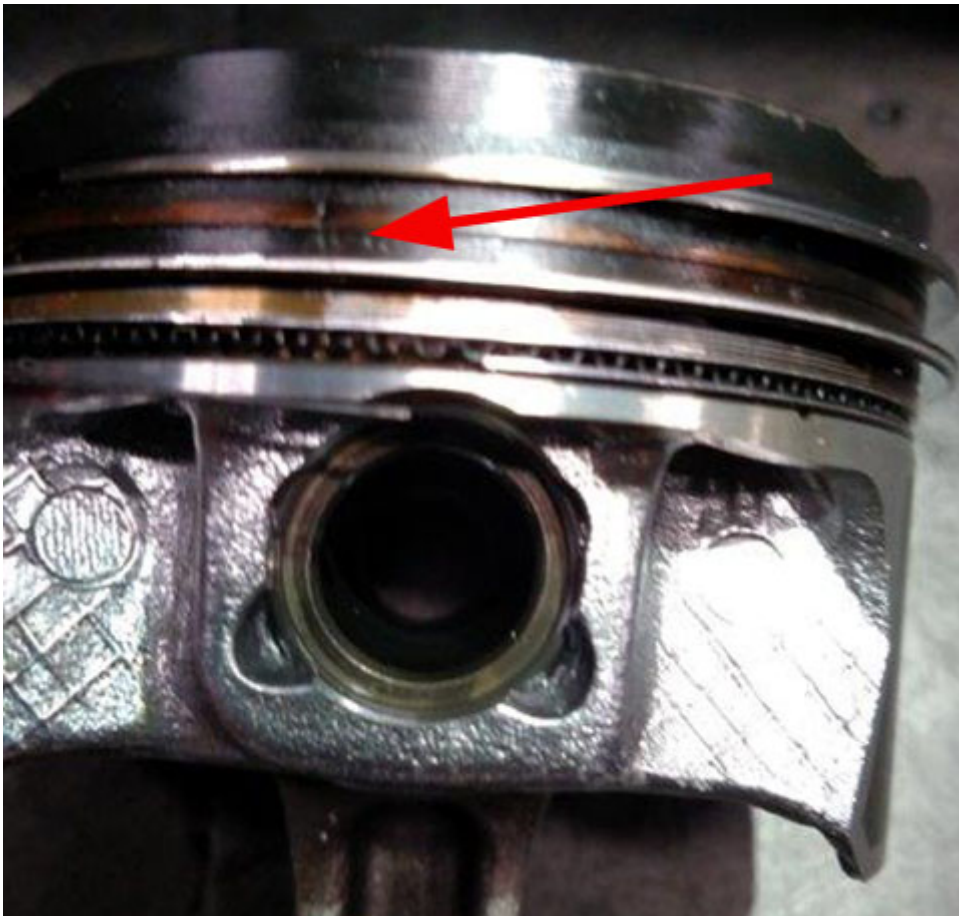
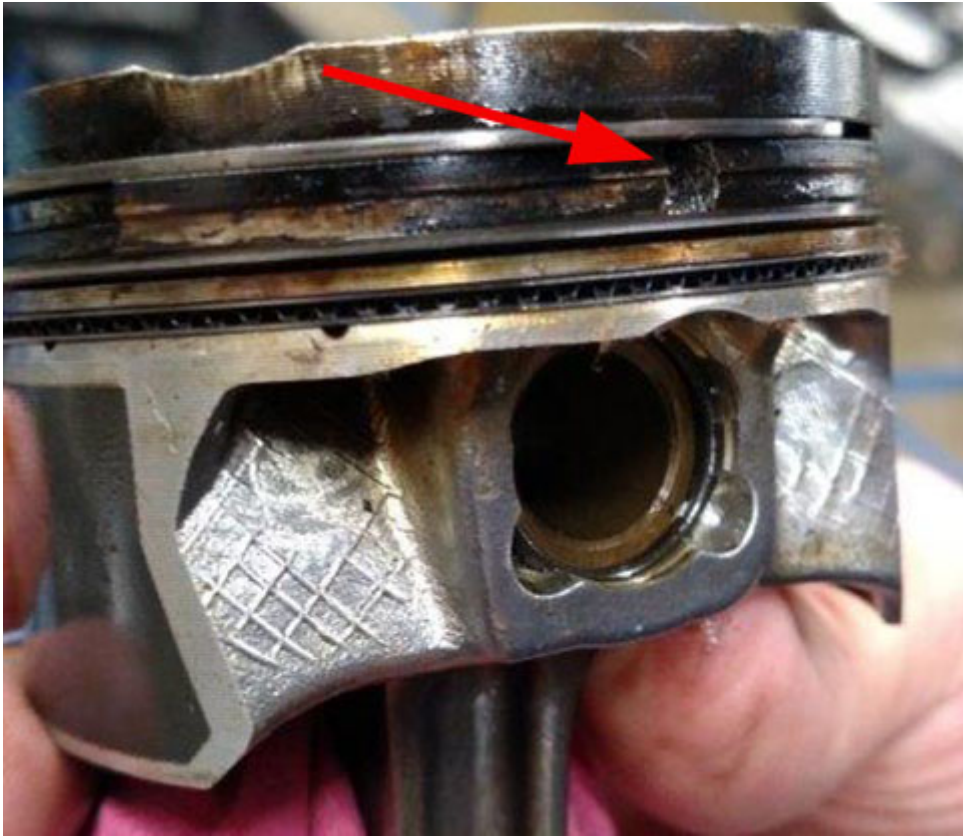
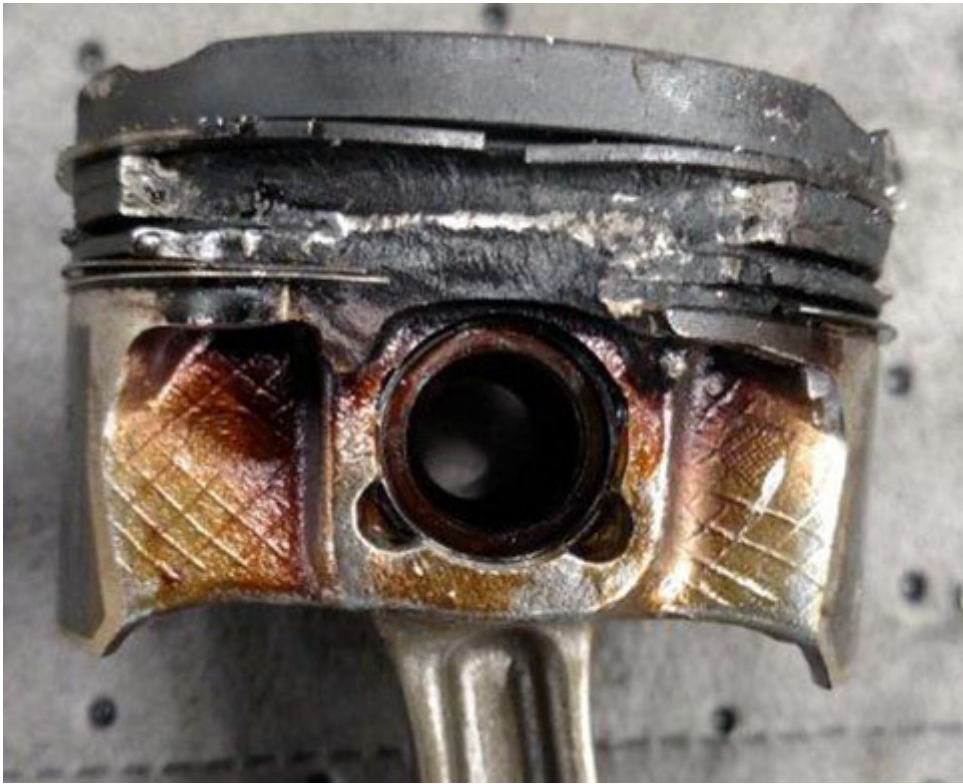
Involved Region or Country	China, Europe, International Operations (GMIO), Korea and North America.
Condition	Some customers may comment on a rough running engine with the Malfunction Indicator Lamp on. Upon inspection, a technician may find DTC P0300 set along with a misfire and low compression in one or more cylinders.
Cause	This condition may be caused by a damaged piston requiring replacement of all four piston and rod assemblies with an updated part number.

Shown below are examples of pistons with varying levels of damage.

If the cylinder wall surface has not been compromised, replace all four piston and rod assemblies.

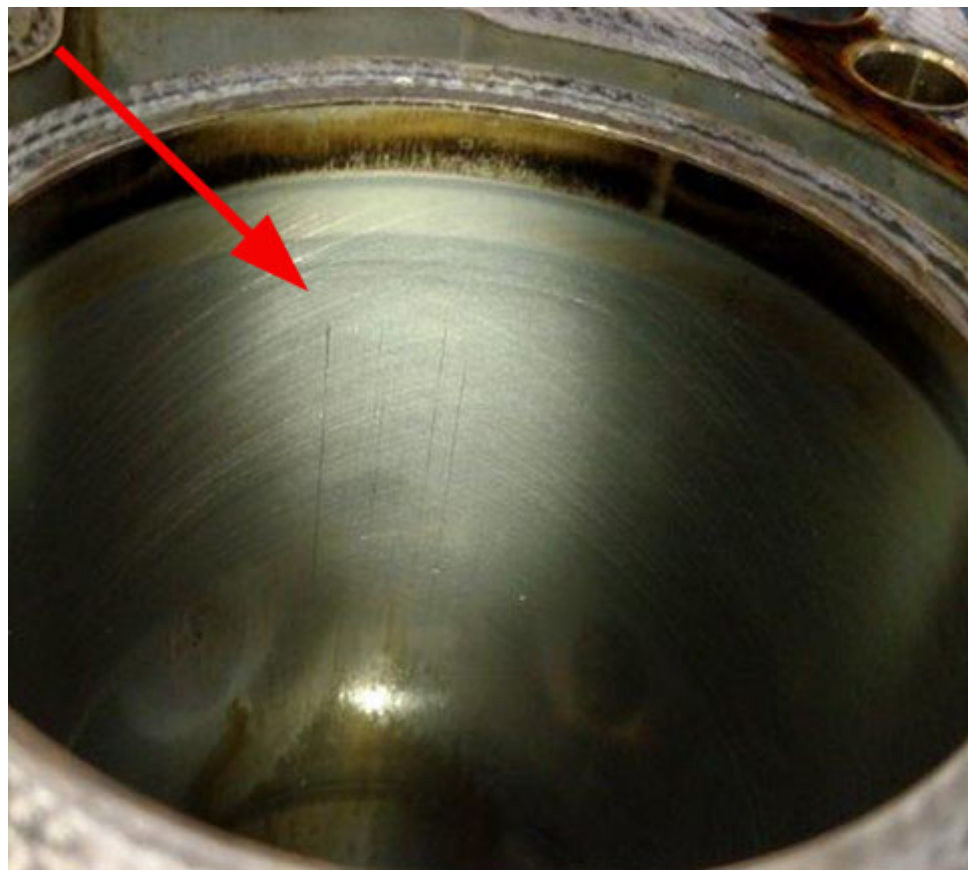
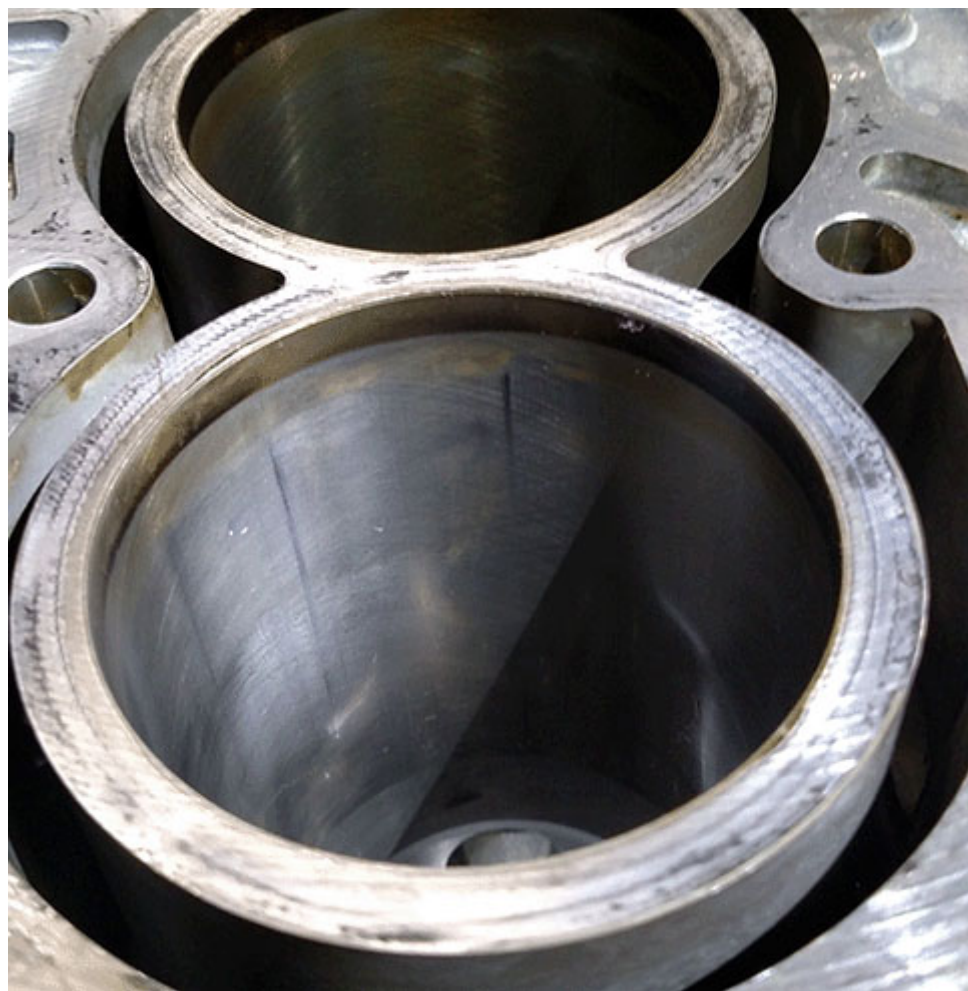
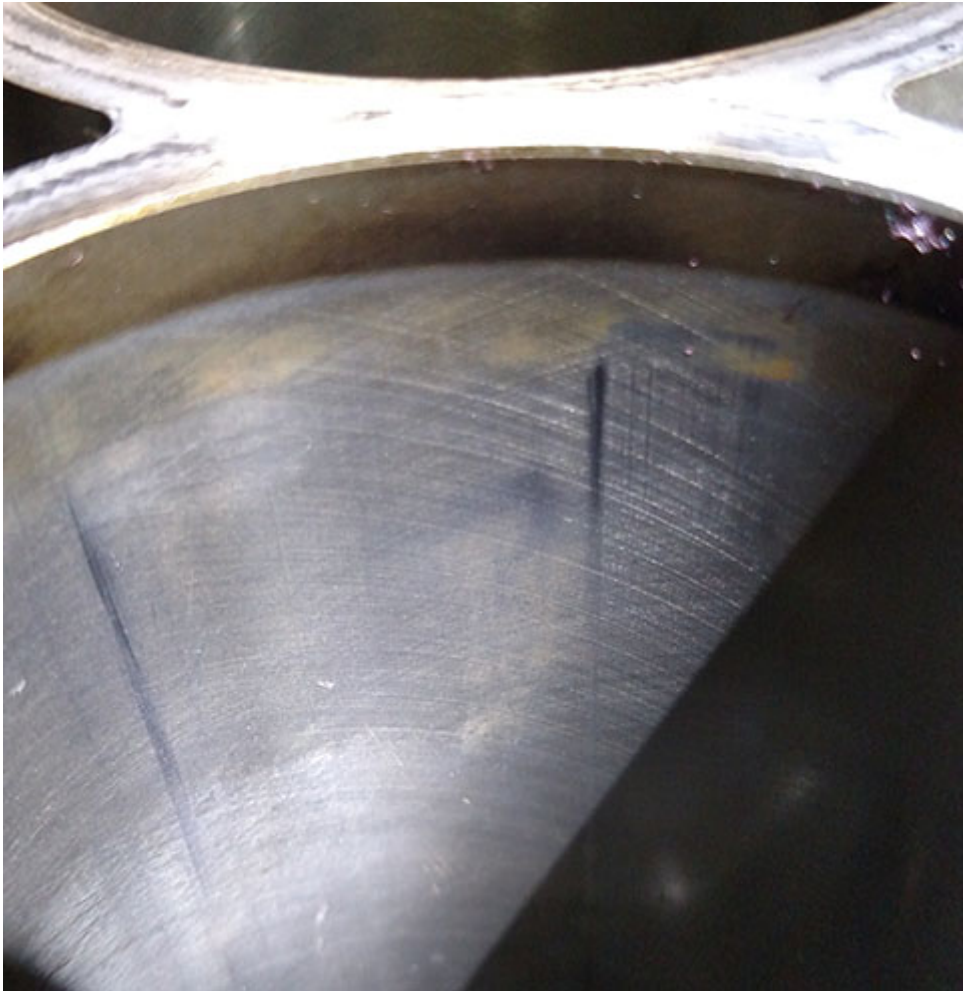
Shown below are several examples of light vertical marks visible on the cylinder wall.

In these examples, none of the marks in the cylinder walls could be felt with the finger tip or nail and engine replacement is not recommended.

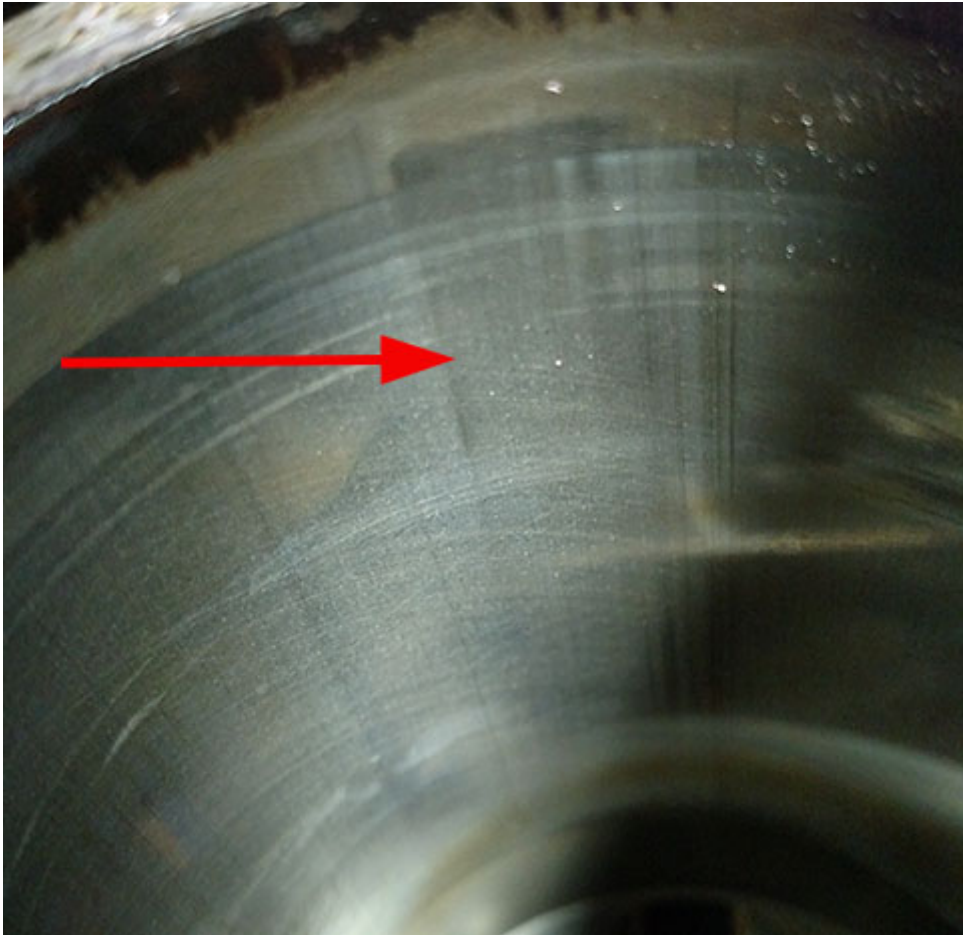
Shown below is an example of a damaged cylinder wall.

In this example the scuffing is wide and has removed the crosshatch from the cylinder wall in the area above the arrow.

This would result in oil consumption and requires engine replacement.
