PIT5391E No Crank / Start then Immediate Stall / SES MIL / Service 4WD / Relay Clicking / Rearview Camera Inop / DTC (Inspect Ignition 1 voltage)

This PI was superseded to add the 2019 model year and update the recommendation section. Please discard PIT5391D.

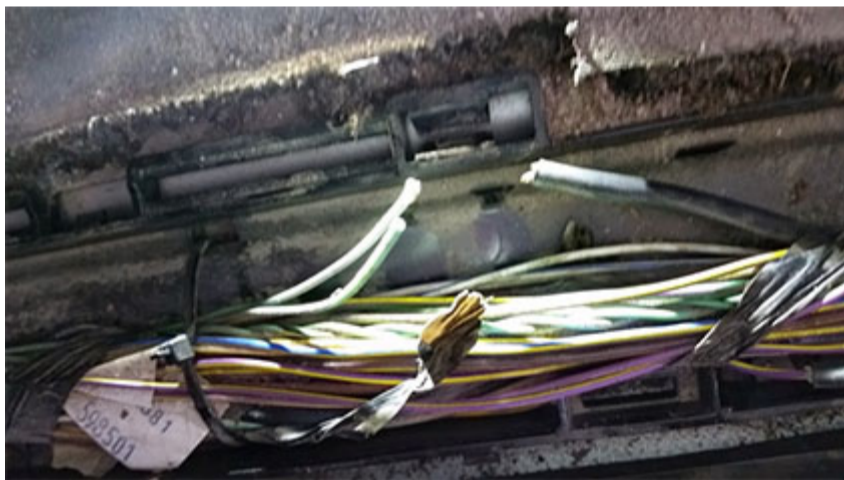
3. Circuit 5199 under the driver's sill plate for being damaged/corroded, as shown below.

Repair any wiring / terminal issues using the appropriate SI wiring repair documentation.
