PIP4005A Intermittent No Crank, Battery Light, and/or SES Light - Inspect Hybrid Battery

Brand:	Model:	Model Years:	VIN:		Engine:	Transmissions:
			from	to		
Saturn	Vue	2007 - 2009	All	All	All	All

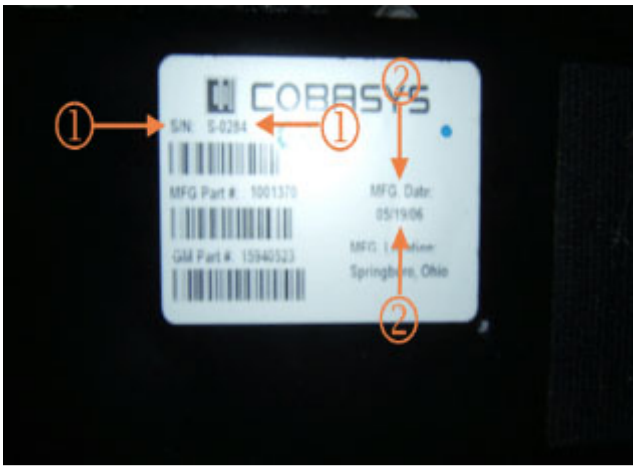
1) Serial Number

2) Manufacturing Date

If the SI diagnostics do not isolate a cause for this concern, follow all safety precautions and SI procedures to check for a loose negative hybrid battery cable at the hybrid battery. This is the cable on the driver's side of the hybrid battery. If the cable is loose, follow SI procedures to remove the negative hybrid battery cable from the hybrid battery and note the break-away torque of the composite nut on the repair order. Once the cable is removed, remove the fuse the fuse that is behind the negative hybrid battery cable terminal and inspect the negative hybrid battery stud, fuse, and negative cable terminal for signs of arcing. If there is any sign of arcing, replace the damaged component (s) as necessary. If the negative hybrid battery stud shows signs of arcing, it will be necessary to replace the complete hybrid battery assembly. If the negative cable was loose but there was no sign of arcing on any of these components, reassemble the negative hybrid battery connection by following all safety precautions and SI procedures. The composite nut for the negative hybrid battery cable should be torqued to 95 lb in (10.7 Nm). Once the composite nut is torqued to specification, confirm that the negative cable is tight. If so, note the serial number and manufacturing date (shown in the photo below) on the repair order.

Important: As requested above, please document the battery serial number, battery manufacturing date, and composite nut break-away torque on the repair order. If there is a TAC case on this concern, please contact TAC and ask the TAC consultant to document this information in your TAC case.
