PIC6285C Diagnostic Aid for DTCs P1AEE and P1AEF, Control Module Hybrid/EV Battery System Voltage High Voltage (Over-Voltage)

Brand:	Model:	Model Years:	VIN:		Engine:	Transmissions:
			from	to		
Chevrolet	Volt	2016 - 2019	All	All	All	All

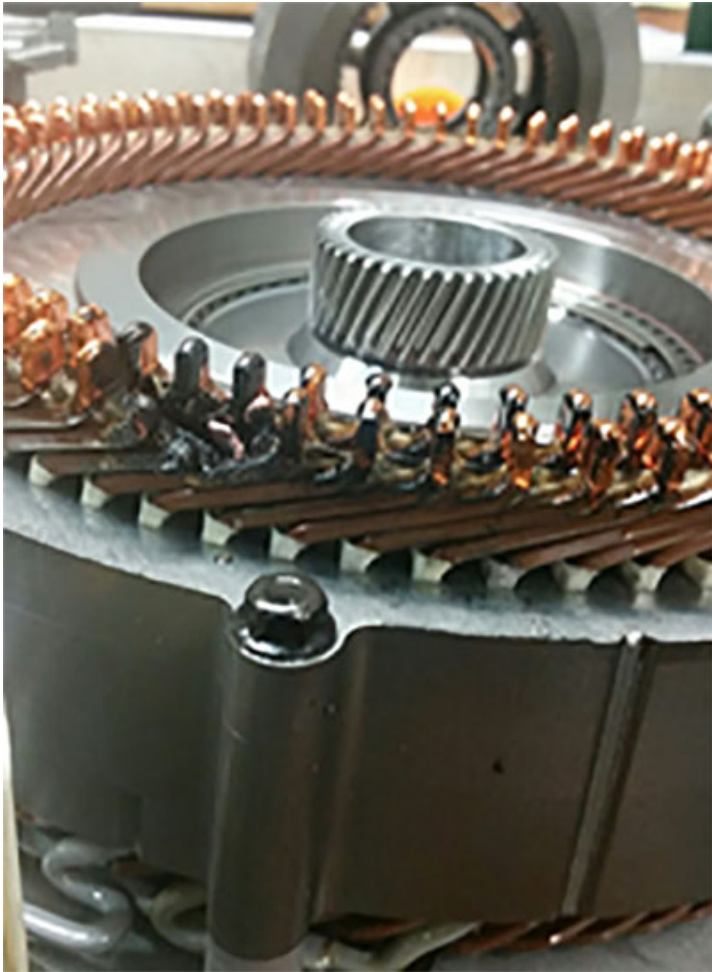
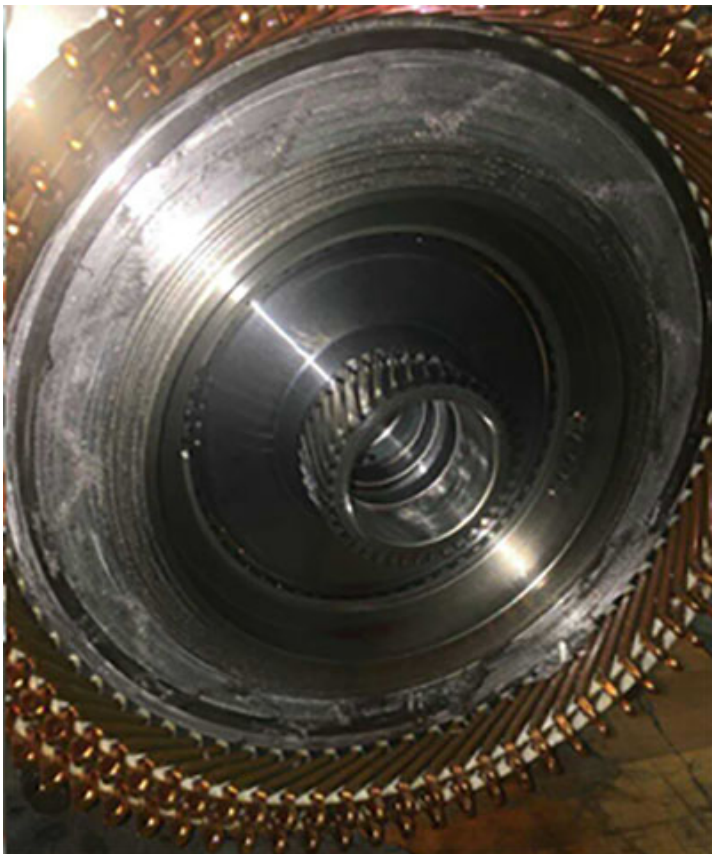
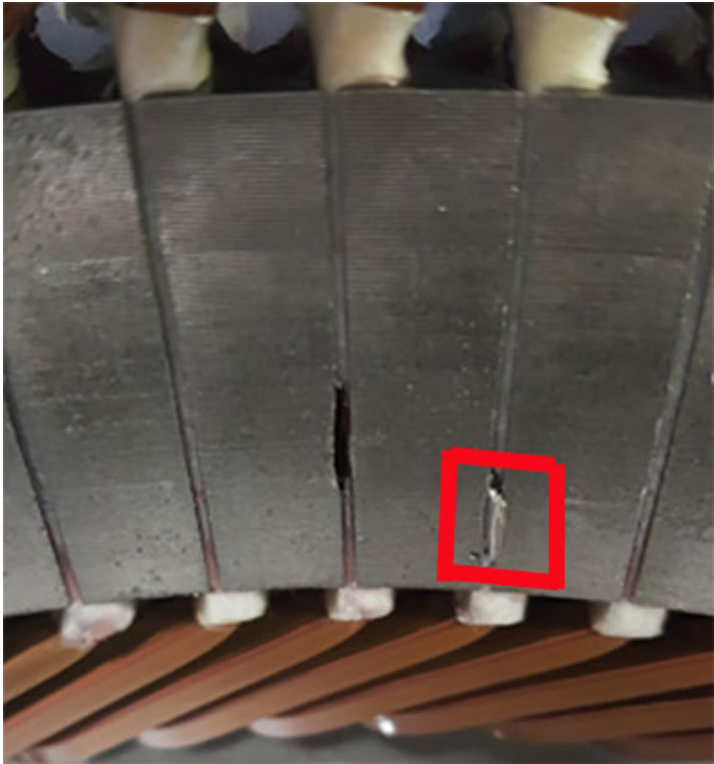
If accompanied by DTCs P1AF0/P1AF2/P1E22 or P0C01/P0C04, then the loss of isolation will be located within the transmission, usually due to debris in the motor stators from a failed internal component.

Examples of debris causing stator problems:

Use the *Loss of Isolation on the High Voltage Main Bus* procedure in SI to help pinpoint which subsystem is causing the loss of isolation.

Note: Any loss of isolation will not self-heal and needs to be repaired for vehicle safety. Clearing codes without repair is not an acceptable remedy of this category due to the vehicle hazards created by P1AEE and P1AEF.

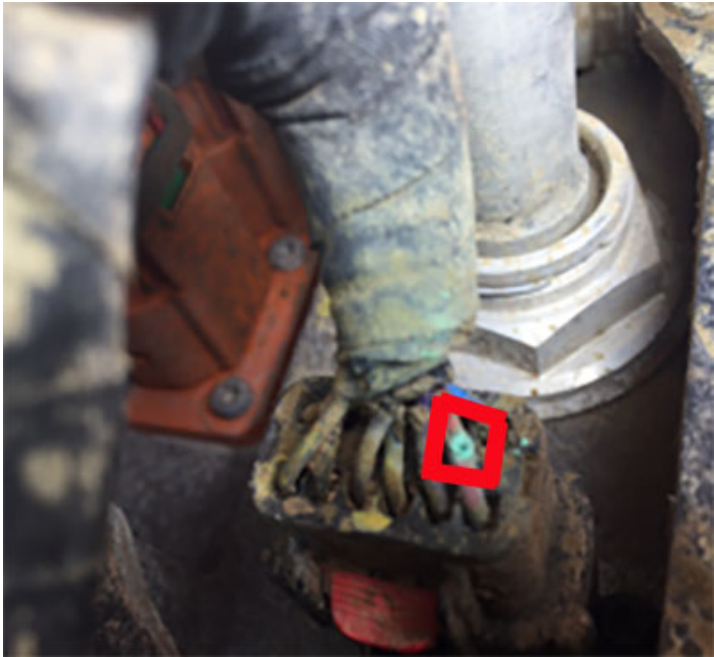
Any compromise in these circuits may cause the contactors to open unexpectedly.

Example of connector X357 with stone impingement and corrosion on wiring:

Inspect circuits 3961 and 3959 for contactor control as well as B+ 5240 and ground circuit 2050 (G302).

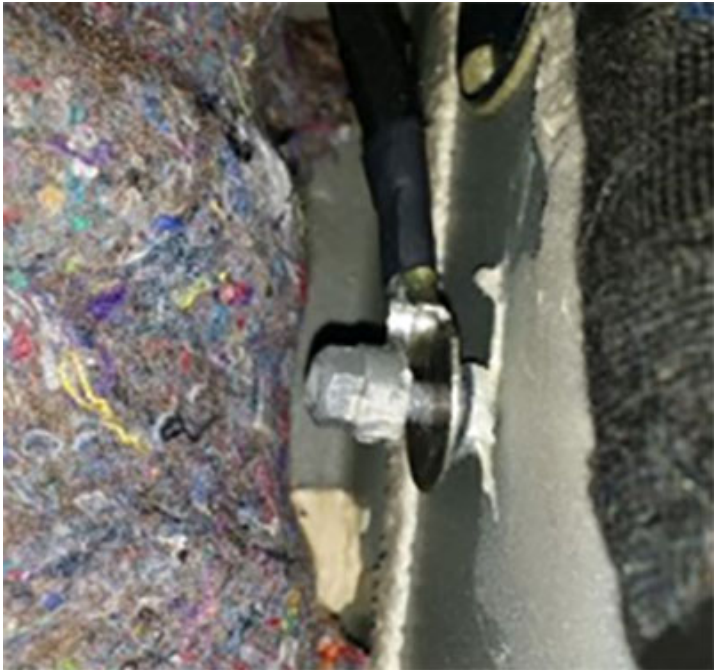
Example of loose ground G302:

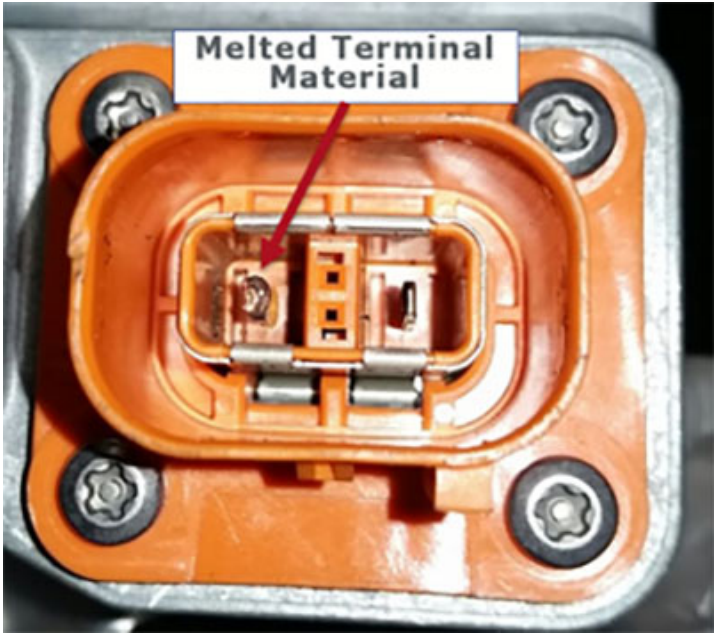
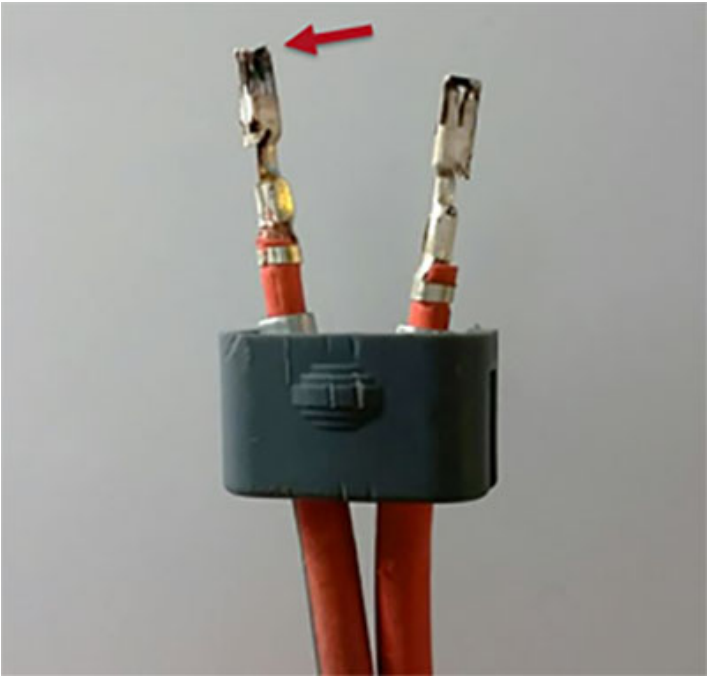
Example of a loose connector X2 at the K10 Coolant Heater Control Module:

This is expected to be a less common category for P1AEE and P1AEF. If one of the parameters is near but not equal to zero, properly inspect each of the orange high voltage connectors on the vehicle for a loose connection on the high voltage bus.
