PIT5287E Diagnostic Tip - Front Shock Terminal Removal

With Magnetic Ride Suspension Package (RPO Z95)

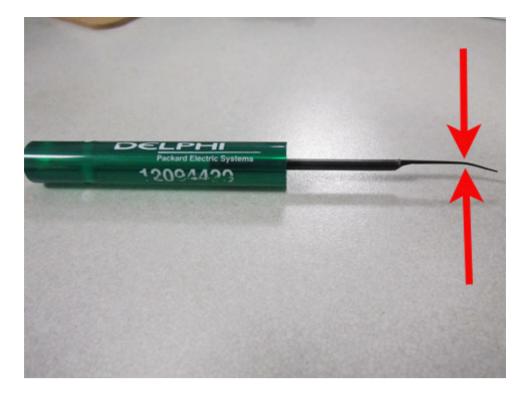
Certain repairs to the front suspension require the removal of the front shock electrical connector terminals. Because the terminals are positioned deep into the connector body, it may be difficult to remove the terminals.

The use of terminal release tool J-38125-12A (Delphi # 12094429), with a small modification, has been found to make removal of the terminal(s) much easier.

Slightly bend the end of the J-38125-12A release tool, as shown in the photo below.

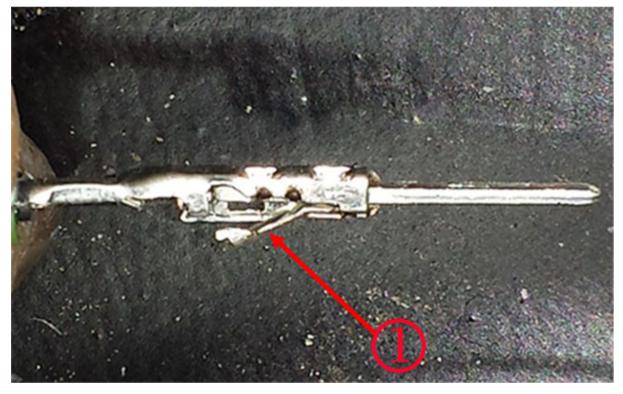
While looking down into the connector body at the terminals, there is a purple TPA that will align itself in the release position when the release tool is inserted into the release hole. Shown below is a shock terminal, that is already removed from the connector body, to show the metal locking tab (1) that will need to be pushed in with the terminal release tool before the terminal will pull out of the connector body.
