PIC6352 Diagnostic Tip - Service Night Vision - Unable to Perform Night Vision Camera Control Module Learn With a Possible Procedure 31 Request Out Of Range Message

Brand:	Model:	Model Years:	VIN:		Engine:	Transmissions:
			from	to		
Cadillac	CT6	2016 - 2020	All	All	All	All
Cadillac	XT5	2020	All	All	All	All
Cadillac	XT6	2020	All	All	All	All

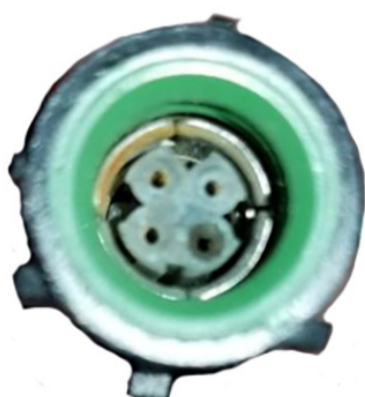
Night Vision Camera Connector:

Involved Region or Country	North America
Additional Options (RPO)	UV3
Condition	Unable to perform Night Vision Camera Control Module Learn with a possible Procedure 31 Request Out Of Range message.
Cause	Possible loose connection or corrosion in the LVDS cable from B276 Night Vision Camera to K172 Night Vision Camera Control Module

Examples of corrosion found in LVDS connectors (usually found with damaged camera which allows water intrusion)

Cycle connections on the LVDS cable at X1 of the B276 Night Vision Camera,

Check for any signs of corrosion in the connectors, Make sure CPA's are locked in place. Re-attempt the Night Vision Camera Control Module Learn.

Note: Do Not replace the B276 Night Vision Camera until the LVDS cable connections are cycled and inspected.
