Preliminary Information

PIT5552C Rear Vision or Surround Vision Camera Image Yellow / Blurry / Distorted / Scrolling / No Grid Lines / Blue Screen with Gridlines / Service Rear Vision System Message

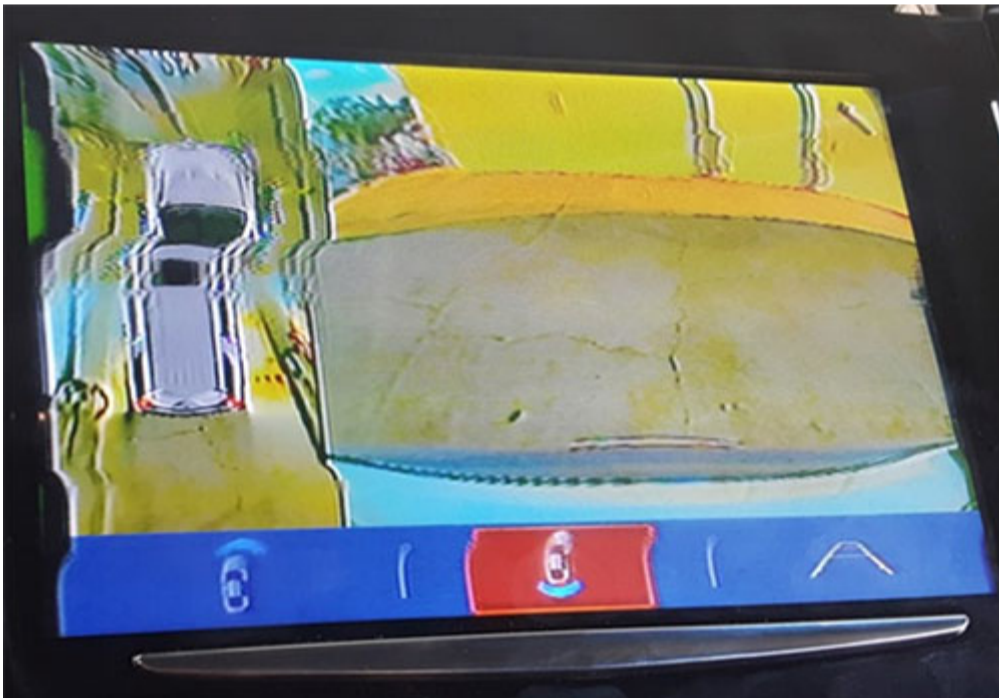
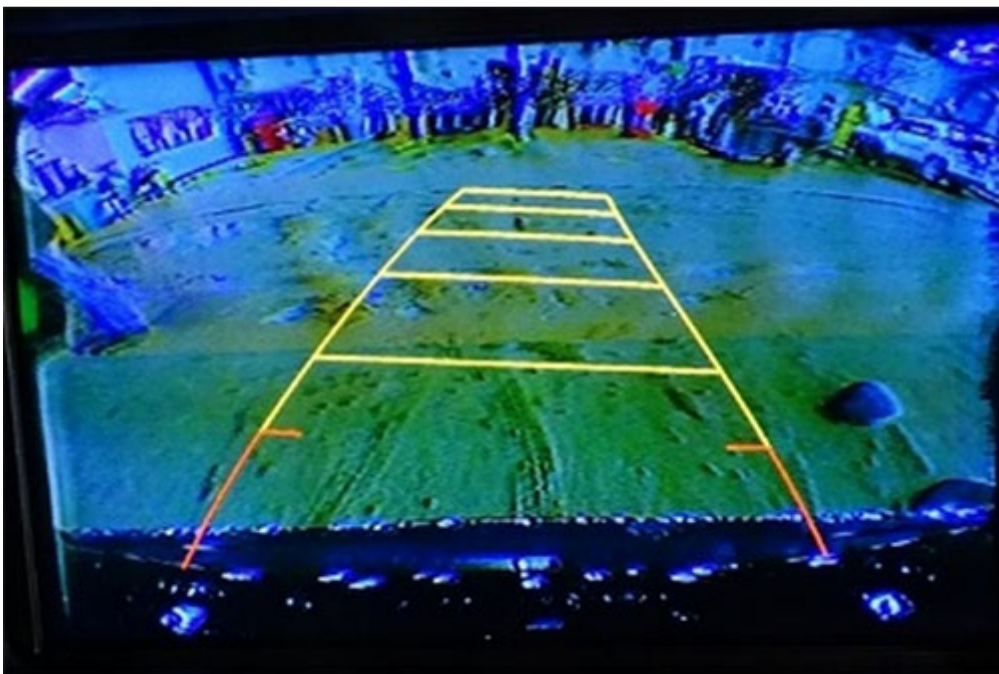
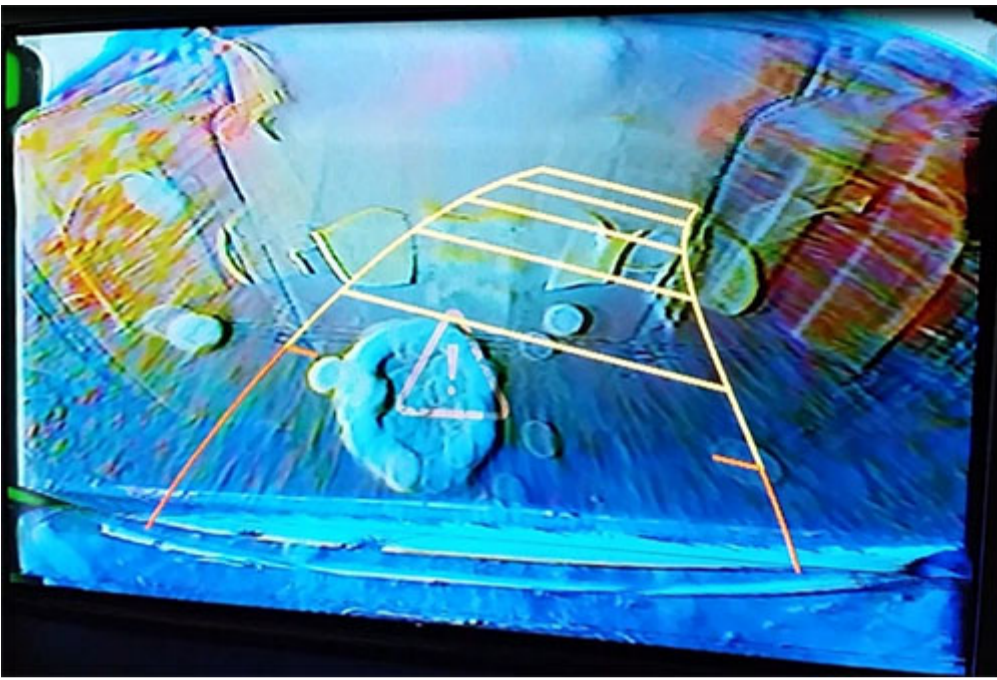
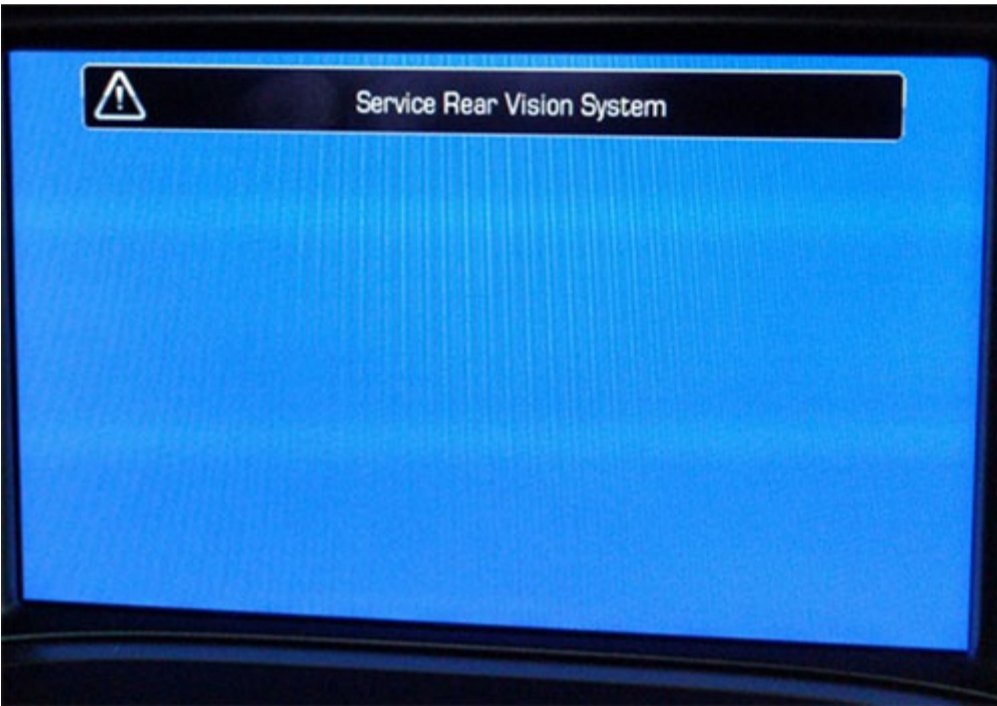
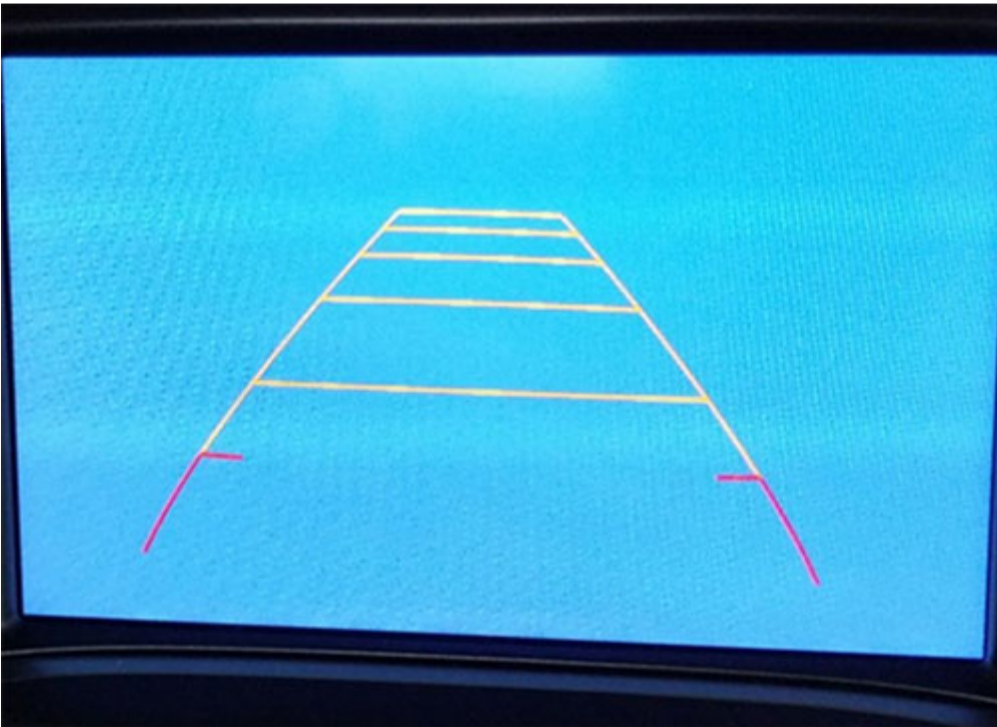
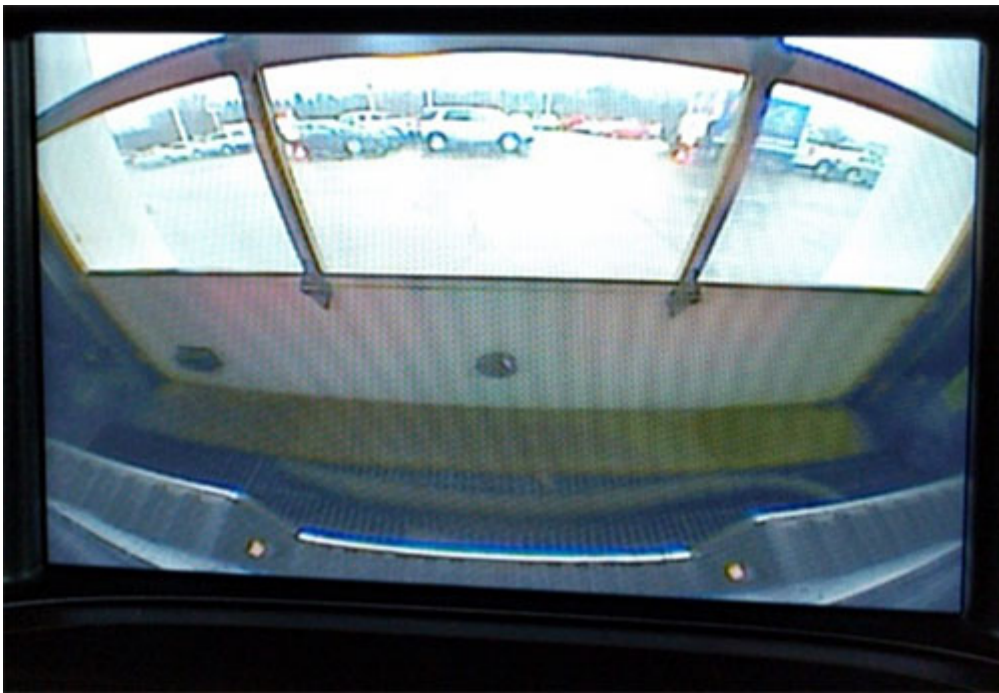
Involved Region or Country	North America and Middle East
Additional Options (RPO)	With Rear Vision Camera (RPO UVC) or Surround Vision (RPO UVH)
Condition	<p>Some customers may have a concern with the rear vision camera or surround vision camera image being:</p> <ul style="list-style-type: none"> - Yellow - Blurry - Distorted - Image scrolling - Image with NO gridlines - Screen is blue with gridlines - Screen is blue with Service Rear Vision System message <p>These concerns may be present with or without any DTCs. Examples of these issues are shown below.</p>
Cause	<p>Cause 1: Aftermarket devices such as the items listed in the latest version of PIC5650 have been known to cause issues with the camera display. Because they are so common, 12 volt to USB adapters have been the number 1 culprit causing image issues.</p> <p>Cause 2: A poor connection in the camera signal circuits 6972 and/or 6973. The camera signal circuits 6972 and 6973 run between the</p>

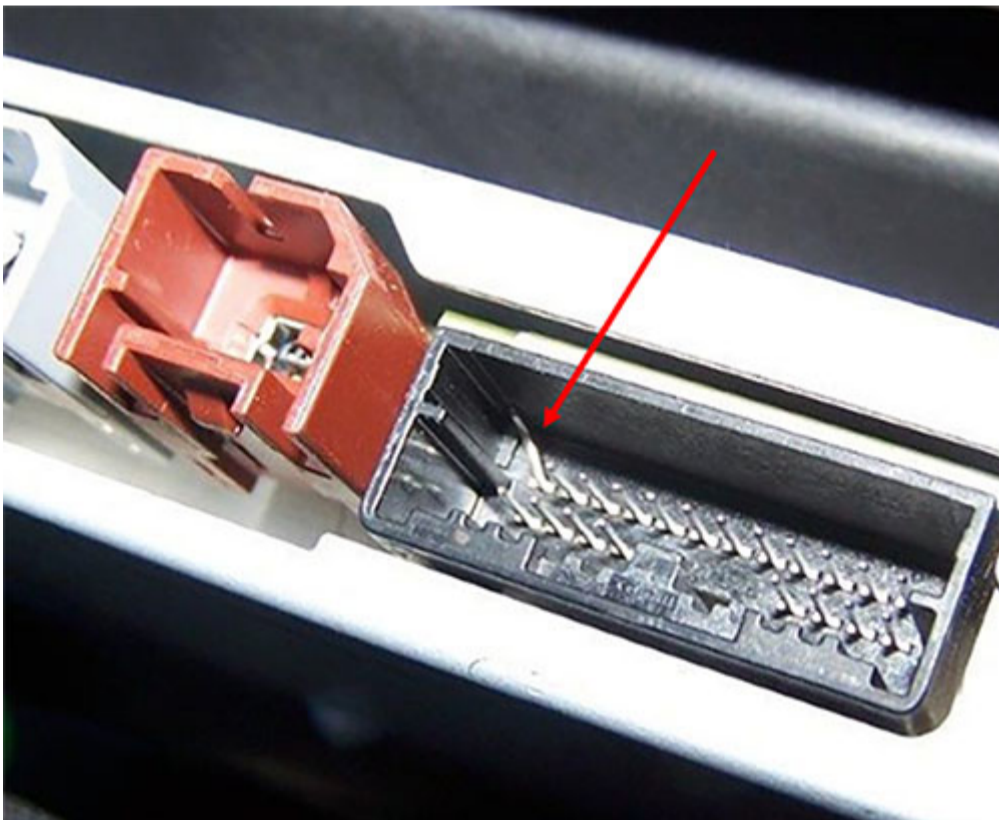
For the 2017-2019 Models, another common area is at the HMI Bypass Module K188. An example of this bent terminal at the HMI Bypass Module K188 connector X1 pin 20 can be seen below.

Correction 2: Inspect the camera signal circuits 6972 and 6973 for opens, high resistance, poor terminal tension, bent terminals, etc. Replace and/or repair any damaged terminals, module(s) with bent pins, or wiring as necessary.
