Bulletin No.: PIT5451C  
Published date: 02/25/2019

### PIT5451C Vibration at Highway Speeds

Brand:	Model:	Model Years:	VIN:		Engine:	Transmissions:
			from	to		
Chevrolet	Silverado 3500 Dual Rear Wheel	2011 - 2019	All *See Note	All *See Note	All	All
GMC	Sierra 3500 Dual Rear Wheel	2011 - 2019	All *See Note	All *See Note	All	All

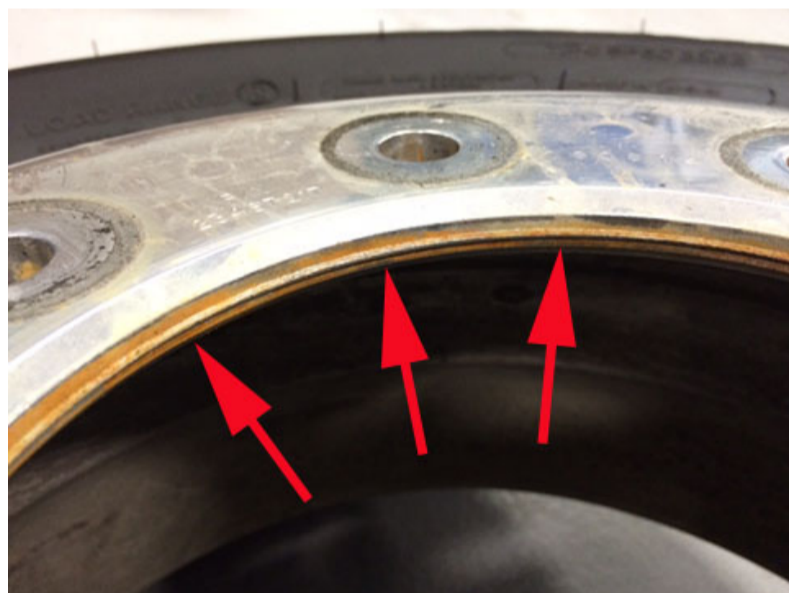
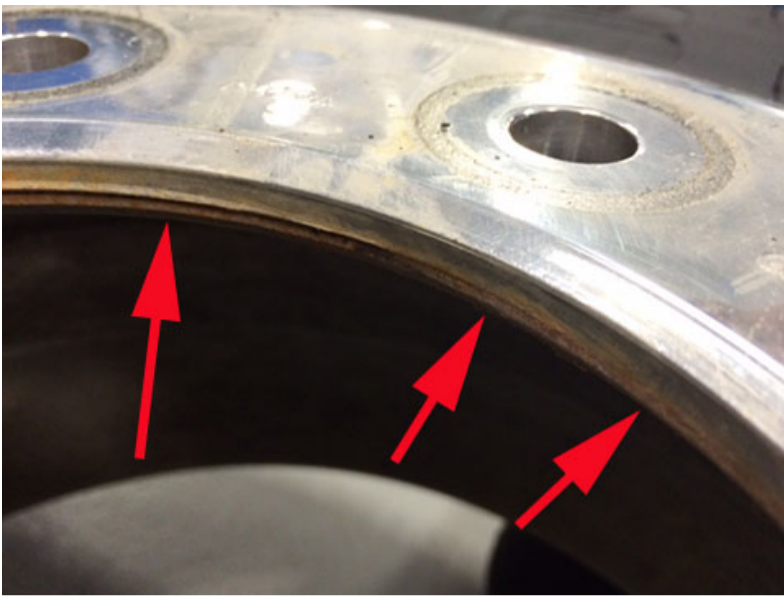
Inspect the front aluminum wheel hub openings for a rolled lip of aluminum in the hub opening (shown below.)

This is caused when the wheel is not centered on the hub and is then forced over the hub extension centering lip (shown below) during torquing of the wheel. These wheels **MUST** be manually tightened down to properly center the wheel on the hub before torquing. If this condition is found, replace the affected wheel.
