Bulletin No.: PIT5657
Published date: 02/26/2019

PIT5657 Loose Shifter Lever and/or Poor Shift Actuation From Shift Lever

Brand:	Model:	Model Years:	VIN:		Engine:	Transmissions:
			from	to		
Chevrolet	Silverado 1500 (New Model)	2019	All	All	All	All
GMC	Sierra 1500 (New Model)	2019	All	All	All	All

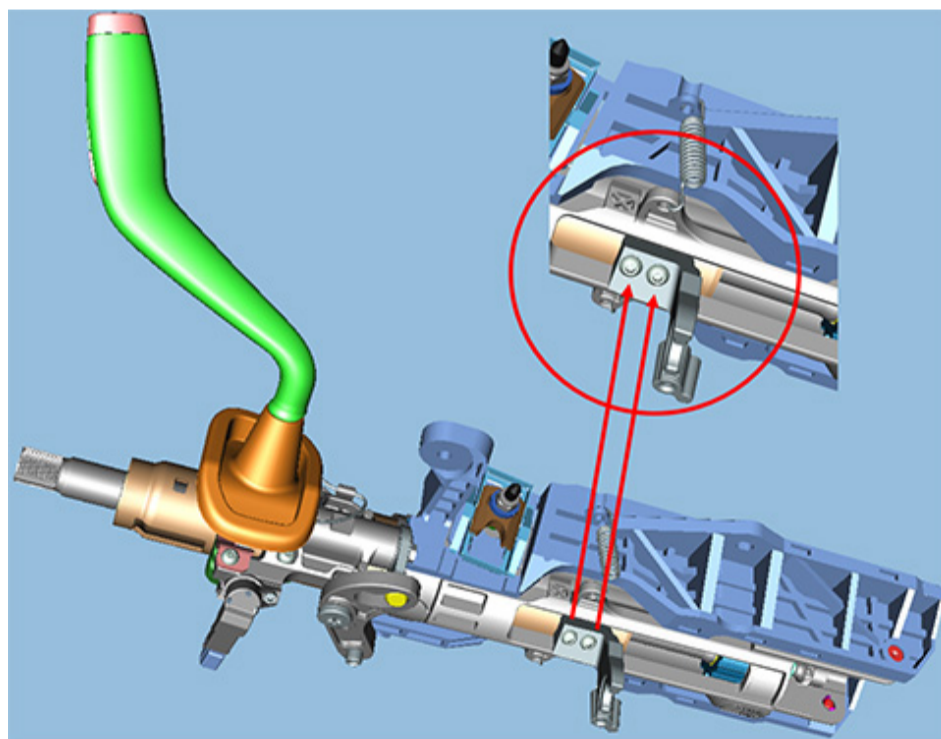
Involved Region or Country	North America
Condition	Some customers may comment of a loose shifter lever or poor shift actuation from the shift handle.
Cause	This concern could be caused by the shift cable bracket attaching bolts being loose, see picture below.

Note: Do NOT tighten these bolts, they are not serviceable.

Inspect the shift cable bracket attaching bolts for being loose. If the bolts are found to be loose, replace the steering column assembly. Do NOT tighten or replace these bolts, they are not serviceable.
