Mack Model LEU , LR , MRU - TerraPro , CHU - Pinnacle, Axle back , CXU - Pinnacle, Axle front , GU - Granite , TD - Titan

Volvo Model VNL , VNM , VNX , VAH , VHD

Title ** Tech Tip ** TT - 007 - 2015 - Diagnosing The Aftertreatment Control Module DTCs P202D, P208E, P20E8 - OBD13 (Commonly Model Year 2014); Newer Chassis AFTER Reviewing Other Solutions

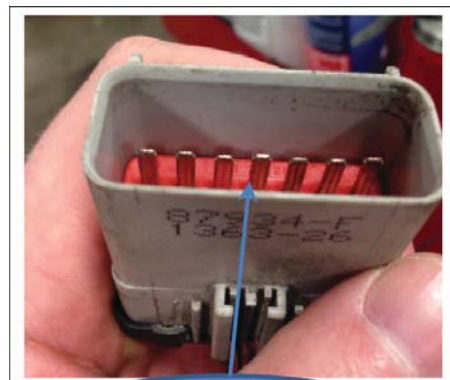
First inspection-the connector looks OK

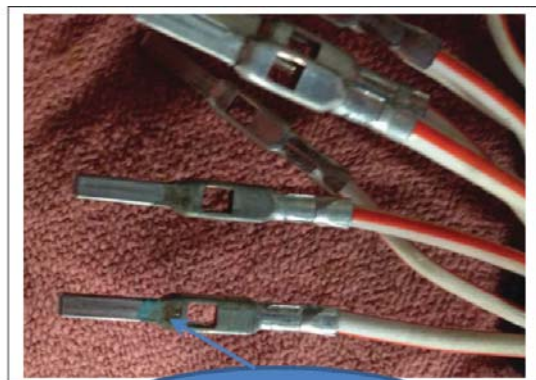
1. Inspect the electrical circuit connections between the ACM and the DEF pump at the DEF pump connector, ACM connector, and FCUT connector. Pay special attention to the FCUT connector. A minor amount of oxidation or corrosion will cause these DTCs.

After removing the red retainer, corrosion is seen present in the connector.

If any corrosion is found in the FCUT connector, replace terminals on the front chassis harness and urea tank harness as required.

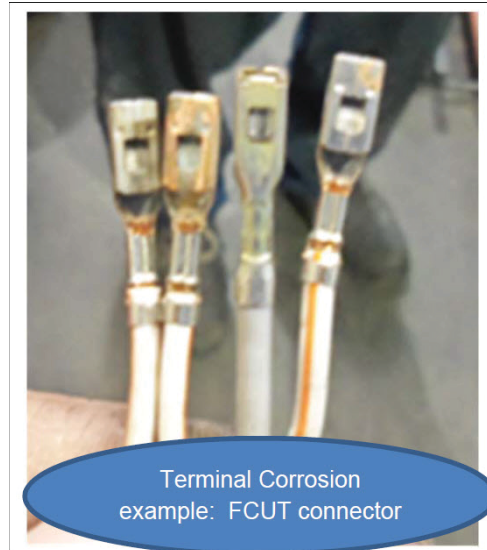
3. If the above actions do not resolve the complaint, proceed with the applicable Guided Diagnostics. Terminal Corrosion example: FCUT connector Debris found in DEF pump connector screens

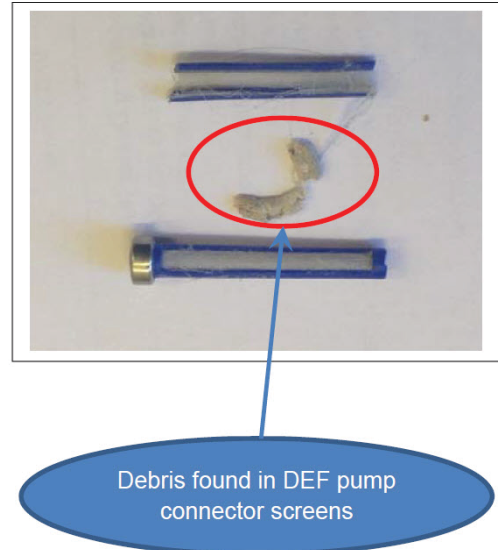
2. Inspect DEF system for contamination and clean as required. Debris can build up in the filter screens under normal operation and remain trapped in the system due to the reversion cycle at key off.

Remove the Inlet and backflow connectors and inspect the filter screens for debris and replace as required. Reference Impact 2589-11-02-05 Aftertreatment Diesel Exhaust Fluid (DEF) Contamination Flush
