# UPDATE Technical Bulletin

## 51G4 UPDATE – Seam Sealer Application (NVLW)

Model(s)	Year	VIN Range	Vehicle-Specific Equipment
Jetta	2019	See Campaign/Action screen in Elsa	See Campaign/Action screen in Elsa

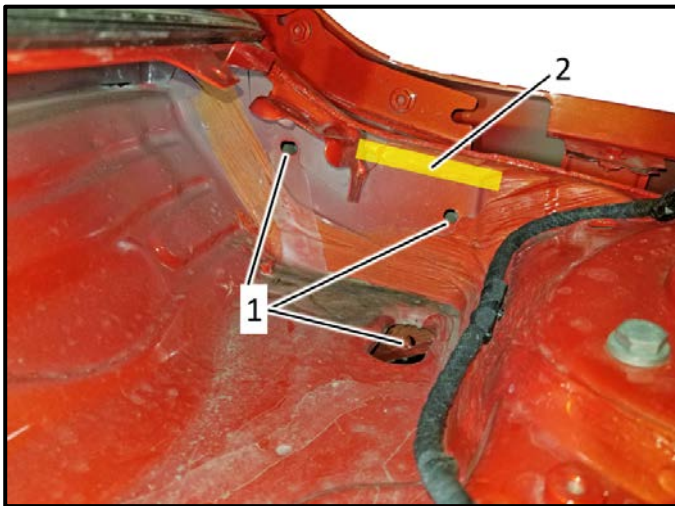
## Apply seam sealer driver side.

Water leak due to improper application of body seam sealer.

- Use a gloved finger or a small brush to apply the seam sealer.
- Ensure area is dry.
- Completely cover holes <1> with sealer.

### ! NOTE

Do not cover the large plenum chamber drain.

- Completely cover exposed seams in the shaded area <2>.
