Technical Bulletin

Model(s)	Year	Eng. Code	Trans. Code	VIN Range From	VIN Range To
Passat	2018 - 2019	All	All	All	All

64 19 01 January 2, 2019 2053045/1

Window Inoperative, Window Pinch Protection Activated, or Window Noisy During Operation

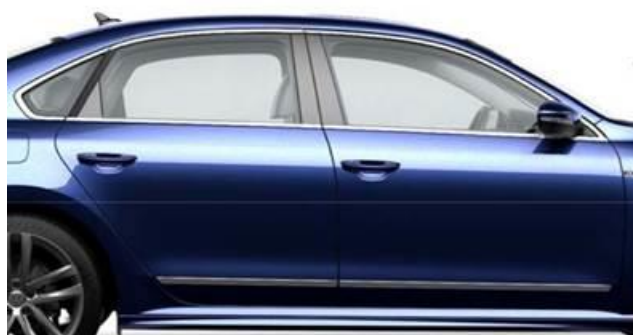
Figure 1

- Check outer door panel for any indication of exterior damage.
- Take pictures of any defect identified during inspection.
- Take side view picture(s) of the vehicle on the side that the complaint was reported. Example, figure 1.

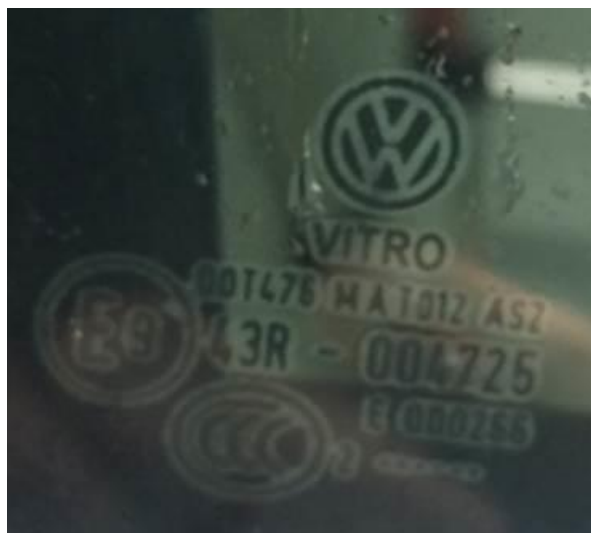
Figure 2

- Take picture(s) of the window glass label. Example, figure 2.

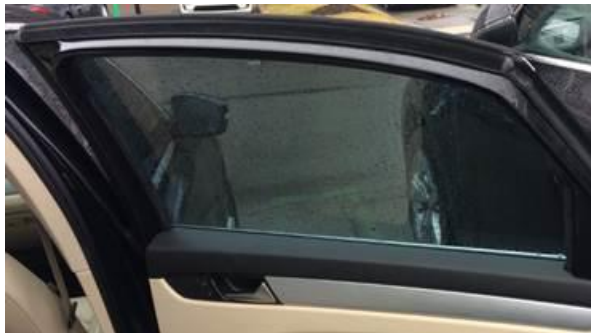
Figure 3

- Take picture(s) of the interior of the window glass for which the complaint was reported. Example, figure 3
