SERVICE BULLETIN

APPLICABILITY: 2014-2018MY Forester

NUMBER: 04-23-18R

SUBJECT: Power Steering System Diagnostics

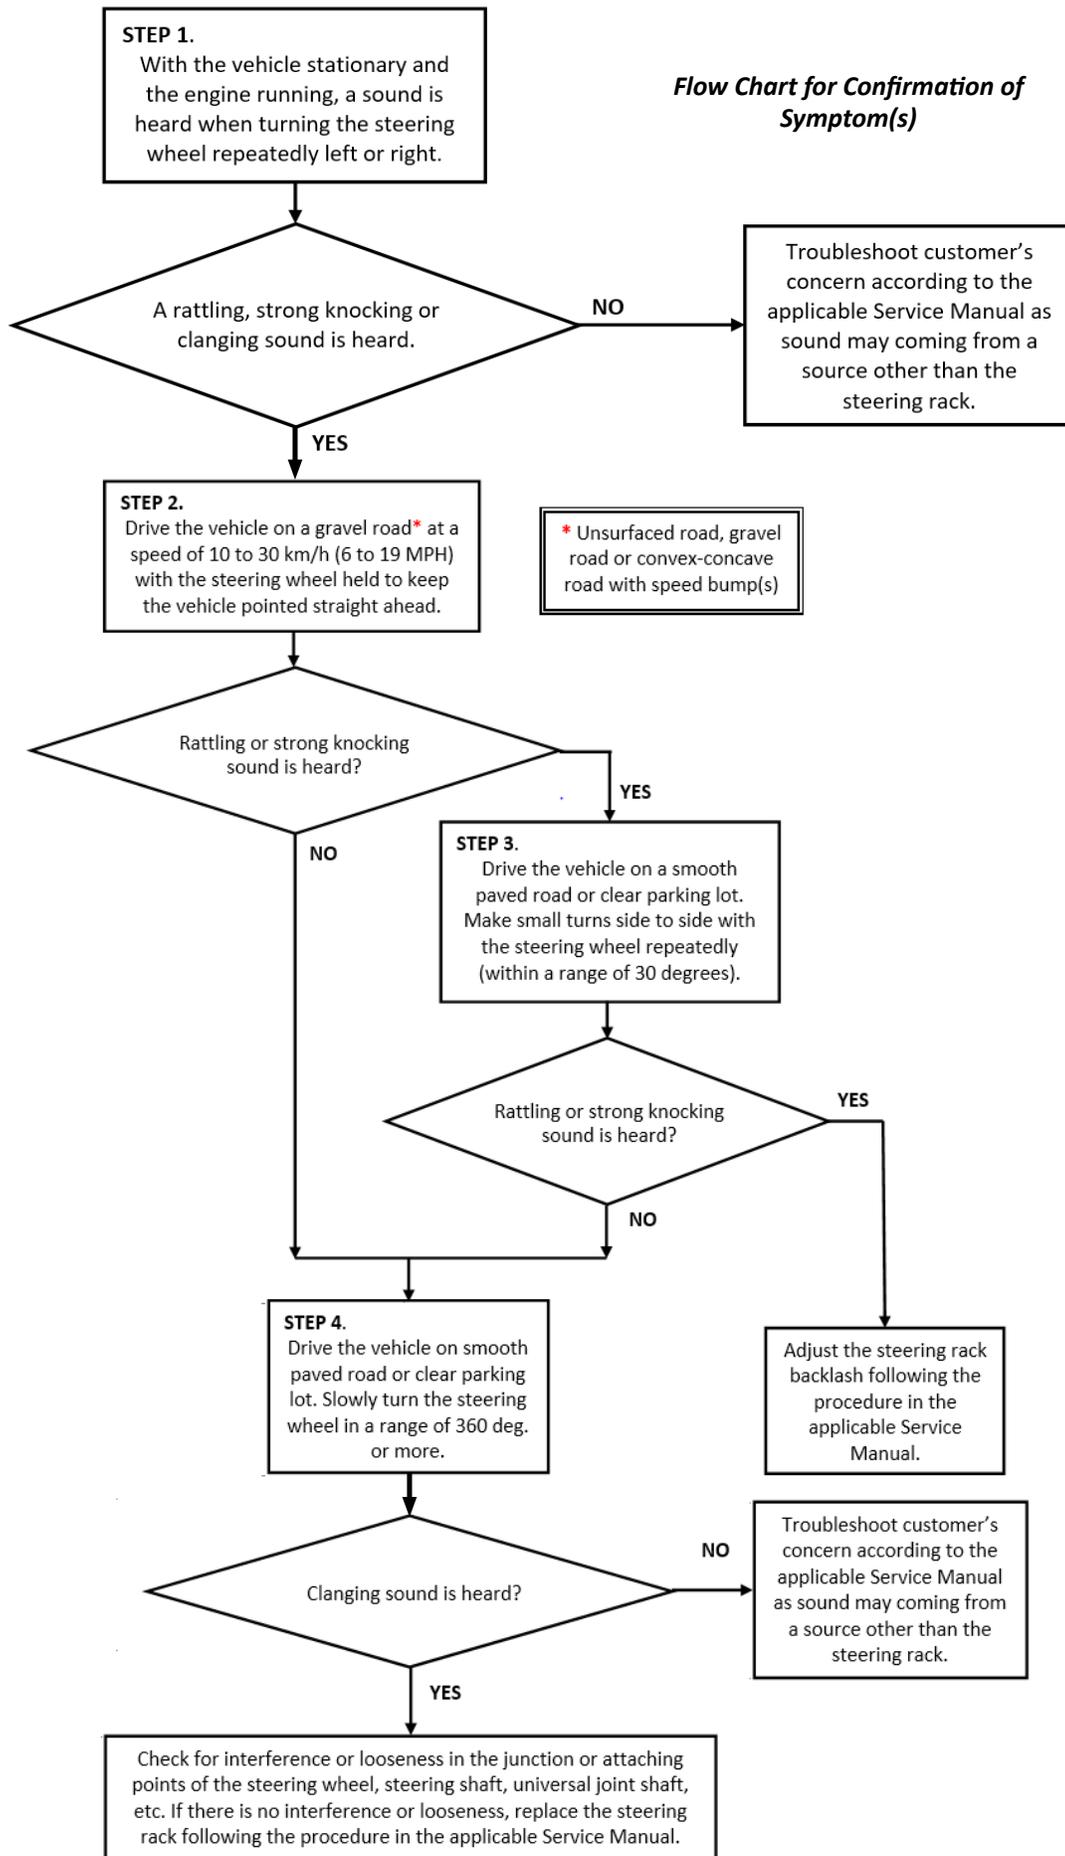
Flow Chart for Confirmation of Symptom(s)

This bulletin provides helpful tips to simplify the diagnosis of sound concerns originating in the electronic power steering (EPS) gearbox (steering rack) assembly. If a vehicle presents with a “rattling”, “knocking” or possibly a “clanging” type sound coming from the steering rack and / or a vibration felt through the steering wheel, use the flow chart below to help make diagnosis of the concern easier.

- **“Rattling”:** Sound or vibration heard or felt in the steering that occurs while driving and without any steering wheel input (travelling straight ahead).
- **“Knocking”:** A “muffled” sound or possibly a vibration -type feeling that occurs with the engine running and the vehicle either in motion or stationary.
- **“Clanging”:** A metallic -type sound heard with the engine running and the vehicle either in motion or stationary while turning the steering wheel left or right.

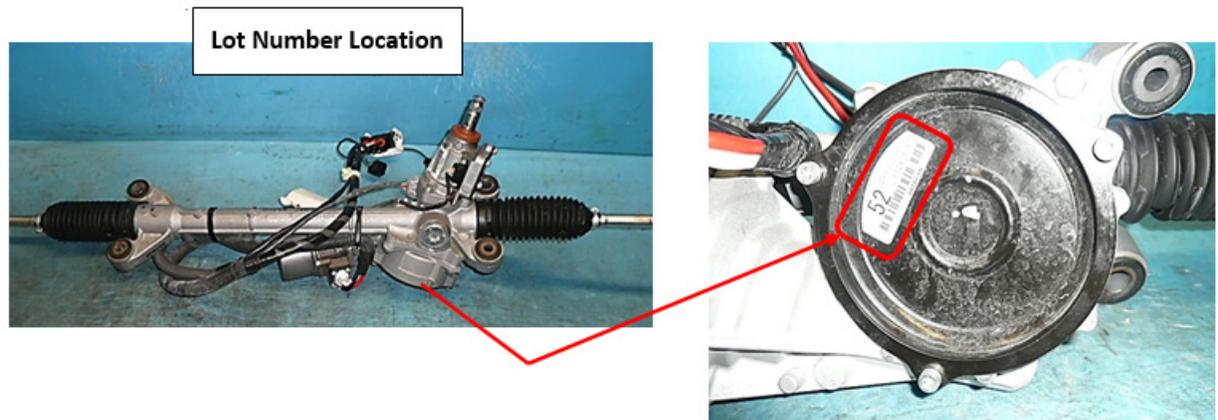
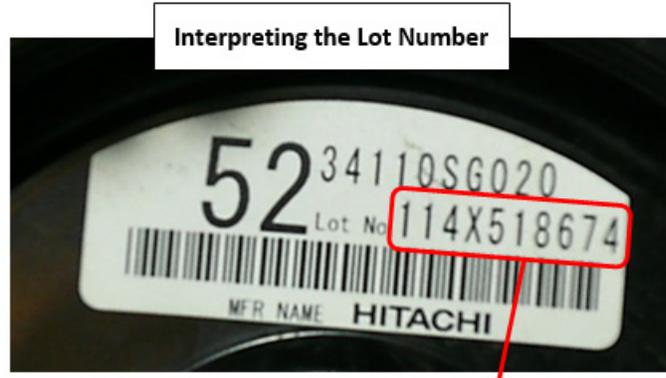
IMPORTANT: Use the information below to locate and interpret the Lot Number found on the bottom cover as shown. A change was made to the EPS rack assembly during June of 2017 but, there is not a starting VIN number available for when these parts were incorporated into the vehicle production. Therefore, never take it for granted a vehicle produced during or after June of 2017 has the new EPS rack installed. **Always** inspect the Lot Number **BEFORE** replacing any EPS rack assembly on a vehicle affected by this bulletin.

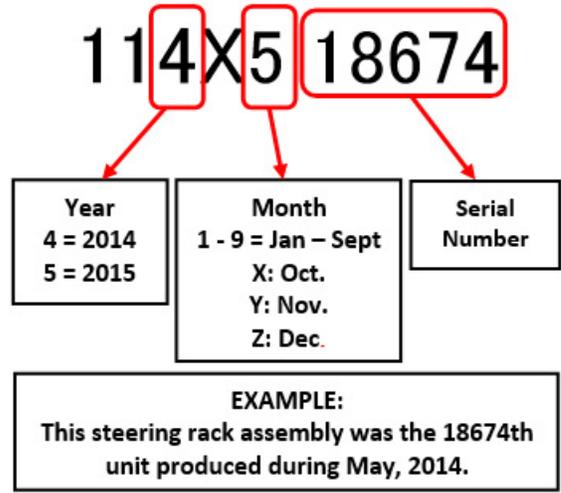
Interpreting the Lot Number

IMPORTANT NOTE: The information provided in this bulletin is only applicable to vehicles equipped with EPS racks with Lot Numbers **BEFORE 117X614038**. A procedure for interpreting the Lot Number is provided after the flow chart shown below. If any of the concerns described below are verified on an EPS rack **with or after** Lot Number 117X614038, diagnose following the procedure in the applicable Service Manual.

If diagnostics determine EPS rack replacement is necessary, follow the procedure in the applicable Service Manual for the repair.
