SERVICE INFORMATION BULLETIN

APPLICABILITY: 2015-2017MY Legacy and Outback
 2015-2016 Impreza
 2015-2017 Crosstrek
 2016-2018MY Forester
 2016-2018MY WRX

NUMBER: 15-205-16R

SUBJECT: Reprogramming File Availability to Address Operational Concerns with “Gen 2.0” and “Gen 2.1” Fujitsu-TEN (F10) / **Denso-TEN (D10)** Navigation and 7” Display Audio Units

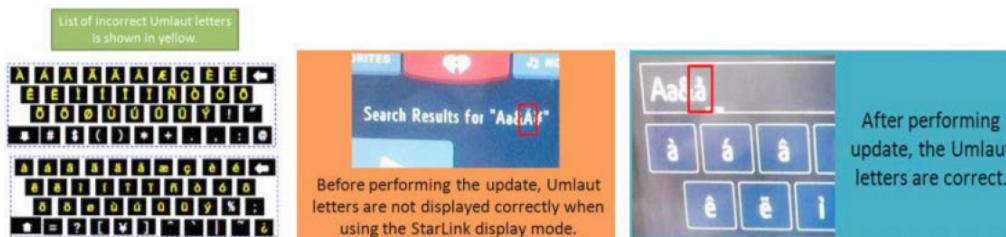
- Navigation function is slow to start when selected.
- No map display with key or ignition in “ACC” (accessory) position.
- No voice guidance provided from Navigation system after selecting a route unless the ignition is cycled off and back on again.
- Steering wheel switch controls are inoperative with an iPod (MP3) player connected to the USB.
- Incorrect Umlaut characters are shown on StarLink display.

If the software version for the head unit is earlier the one listed above, and the condition is listed, then application of the latest software should resolve it.

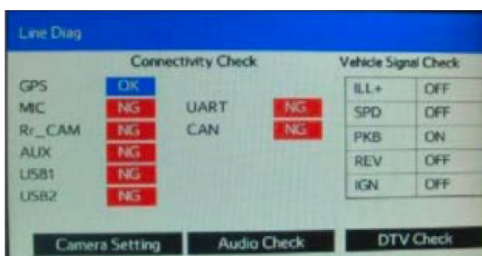
- No response from the soft touch keys on display.
- Back-Up Camera is displayed when shifter is in positions other than Reverse.
- “Line Diag” screen is displayed intermittently while driving.

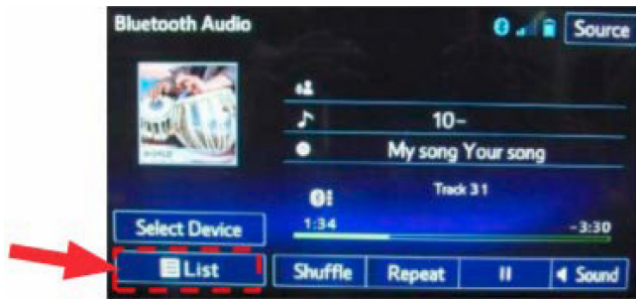
- “LIST” soft touch key is not displayed on Bluetooth Audio screen while using Bluetooth audio feature with an Apple device utilizing iOS8 software version.

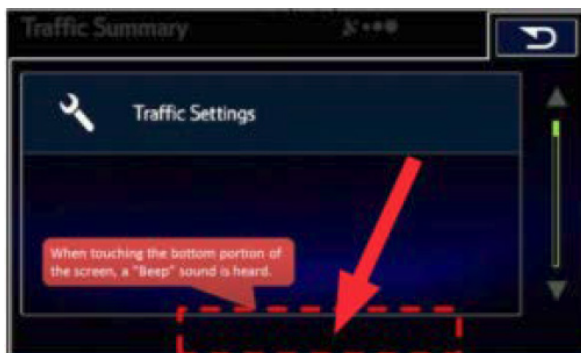
- “Beep” sound heard when touching the bottom of the display screen where no function soft touch keys are displayed.

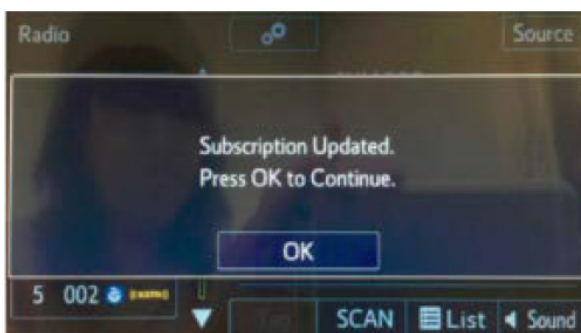
- SXM caution message screen is displayed in English even when French language operation settings are selected.

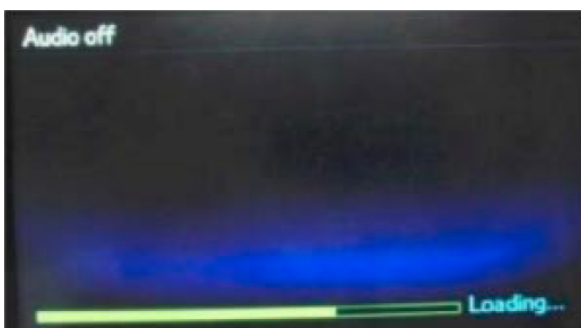
- The following symptoms are all related to the inability of the software to properly load. One or all of these 5 conditions may occur at the same time:

- Repeated display of the “Loading” screen at initial unit start-up

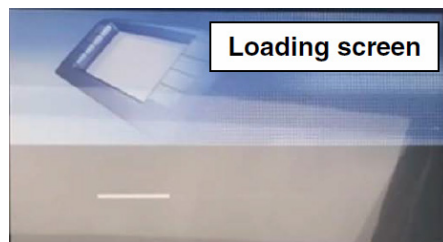
- The Navigation system freezes when re-routing while using traffic information supplied by SXM.
- The Navigation system re-boots from the Loading screen when utilizing the remote engine starter (RES) feature (if equipped).

If the software version for the head unit is earlier the one listed above, and the condition is listed, then application of the latest software should resolve it.
