ARTICLES CONTAINED IN THIS ISSUE

01 QMR OF THE MONTH

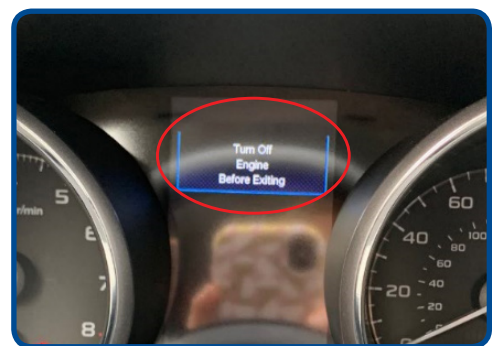
If the ignition on a Push-Button Start car is switched OFF before the shift selector is placed in Park, the ignition mode changes to ACC mode as indicated by the orange LED on the START button. In this case, the radio remains on and a message will appear in the combination meter display stating “Turn Off Engine Before Exiting” even though engine is already OFF and the driver’s door is opened. This is a normal operating characteristic. A similar condition may occur if there is a concern with park switch or park switch signal at the time the ignition is switched off. This condition can easily be alleviated by starting the engine and shutting it back off again while keeping the selector in Park.

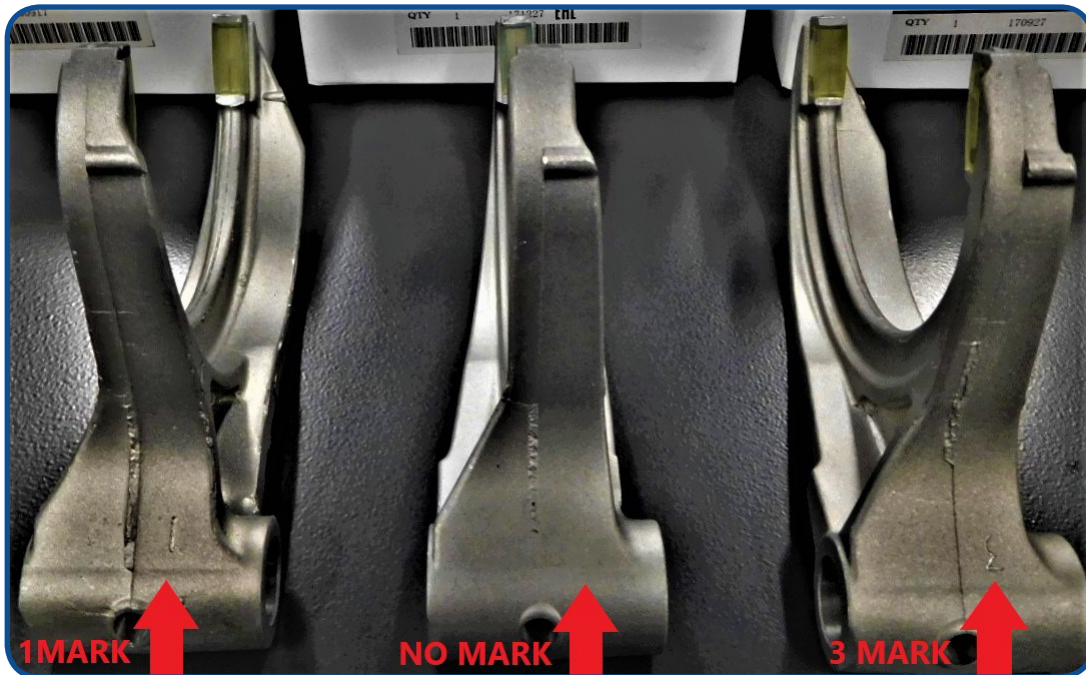
03 SELECTABLE SHIFT FORK IDENTIFICATION MARKS

Split case manual transmission shift forks should be checked and adjusted any time internal transmission service is performed. Shift forks are identified by stamped numbers, or lack of stamped numbers located near the roll pin hole. See below photo of selectable 1-2 shift forks.

3-4 and 5-6 are also selectable. Marks may be in a different area, but the mark will ALWAYS be stamped into the fork.

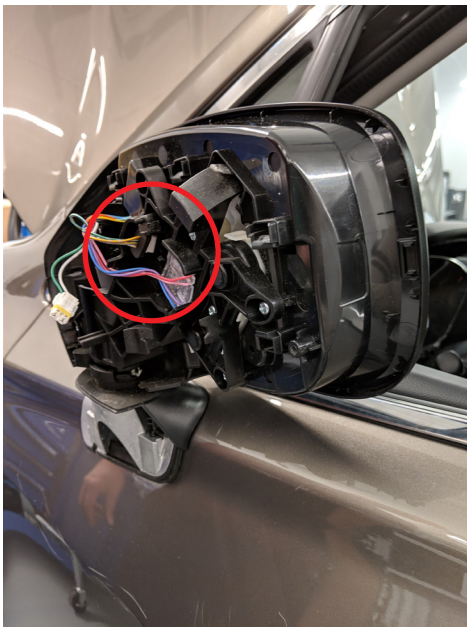
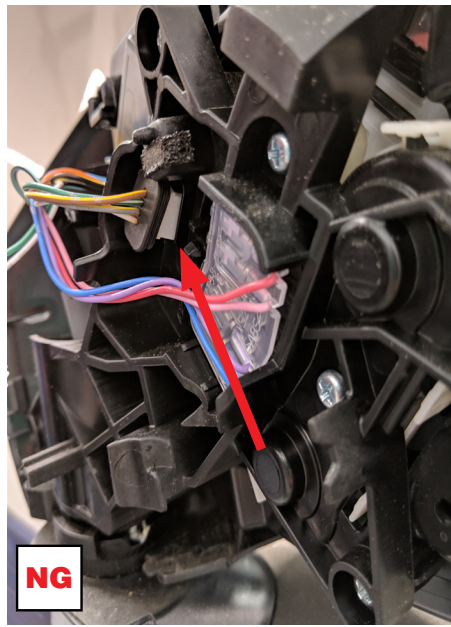
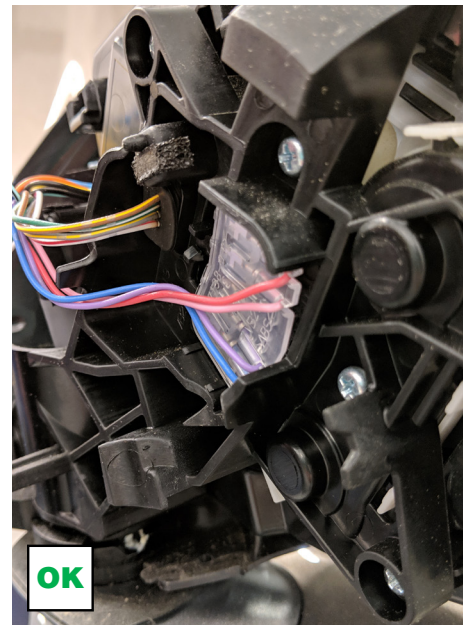
A small number of field reports have been received with a concern involving the DMS system being inoperative. One of these reports stated a DTC U0156 for Lost Communication was stored in multiple modules. In addition, the seat memory feature was also found to be inoperative. After performing extensive electrical diagnostics, the root cause was traced to a loose harness connector located behind the lower exterior trim cover of the driver's door mirror assembly. After re-seating the connector and making sure it was fully locked in place, all systems returned to normal operation. The photo below shows the loose connector.

***UPDATE:** A production change was made to the routing of the wiring harness starting with VIN KH452339.

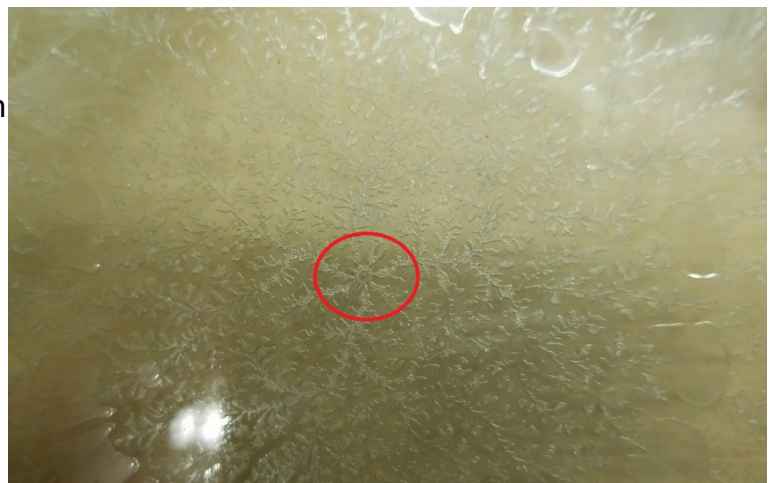
Damage resembling a snowflake inside glass panes is caused by application of excessive heat to the glass such as during the application of window tint. This type of damage is not a matter for warranty coverage.
