SERVICE BULLETIN

APPLICABILITY: 2015-18MY Legacy and Outback **NUMBER:** 05-67-19
SUBJECT: Wheel Hub / Bearing Assembly- Design Change **DATE:** 01/24/19

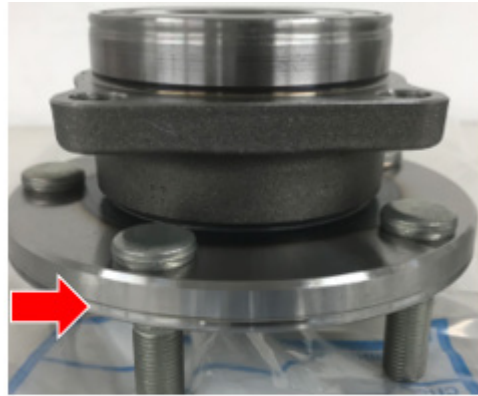
**28373VA020:
WITH identifying groove**

* Includes an identification groove as pictured below.
