January 2019  
FL800A  
NHTSA #18V-787  
Transport Canada #18-624

## Subject: Cascadia Steering Wheel Airbags

**Models Affected: Specific Freightliner Cascadia vehicles manufactured August 3, 2017, through October 31, 2018.**

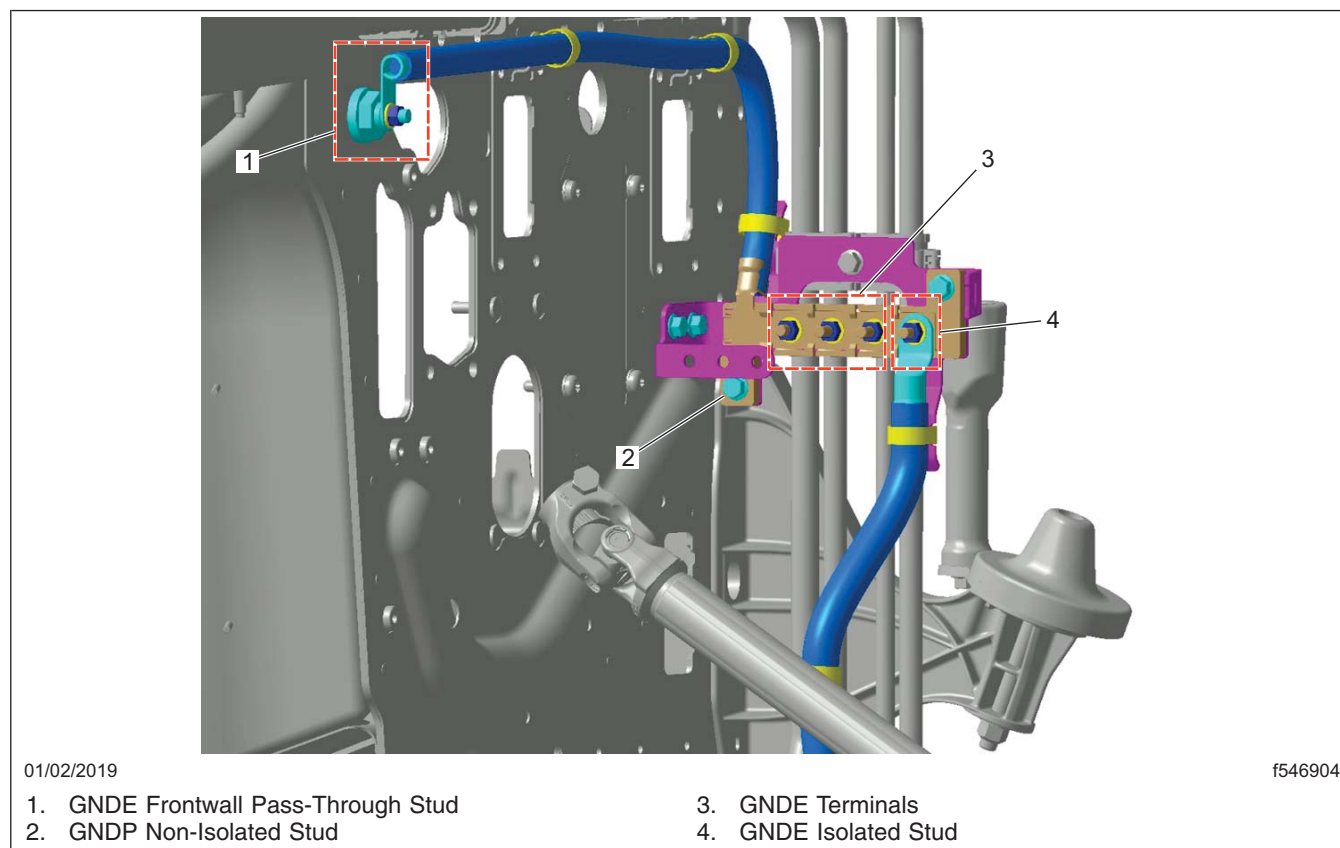
**Fig. 1, MGJB and Frontwall Grounds**

NOTE: There should always be FOUR ring eyes attached to the GNDP non-isolated stud.

11. Inspect the GNDP non-isolated stud, located on the lower aft portion of the MGJB bracket. Verify that the GNDP non-isolated stud is clean, configured properly, and torqued correctly. Disassemble and inspect the stud for overspray on the flat surfaces, and in between the ring eyes. Verify there are exactly four (4) circuits on ring eye terminals that attach to the GNDP non-isolated stud on every vehicle. If more or less are found on this stud, combine this inspection step with the next one for GNDE MGJB, separate and group the cables until four GNDP connections are confirmed. Fan these GNDP ring eyes properly on the non-isolated stud and then torque. Repaint the connection as necessary.
