Subject: RATTLING NOISE FROM LEFT REAR OF VEHICLE	Bulletin No.: 01-009/19
	Last Issued: 02/13/2019

2019 CX-5 2.5L Turbo vehicles with VINs lower than JM3KE*****514172 (produced before Oct. 27, 2018)
2019 CX-5 2.5L Turbo (Mexico Spec) vehicles with VINs lower than JM3KE*****514172 (produced before Oct. 27, 2018)

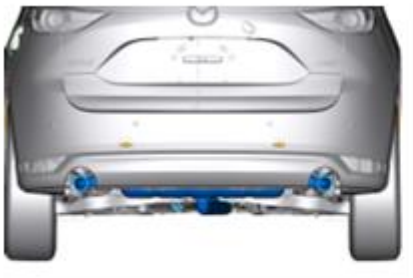
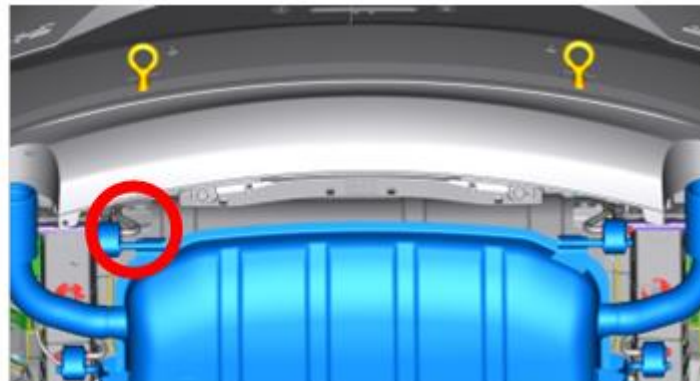
Some customers may notice a rattling noise coming from the left rear of the vehicle while driving on bumpy roads. The noise may be caused by interference between the left rear hanger bracket and the hanger rod, due to a lack of clearance.

The shape of the left rear hanger bracket has been changed.

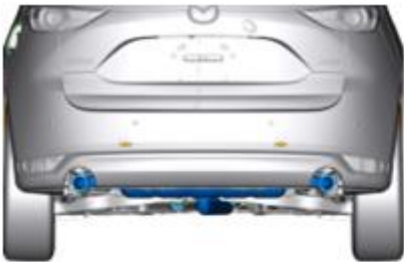
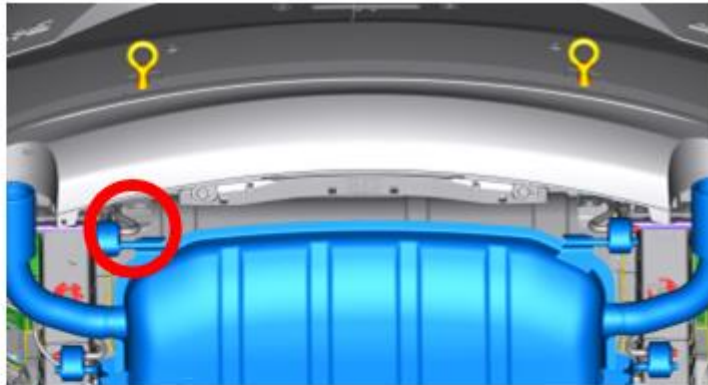
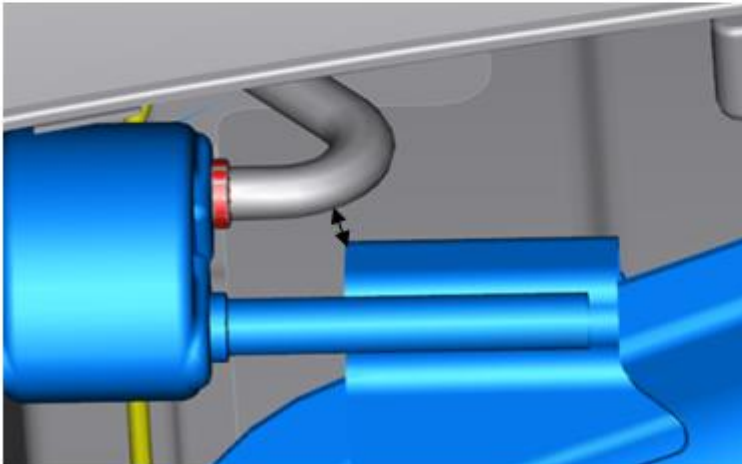
1. Verify the customer concern.
2. Measure the gap between the left rear hanger bracket and the hanger rod.

NOTE: Measure the gap at the narrowest point between the hanger bracket and the hanger rod (as shown above).

3. Depending on the measurement, take the corresponding action.

- If the gap is 7mm or more, this service information does not apply. Inspect and repair vehicle according to the instructions on MGSS online.

- If the gap is less than 7mm, replace the main silencer with a modified one according to the instructions on MGSS online (EXHAUST SYSTEM REMOVAL/INSTALLATION [SKYACTIV-G 2.5T]).

NOTE: The insulator or remainder of the exhaust system does not need to be removed to replace the silencer. Replace the silencer by removing the two (2) nuts and separating the three (3) rubber hangers from the main silencer.

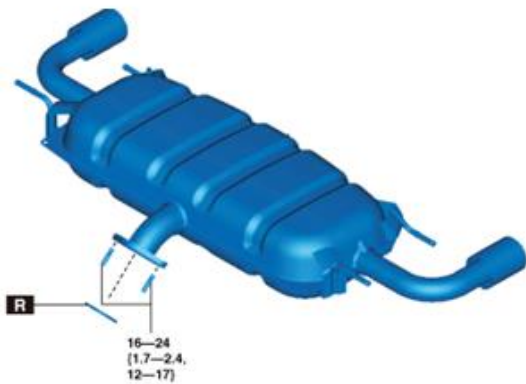
4. Confirm the clearance is 7mm or more as indicated in Step 2.
