Technical Service Bulletin

Subject: IGNITION DOES NOT TURN OFF WHEN PRESSING START / STOP BUTTON	Bulletin No.: 05-001/19
	Last Issued: 02/15/2019

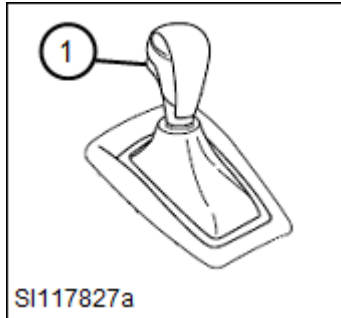
When pressing the START/STOP button in very cold weather, the ignition may not turn off on some vehicles equipped with a lock release button (1) on the selector lever knob. Although the selector lever is in the "P" position and the engine shuts off normally, the ignition may stay on (in accessory mode).

This may be caused by the lock release button in the selector lever knob sticking in the pressed position. An improper production process is causing an internal part to expand with moisture and interfere with other parts. To eliminate this concern, the production process has been modified.

2. Replace the shift selector knob with a modified one according to the instruction in MGSS (AUTOMATIC TRANSAXLE SHIFT MECHANISM REMOVAL/INSTALLATION).

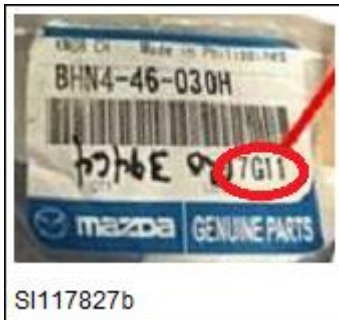
NOTE: When receiving service parts, verify the lot number is on or after 8B23. The lot number is in YMDD format. 8B23 means February 23, 2018.

NOTE: The lot number is only found on the label. If the lot number is unknown or before 8B23, DO NOT use the part. Return it to PDC.
