Technical Service Bulletin

MULTIPLE ELECTRICAL MALFUNCTIONS AFTER BODY REPAIR

Bulletin No.: 09-010/19

Last Issued: 02/05/2019

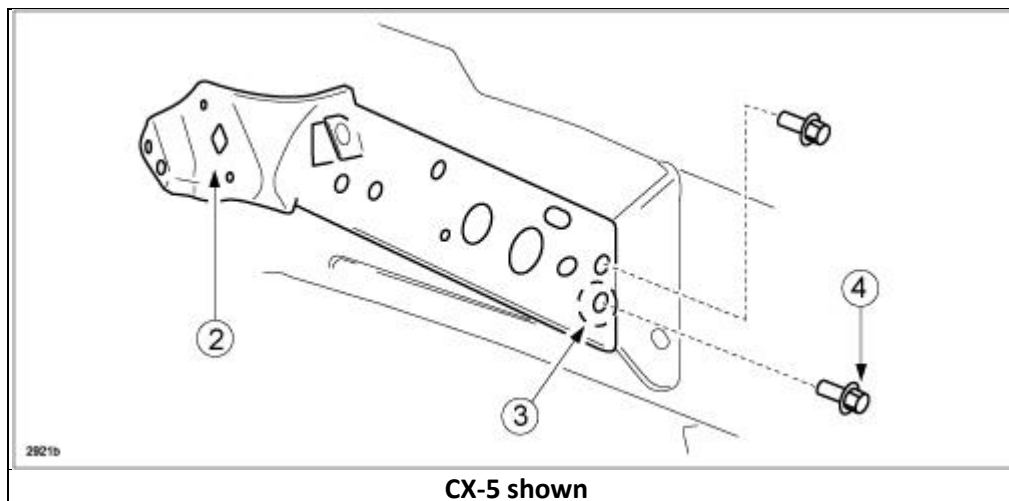
The front fender stay (2) newly painted surface at ground point (3), where attachment bolt (4) is seated, may create a poor front harness ground connection.

NOTE: Do not paint ground point (3) where attachment bolt (4) is seated.

Customers concern can be resolved by sanding off paint at ground point (3) where attachment bolt (4) is seated. After installing the bolt (4), apply touch-up paint to the exposed base material area of the front fender stay.
