Subject: RUST ON FRONT DOOR QUARTER GLASS AT BELTLINE MOLDING	Bulletin No.: 09-011/19
	Last Issued: 02/25/2019

2016-2019 MX-5 with VINs lower than JM1ND*****304583 (produced before December 19, 2018)

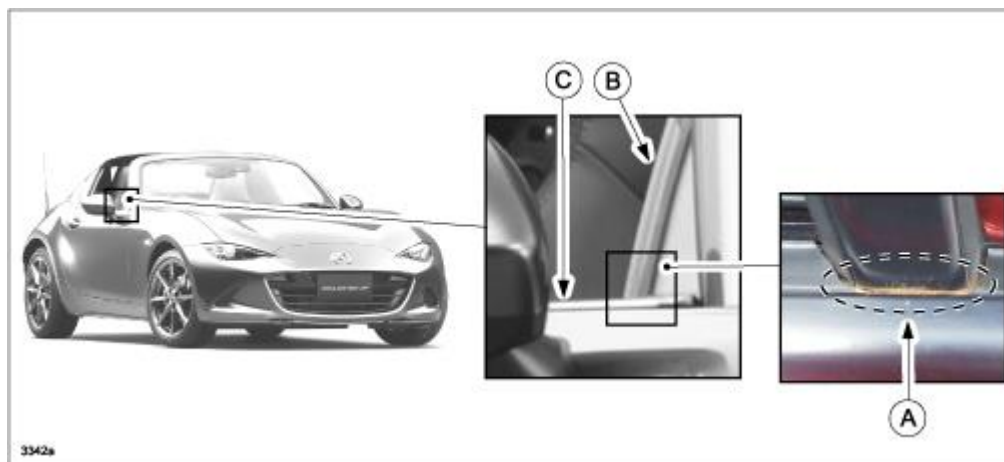
Some vehicles may exhibit rust (A) on the front door quarter glass guide (B) where it contacts the door beltline molding (C). The paint on the quarter glass guide gets damaged from vibration when the door is closed and when driving.

This concern is caused by the beltline molding contacting the quarter glass guide due to production variances. To correct this concern, a spacer has been attached at the contact area to assure an appropriate clearance between the beltline molding and the quarter glass guide.
Customers having this concern should have their vehicle repaired using the following repair procedure.

1. Verify the customer concern.
2. Replace the affected side front beltline molding(s) with a modified one(s) according to the procedure "FRONT BELTLINE MOLDING REMOVAL/INSTALLATION" on MGSS .
3. Replace the affected side front door quarter glass guide(s) (A) on the door quarter glass (B) with a new one(s) according to the procedure "DOOR QUARTER GLASS REMOVAL/INSTALLATION" on MGSS. (C: Bolt, D: Nut)
