Service Alert

Subject: CHECK ENGINE LIGHT ON WITH DTCs P2A04:00, P2272:00 AND/OR OTHER DTCs	Service Alert No.: SA-004/19
	Last Issued: 02/04/2019

2007-2015 CX-9

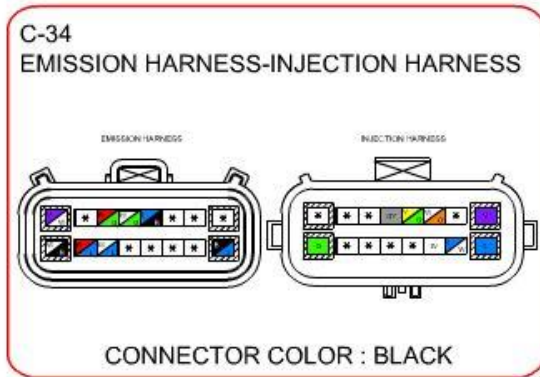
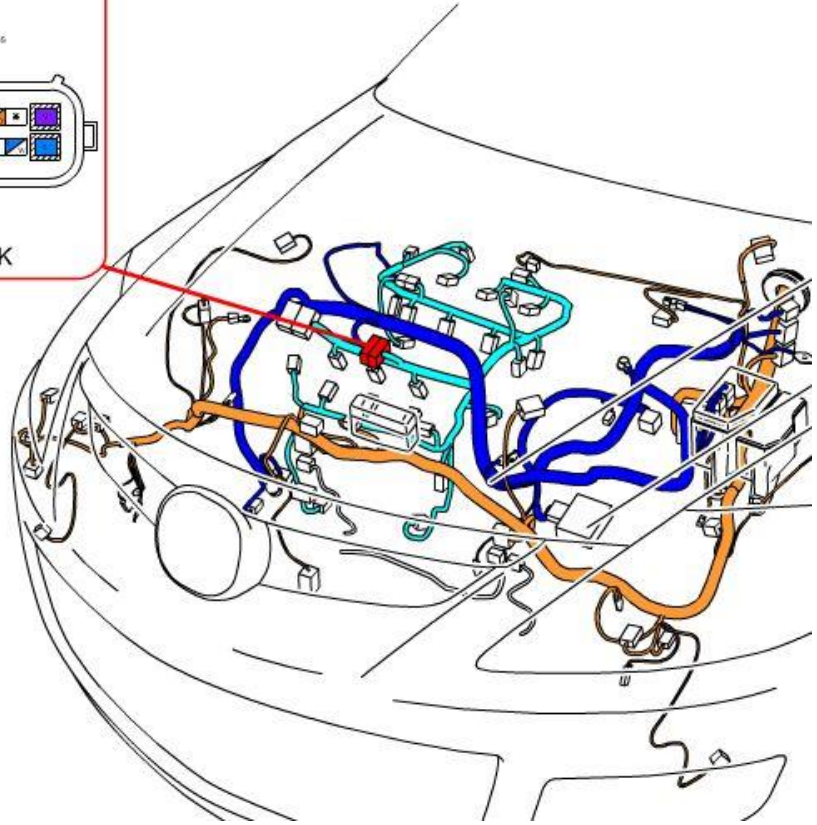
1. Verify the customer concern.
2. Inspect the C-34 connector (shown below) for engine oil contamination.

- If oil contamination is present in the C-34 connector, perform the following steps:

- a. Inspect the engine oil pressure switch for external leaks.
- b. If external leak is found, replace the engine oil pressure switch.
- c. Clean the C-34 connector and harness of oil contamination, then go to step 3.
