## STEERING COLUMN UNIVERSAL JOINT VISUAL INSPECTION

Prevost vehicles

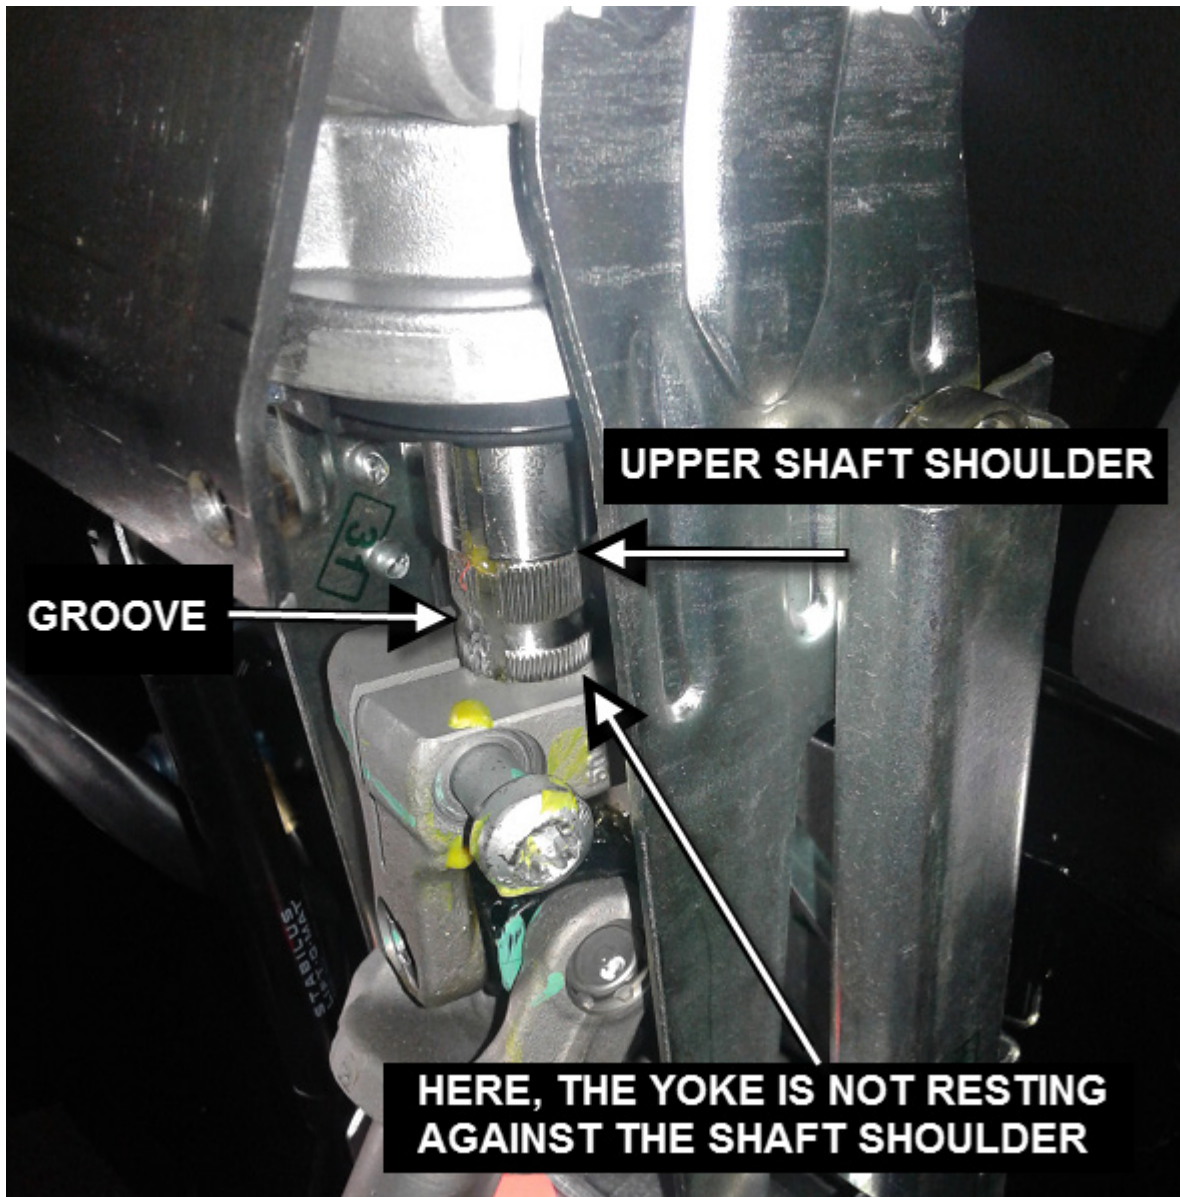
1. Perform a visual inspection of the steering column. First, remove the plastic covers.
2. Make sure that the upper shaft is properly and fully engaged in the yoke. The yoke must rest against the upper shaft shoulder.

**NOT CORRECT**

3. IF THE YOKE IS NOT PROPERLY RESTING AGAINST THE UPPER SHAFT SHOULDER, loosen the pinch bolt.
4. Make sure that the shaft is properly inserted in the yoke bore and that the yoke is pressed against the shaft shoulder. To prevent the yoke from disengaging, the bolt fits in a groove (see picture above).

Tighten the pinch bolt to: **46 lbf-ft**

5. Apply torque seal mark.
6. Reinstall the steering column covers.
