March 7, 2019

Multiple Indicators On and Option Fuse (E21 or B7) Blown

Supersedes 19-005, dated February 19, 2019, to revise the information highlighted in **yellow**

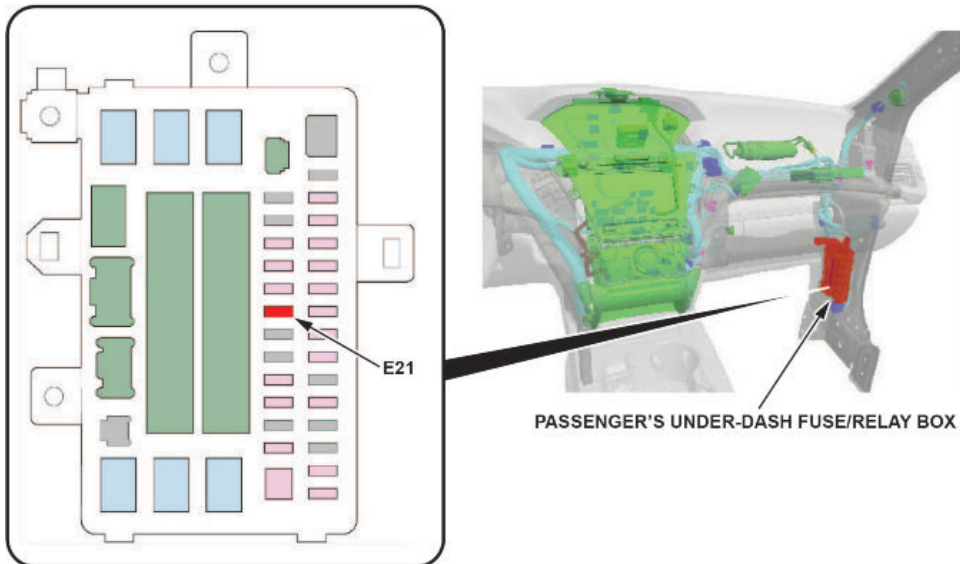
MDX

Under certain conditions, the battery fan motor draws excessive current causing the option fuse to blow.

1. Check the option fuse.

- If the option fuse is blown, replace the blower fan motor. Refer to the service information. Then go to step 2.
- If the option fuse is not blown, this bulletin does not apply. Continue with normal system troubleshooting.

2. Replace the option fuse (7.5 A).
