# Technical Service Bulletin

CONDENSATION / FOG IN FRONT AND REAR COMBINATION LAMPS (HEADLAMP AND TAILLAMP ASSEMBLIES)

**Bulletin No.:** 09-003/19

Last Issued: 03/15/2019

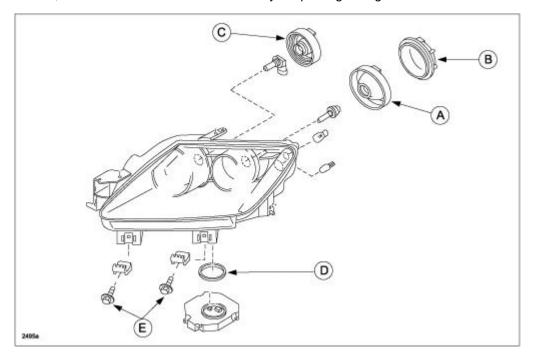
When dealing with customer complaints of excessive condensation and/or water within the headlamp unit, first determine if all the bulb sockets (including O-ring), seals and covers are present and correctly installed. In most cases you will find that the Bulb Seal No. 1 (A) or HID Bulb Seal No. 1 (B) and Bulb Seal No. 2 (C) socket covers have not been correctly installed or are missing due to improper prior repairs (i.e., customer replacing the headlamp bulbs or body shop not transferring them when replacing the headlamp unit(s) due to a collision). Any damage caused by missing socket covers, HID module seal (D), or missing bumper brackets (E) is not covered by warranty policy. If none of these issues exists, explain to the customer that this is a natural phenomenon and not a quality defect. DO NOT attempt repairs as this is considered normal, and is NOT covered under Warranty. Replacing the light unit will not correct this symptom.

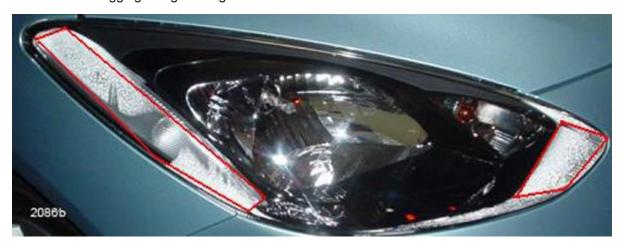
Condensation/fogging along the edges and in the corners is considered normal.

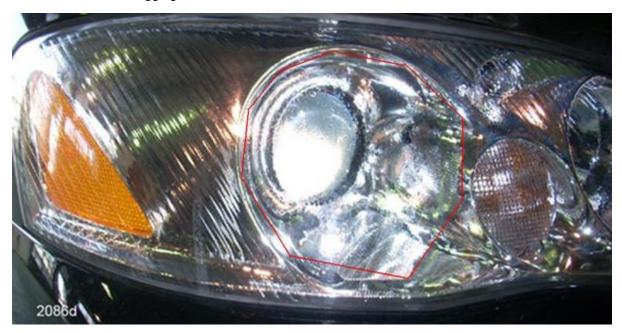
Some condensation/fogging on the lens is considered normal.

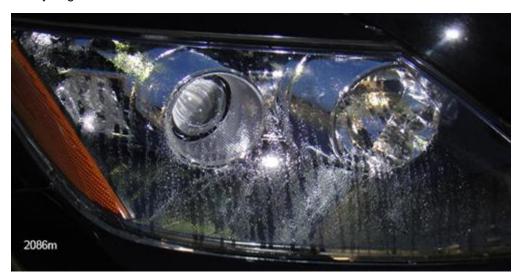
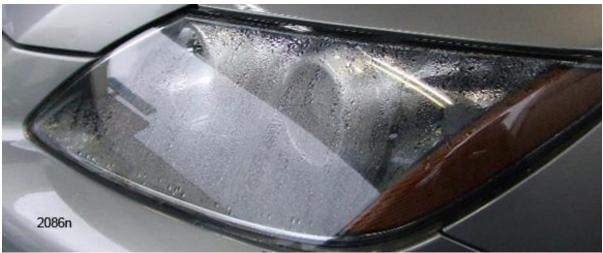
Heavy/large amount of condensation on the lens is not normal.

- The location where the bulbs are fitted has a high air volume with good air circulation, therefore, if a
  large or heavy amount of condensation appears here, the light unit should be replaced. A small
  amount of condensation here is considered normal and should clear after the lights have been on
  for some time and the light unit should not be replaced. Refer to the following pictures for examples.
- If the outside conditions are unfavorable (cold and damp), even fog (dew concentration) as shown in the following pictures will take some time to clear up. Therefore, be careful in making a decision. A picture will be required with every claim for Warranty. If a light unit is found with no problem, and no picture is sent in, the claim may be later debited. You can also perform the following test to determine if the light unit should be replaced.
