Technical Service Bulletin

Subject: LIFTGATE OPENER SWITCH INOPERATIVE	Bulletin No.: 09-012/19
	Last Issued: 03/04/2019

2016-2018 CX-9 vehicles with VINs lower than JM3TC*****237357 (produced before June 30, 2018)

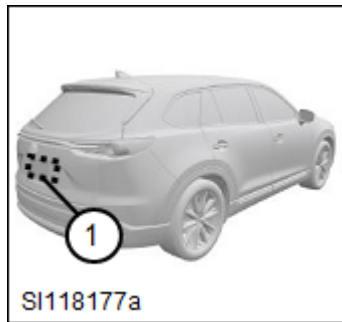
While stopped with the transmission in Park position, some vehicles may exhibit concerns that the liftgate unlatches itself without pressing the liftgate opener switch (1) or it will not unlatch when pressing the liftgate opener switch (1).

This concern may be caused by water entry into the liftgate, through the garnish mounting area or outer panel. Condensation water may enter into the liftgate and drip onto the liftgate opener switch causing corrosion. The corrosion may create a poor contact or short in the liftgate opener switch.

To eliminate this concern in the future, the structure of the liftgate opener switch has been improved.

1. Verify the customer concern.
2. Replace the liftgate opener switch with a new one (including water-proof sheet) according to the instructions on MGSS online: LIFTGATE OPENER SWITCH REMOVAL/INSTALLATION.
