Technical Service Bulletin

Subject: REAR COMBINATION LIGHT(S) ARE FOGGY	Bulletin No.: 09-014/19
	Last Issued: 03/15/2019

2017-2018 CX-5 vehicles with VINs lower than JM3KF*****356208 (produced before Feb. 6, 2018)

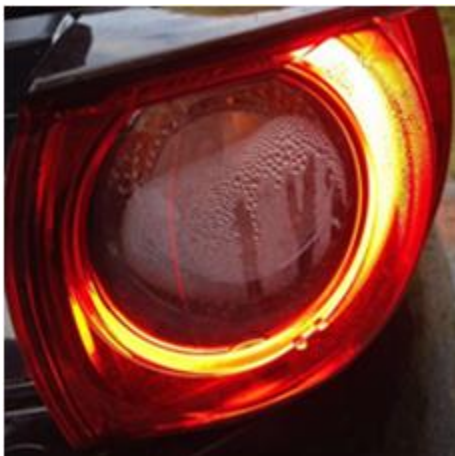
Some customers may complain of foggy rear combination lights (as shown below) after a car wash or heavy rain.

This concern may be caused by water entering into the rear combination lights through the ventilation tubes. To eliminate this from occurring, the ventilation tubes have been changed to a ventilation cap design.

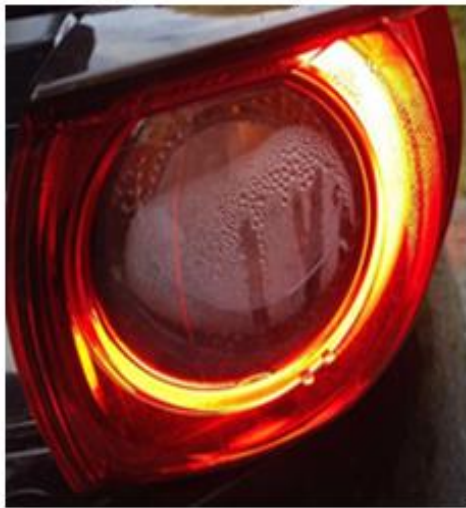
CONDENSATION RUNNING DOWN LENS - REPLACE LIGHT UNIT

1. Verify the customers concern of condensation inside the rear combination lights.
 - a. If condensation is found inside, replace both rear combination light units with new parts according to the instructions on MGSS online (REAR COMBINATION LIGHT REMOVAL/INSTALLATION).
 - b. If condensation is not found inside, go to Step 2.

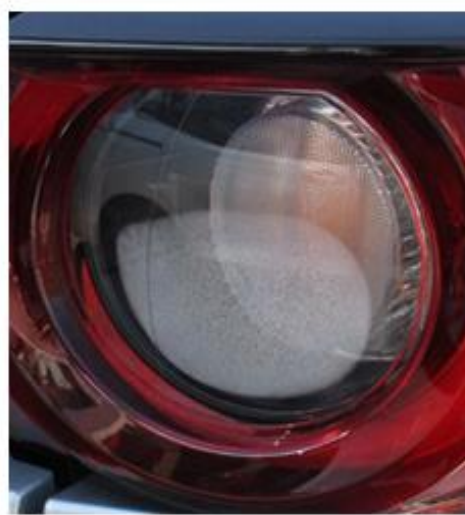
FOGGY UNIT - DO NOT REPLACE LIGHT UNIT

5. **Foggy Unit / No drops on lens:** Hold a dryer to the turn light bulb socket hole and blow **cold air** into the unit for 20 minutes to dry out the inside of the unit.
