Service Bulletin

Bulletin No.: 17-NA-201

Subject: Excessive Windshield Condensation, HVAC Defrost Door Flutter Type Noise Heard

Brand:	Model:	Model Year:		VIN:		Engine:	Transmission:
		from	to	from	to		
Chevrolet	Camaro	2016	2017

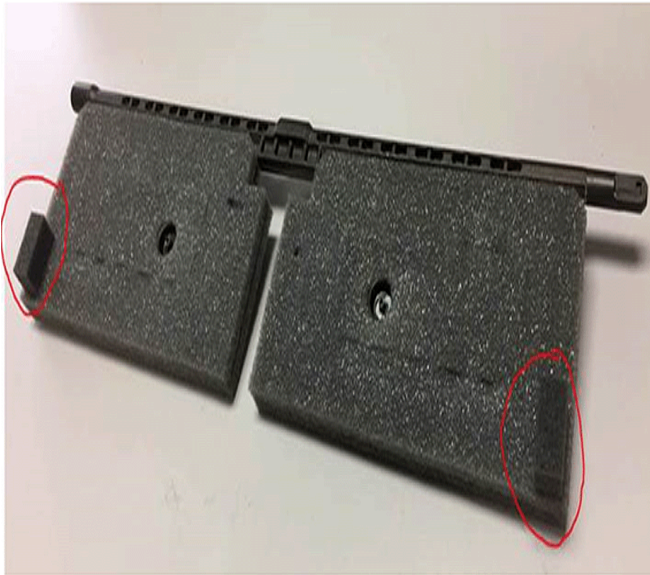
Involved Region or Country	North America and N.A. Export Regions
Condition	<p>Some customers may comment on one of the following conditions:</p> <ul style="list-style-type: none"> Vehicles built between October 15, 2015 – March 12, 2016, a flutter type noise may be heard from the HVAC when in manual mode and set to either floor or tri-level mode. Vehicles built on/after March 13, 2016 may have excessive condensation on the windshield above the center defrost vents.
Cause	<p>These may be caused by one of the following conditions:</p> <ul style="list-style-type: none"> Flutter noise may be due to the HVAC door making contact to the case during high fan speed. <div style="text-align: center;">

</div> <p style="text-align: right;">4779509</p> <ul style="list-style-type: none"> Windshield condensation may be due to the foam pads on the defrost door allowing too much air to pass through, causing excessive condensation on the outside of the windshield. <p>Note: During extreme humid conditions, some condensation can be considered normal.</p> <p>Additional Information: In certain settings, the system is designed to bleed air to the windshield to prevent it from fogging/freezing in cold weather conditions where the ambient temperature is extremely cold and the inside cabin temperature is hot. The best recommendation for customer comfort, and to prevent condensation during hot/humid ambient conditions and cold cabin air, is to place the AC in "auto" or manually set it to the "bi-level" (floor and vent/face/dash) position. Recommended temperature setting is between 68-72 degrees (20-22°C).</p>

- An updated software calibration has been released to address the flutter type noise condition.
- Remove both foam pads located on the defrost door to address the excessive windshield condensation then update the software to address the flutter issue that results when the foam is removed.
