Service Bulletin

Bulletin No.: PIE0501

Subject: Engineering Information – Service Engine Soon (SES) Light On, Rough Idle, Running Lean, Engine Air Leak From the Foul PCV Tube and/or Whistle Type Noise, DTCs P0171 and/or P0174 Set

Brand:	Model:	Model Year:		VIN:		Engine:	Transmission:
		from	to	from	to		
Chevrolet	Silverado 1500 (New Model)	2019	2019			Equipped with 5.3L or 6.2L Engine (RPOs L84, L87)	All
GMC	Sierra 1500 (New Model)

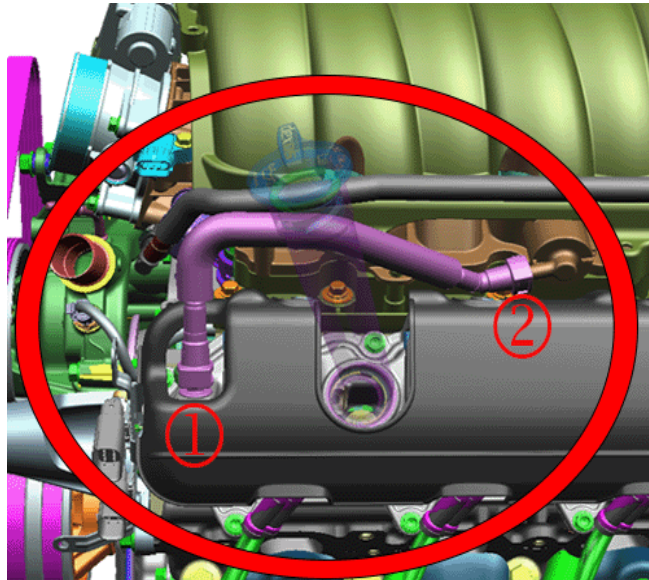
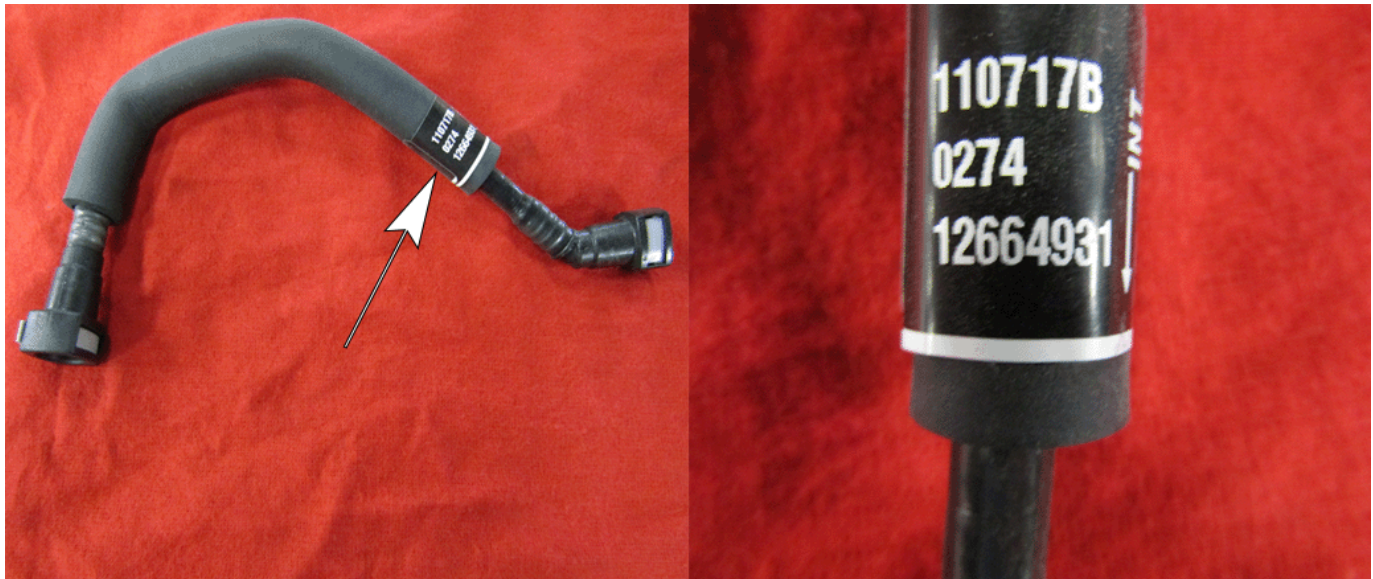
- VIN
- Location Number (shown in the illustrations below)
(RPO L84)

2. If proper tube is installed and oriented correctly then it will be necessary to smoke test to see if there is a leak. If a leak is discovered please take a picture of the leak location.
 - 2.1. If no smoke is detected, then tug on PCV tube ends (Location 1 or 2) to ensure the tube is seated. If tube was not fully seated then properly secure connection by pressing tube in until it clicks and the tube does not come off by pulling on it. Proceed to step 4.
 - 2.2. If smoke is detected, at either at the cover or manifold (Location 1 or 2) Remove and reinstall the same PCV tube to ensure both latches click. Proceed to Step 3.
 - 2.3. If the tube is cracked or damaged in any other location besides (1 or 2) then it will be necessary to remove and replace with a new tube. Proceed to step 4.

3. Repeat smoke test to verify condition is still present. If leak is still present at (Location 1 or 2) remove tube and inspect O-ring seals inside, look for damage or missing O-rings. Take images of findings. Replace with new tube if damage is found. Proceed to step 4.

7. Replace PCV tube with a new PCV tube and repeat steps 4-6 to verify new tube has fixed the concern.
 - If condition is repaired document findings and return vehicle to customer.
