GROUP	MODEL
СНА	2011-2014MY Optima (QF) 2016-2018MY Sorento (UMa)
NUMBER	DATE
060 (Rev 4, 02/15/2019)	January 2016

# TECHNICAL SERVICE BULLETIN

**SUBJECT:** ECU UPGRADE – STEERING LOGIC IMPROVEMENT

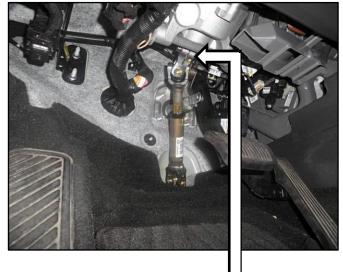
Remove the top bolt from the universal joint. NOTE: place a mark across the universal joint to make reinstallation easier.

After disconnecting the universal joint, do NOT turn the steering wheel more than 270° to prevent damage to the clock spring.

Tightening torque: 21.7 – 25.7lb.ft (29.4 – 34.3N.m)

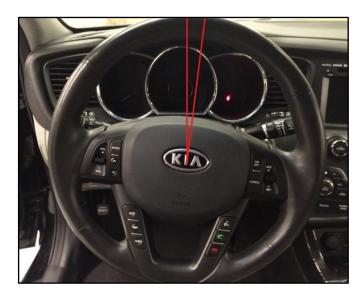
2. Prior to starting the MDPS effort measurement test (page 3), position the steering wheel slightly to the right, as shown, with the Steering Angle Sensor (SAS) in the positive range. NOTE: attempting to start the steering effort test with the SAS in the negative range will trigger an error message and prevent the test from running.

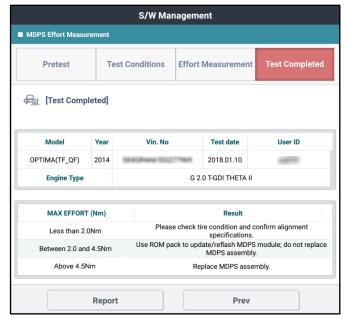
14. Refer to the table below for the correct course of action after the 'Test Completed' screen is displayed. NOTE: select Report to save the report for future reference.

Item	Max. Effort	Remedy	Proceed to	
Steering Effort Value	0 - 1.5 lb.ft (0 - 2.0 Nm)	No further action is required	N/A	
	1.5 - 3.3 lb.ft (2.0 - 4.5 Nm)	ECU Upgrade	Page 7	
	3.3 lb.ft (4.5Nm) or higher	Replace MDPS	Page 12

If no further action is required, reinstall the universal joint and secure in place using the original bolt.

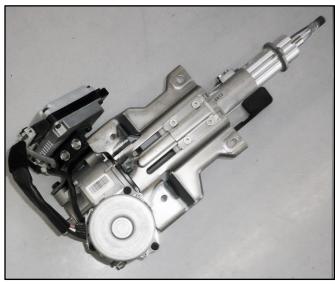
#### MDPS Replacement Procedure (for MDPS Effort Value greater than 3.3lb.ft/4.5N.m):

Replace the MDPS assembly by referring to the "Steering System → Electric Power Steering → Steering Column and Shaft → Repair procedures" chapter in the applicable Shop Manual on KGIS.
